RE: Notice Pursuant to 49 CFR Sec. 573.5

SKF USA Inc. ("SKF") has determined that a defect which relates to motor vehicle safety exists in an item of motor vehicle equipment manufactured by SKF at its Glasgow, KY plant. The item of equipment that is of concern is a hub unit that is more particularly described below.

The item of equipment that contains the safety related defect is identified by SKF as its part number BR930361 (the "Hub Unit"). The applications for the Hub Unit are: The front axles of the Dodge Durango, model years 1999-2003, equipped with 2-wheel drive, rear wheel ABS; and the Dodge Dakota, model years 1997-2004, also equipped with 2-wheel drive, rear wheel ABS. The Hub Unit was a new product in that it was not manufactured by SKF prior to its initial production by SKF at its Glasgow, Kentucky plant. Production of the Hub Unit commenced in April, 2008. SKF did not supply the Hub Unit to any vehicle or other manufacturer, but sold the Hub Unit as a service part into the vehicle service market starting in June, 2008.

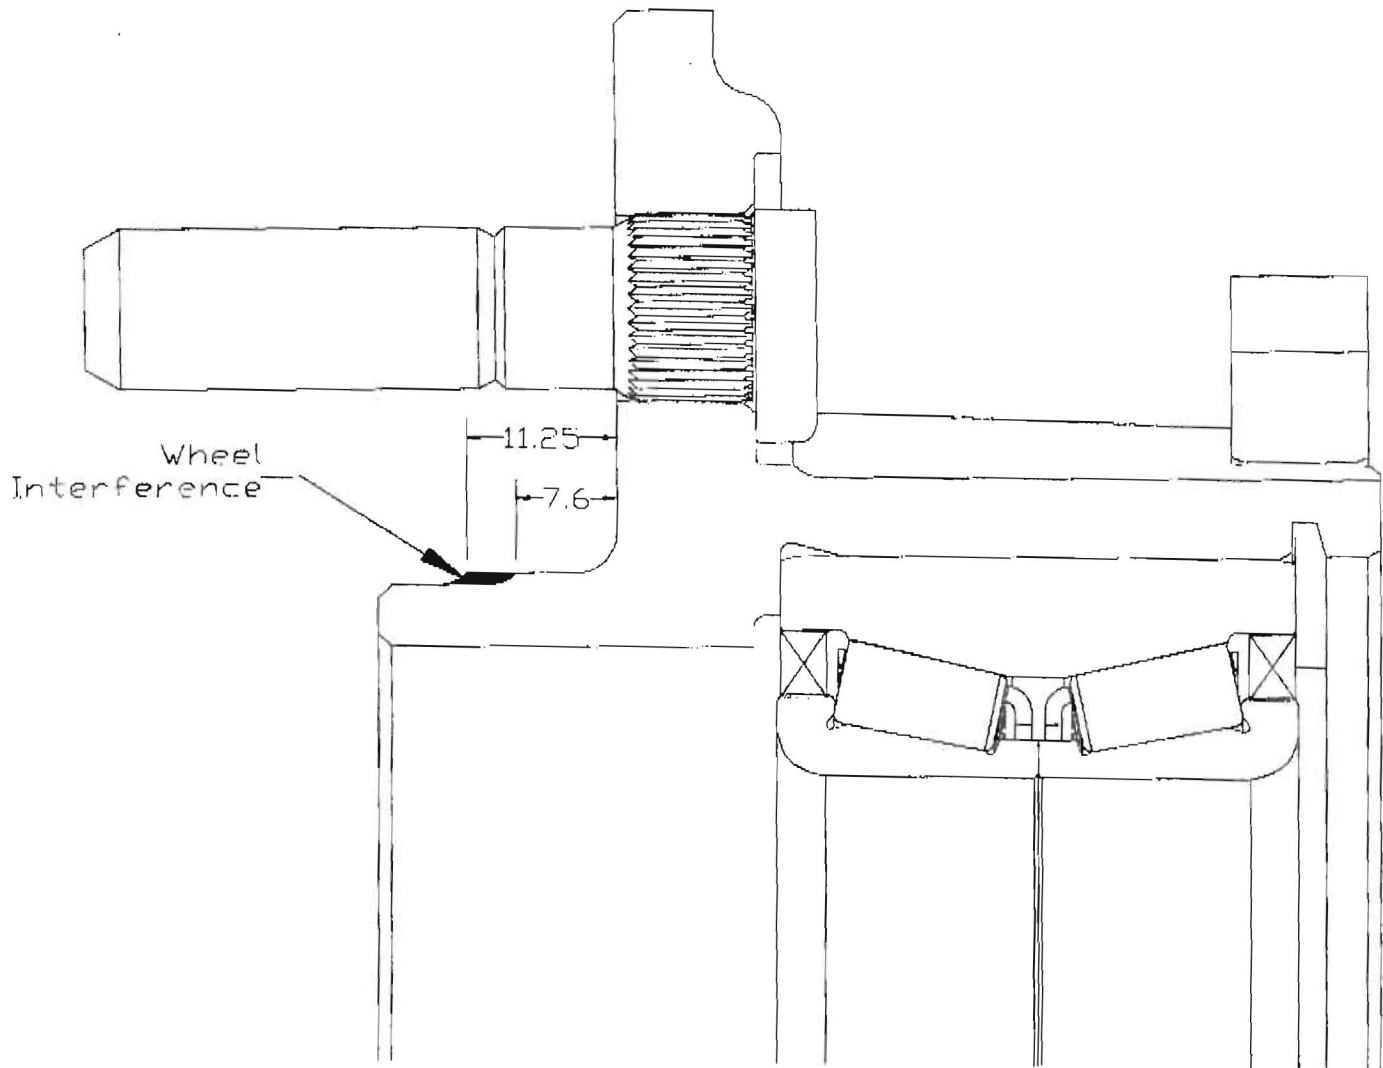
EXHIBIT II

The defect resulted from an error in a specification for the length of the rotor pilot for the Hub Unit. The error was contained in a manufacturing product drawing provided to SKF's Glasgow, Kentucky plant to manufacture the Hub Units. The specification indicated in the drawing was too long. The dimension specified was 11.25 mm. The correct dimension is 7.6 mm. This results in the wheel not seating fully against the hub

flange face during mounting. The error in specifying the length of the rotor pilot resulted in excess material remaining on the rotor pilot which prevents the wheel from fully seating against the hub flange face. Exhibit II attached to this notice indicates the location of the defect.

The defect is believed to result in excessive vibration, which likely is communicated through the steering system of the vehicle, and to also cause excessive noise prior to failure. However, SKF's investigation is not complete, and it is not certain if wheel-end separation would always be preceded by the symptoms of excessive vibration and noise. The mode of failure consists of improper mating of the wheel to the hub flange face, which can lead to brake rotor noise, excessive vibration, difficulty removing the wheel after installation and operation of the vehicle, and wheel-end separation during vehicle operation. As of the date of this notice, SKF has only one report from the field of a wheel-end separation.

SKF proposes to replace, at its expense, all the Hub Units in the suspect population of parts manufactured at its Glasgow, Kentucky plant. SKF has 4,000 pieces of correctly finished Hub Units in stock at its Glasgow plant which can be used to support the recall. The specifics of the recall program to affect a remedy are yet to be determined by SKF.
