Safety Defect and Noncompliance Report Guide for Vehicles

Part 573 Defect and Noncompliance Report

The manufacturer's identification number for this recall is 07V-343.

Re: Defect Information Report FL-509, ZF 8018 Steering Gear Spacer

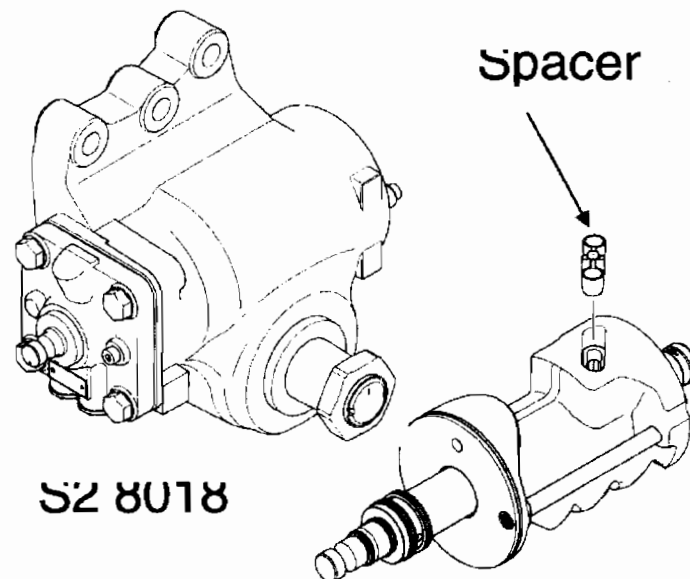
The SPACER's role is to keep the recirculation semi-tube in position. Play between the recirculation semi-tube and the ball circulation may result from the insufficient height of the 8016 type spacer (compared with the height of the correct 8018 type spacer). Consequently, the balls do not return in the circuit.

Within an undefined period, all 21 balls leave the circuit, or they are destroyed by a mechanical pressing force.

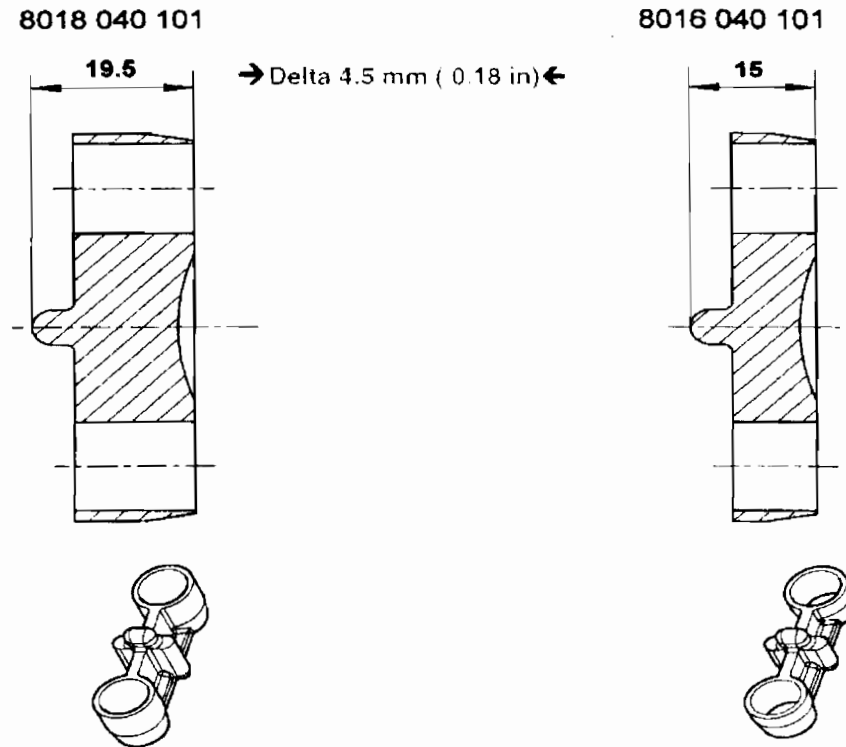
Employee / assembly failure: Spacer from 8016 type incorrectly assembled in 8018 steering gear. The form of the 8016 and 8018 spacers is identical on two levels; the only difference is that of the height, because of the different diameters of the pistons!

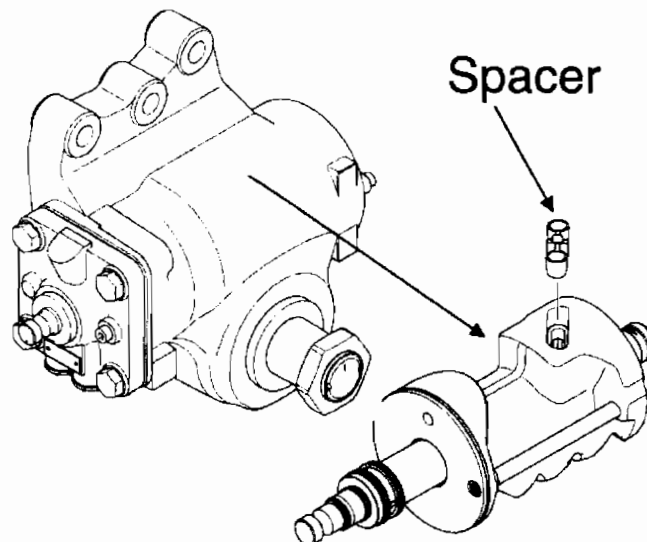
As part of our continuous product monitoring process we received some Servocom S2, type 8018, back from the field for analysis. The result of the examinations of the steering gears showed that a spacer with the wrong dimensions had been fitted in our assembly.

The role of the SPACER is to ensure the return function of the recirculating balls.

If the height of the spacer which has been installed is insufficient, the play in the return function of the recirculating balls is excessive. As a consequence there is a failure in the circulatory function of these balls. The vehicle operator will recognize this failure mode as a higher force required at the steering wheel or would recognize a requirement for more steering wheel adjustment while driving in a straight line. If the failure mode is allowed to continue, the final result will be the interruption in the connection between the steering wheel and the wheels of the vehicle. In this case the vehicle can no longer be steered.

We urgently recommend that a meeting be scheduled to define the further steps which should be taken.

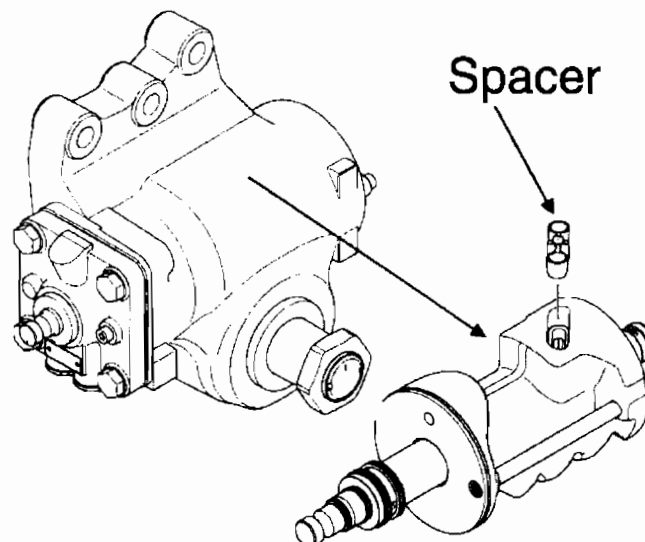
As part of our continuous product monitoring process we received some Servocom S2, type 8018, back from the field for analysis. The result of the examinations of the steering gears showed that a spacer with the wrong dimensions had been fitted in our assembly.

The role of the SPACER is to ensure the return function of the recirculating balls.

If the height of the spacer which has been installed is insufficient, the play in the return function of the recirculating balls is excessive. As a consequence there is a failure in the circulatory function of these balls. The vehicle operator will recognize this failure mode as a higher force required at the steering wheel or would recognize a requirement for more steering wheel adjustment while driving in a straight line. If the failure mode is allowed to continue, the final result will be the interruption in the connection between the steering wheel and the wheels of the vehicle. In this case the vehicle can no longer be steered.

We urgently recommend that a meeting be scheduled to define the further steps which should be taken.

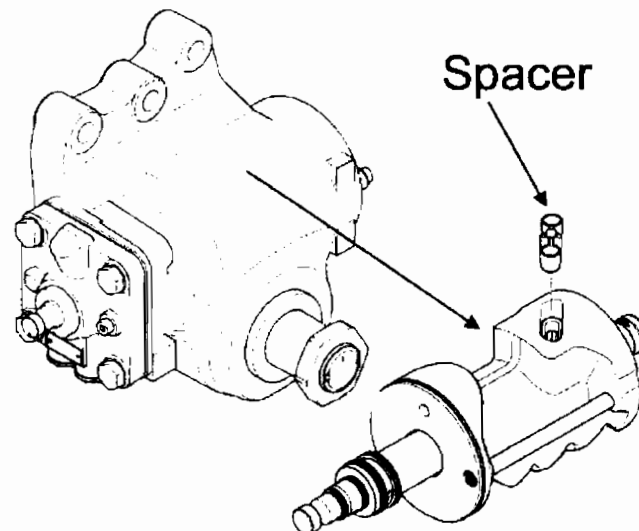
As part of our continuous product monitoring process we received some Servocom S2, type 8018, back from the field for analysis. The result of the examinations of the steering gears showed that a spacer with the wrong dimensions had been fitted in our assembly.

The role of the SPACER is to ensure the return function of the recirculating balls.

If the height of the spacer which has been installed is insufficient, the play in the return function of the recirculating balls is excessive. As a consequence there is a failure in the circulatory function of these balls. The vehicle operator will recognize this failure mode as a higher force required at the steering wheel or would recognize a requirement for more steering wheel adjustment while driving in a straight line. If the failure mode is allowed to continue, the final result will be the interruption in the connection between the steering wheel and the wheels of the vehicle. In this case the vehicle can no longer be steered.

We urgently recommend that a meeting be scheduled to define the further steps which should be taken.

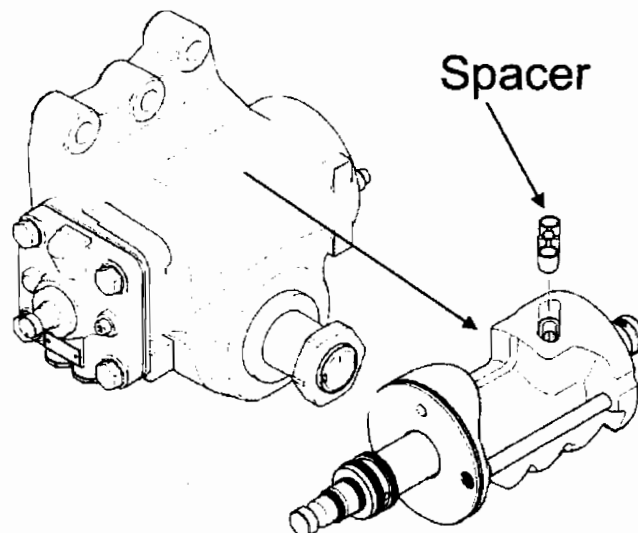
As part of our continuous product monitoring process we received some Servocom S2, type 8018, back from the field for analysis. The result of the examinations of the steering gears showed that a spacer with the wrong dimensions had been fitted in our assembly.

The role of the SPACER is to ensure the return function of the recirculating balls.

If the height of the spacer which has been installed is insufficient, the play in the return function of the recirculating balls is excessive. As a consequence there is a failure in the circulatory function of these balls. The vehicle operator will recognize this failure mode as a higher force required at the steering wheel or would recognize a requirement for more steering wheel adjustment while driving in a straight line. If the failure mode is allowed to continue, the final result will be the interruption in the connection between the steering wheel and the wheels of the vehicle. In this case the vehicle can no longer be steered.

We urgently recommend that a meeting be scheduled to define the further steps which should be taken.

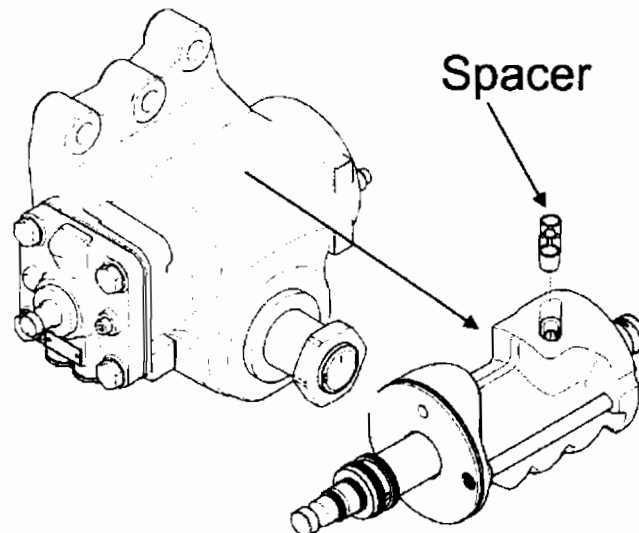
As part of our continuous product monitoring process we received some Servocom S2, type 8018, back from the field for analysis. The result of the examinations of the steering gears showed that a spacer with the wrong dimensions had been fitted in our assembly.

The role of the SPACER is to ensure the return function of the recirculating balls.

If the height of the spacer which has been installed is insufficient, the play in the return function of the recirculating balls is excessive. As a consequence there is a failure in the circulatory function of these balls. The vehicle operator will recognize this failure mode as a higher force required at the steering wheel or would recognize a requirement for more steering wheel adjustment while driving in a straight line. If the failure mode is allowed to continue, the final result will be the interruption in the connection between the steering wheel and the wheels of the vehicle. In this case the vehicle can no longer be steered.

We urgently recommend that a meeting be scheduled to define the further steps which should be taken.

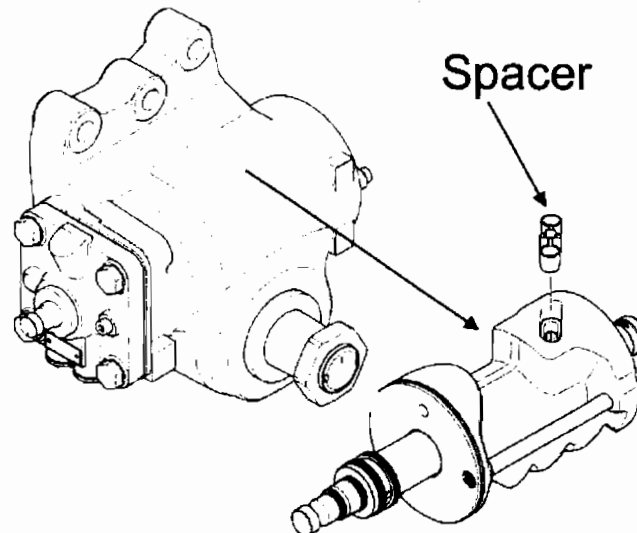
As part of our continuous product monitoring process we received some Servocom S2, type 8018, back from the field for analysis. The result of the examinations of the steering gears showed that a spacer with the wrong dimensions had been fitted in our assembly.

The role of the SPACER is to ensure the return function of the recirculating balls.

If the height of the spacer which has been installed is insufficient, the play in the return function of the recirculating balls is excessive. As a consequence there is a failure in the circulatory function of these balls. The vehicle operator will recognize this failure mode as a higher force required at the steering wheel or would recognize a requirement for more steering wheel adjustment while driving in a straight line. If the failure mode is allowed to continue, the final result will be the interruption in the connection between the steering wheel and the wheels of the vehicle. In this case the vehicle can no longer be steered.

We urgently recommend that a meeting be scheduled to define the further steps which should be taken.
