Re: Goshen Coach
Defect and Non-Compliance Report

Subject: NHTSA Threshold Warning Signal Recall (Recall Number 06E-094)

Service Bulletin 34273

Instructions for Braun Corporation "Public and Private Use" Dual Parallel Arm Lift Threshold Sensitivity Evaluation and NHTSA Compliance Applicable for NL, NCL and NVL Series Lifts

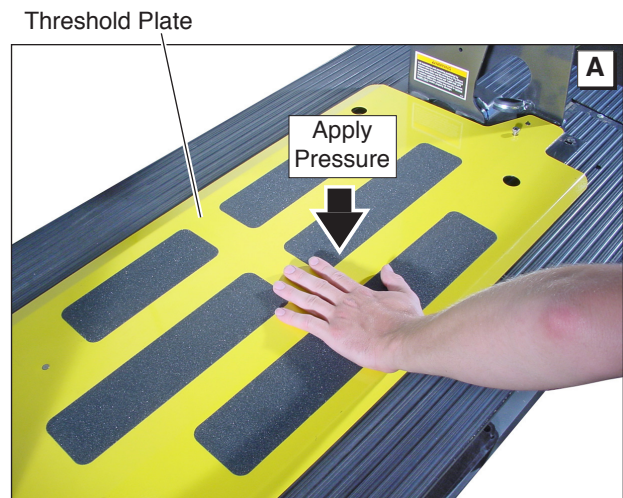
1. Turn Lift Power switch ON. Deploy the lift platform fully to the ground.
2. Apply hand pressure on the center of the threshold plate as shown in Photo A. The visual and/or audible threshold warning* should be activated when you push down.

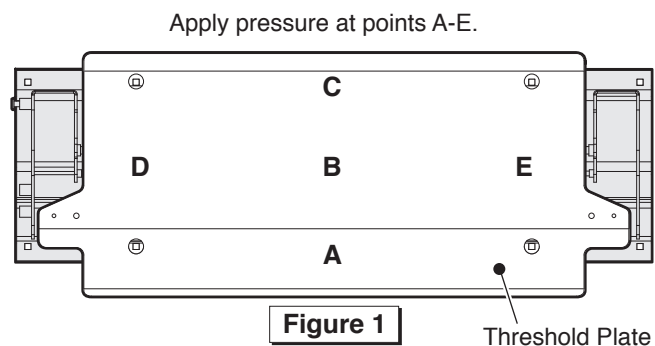
Repeat the sensitivity test procedure at positions A-E shown in Figure 1.

If the threshold alarm is not activated at all positions, perform the retrofit procedures detailed on pages 2 and 3 of this bulletin. Repeat the sensitivity test procedures following the retrofit. If the lift still does not meet the requirement, contact a Braun Corporation Product Support representative at 1-800-THE LIFT[®].

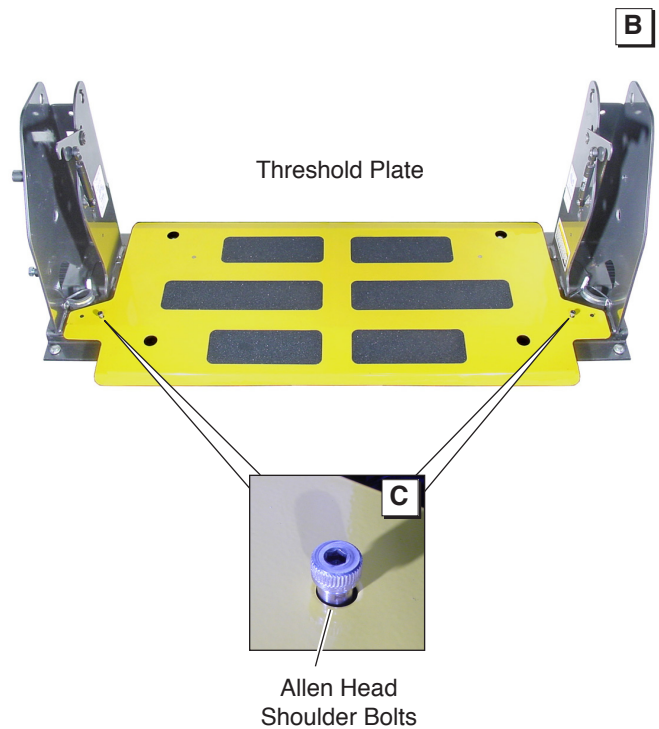
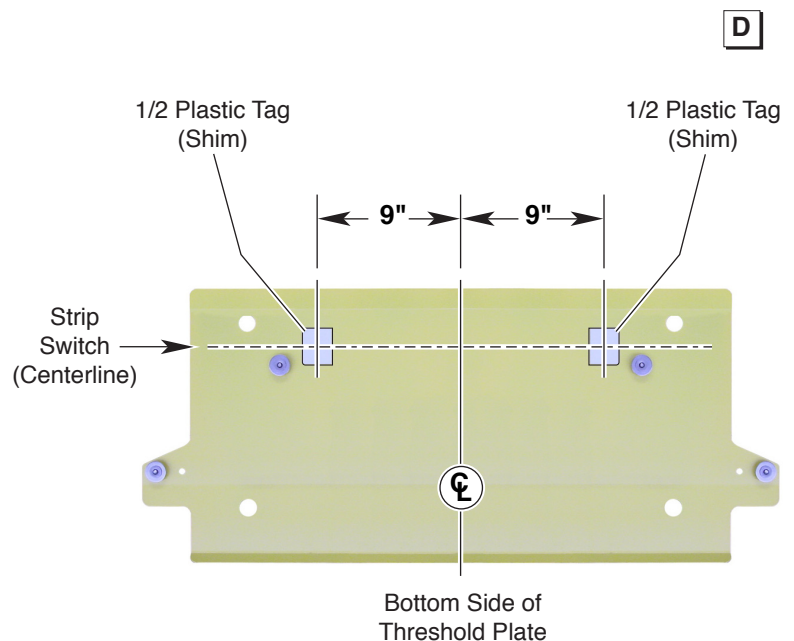
Turn threshold plate over. See Photo D. The strip switches typically leave an impression (mark) on the yellow plate from use. Use the impression of the inboard strip switch as a centerline for shim positioning (or measure to establish position).

Position each shim 9" from the center of the threshold plate (see Photo D). Align the tags with the strip switch centerline. Clean the surface as detailed below and affix the adhesive-backed tag to the plate (**press firmly**).

Note: Clean the surface with isopropyl alcohol before affixing the tag. Use a clean cloth or paper towels. Do not use oily shop rags. Wipe surface free of residue with dry portion of cleaning cloth.

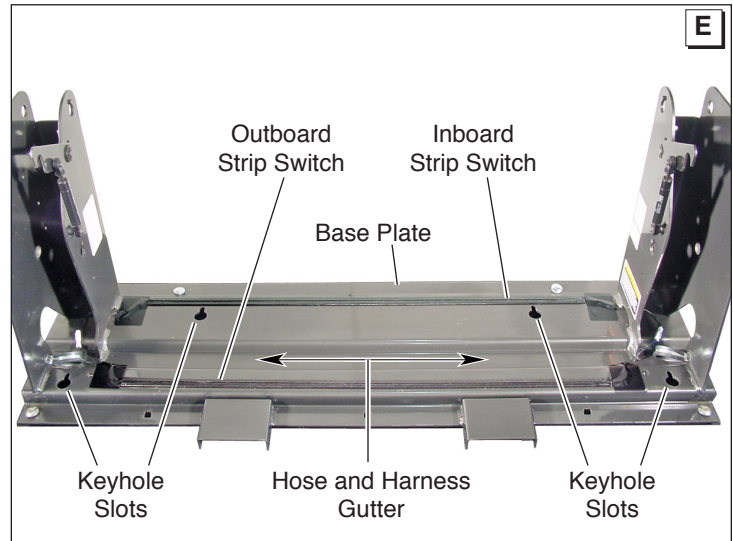
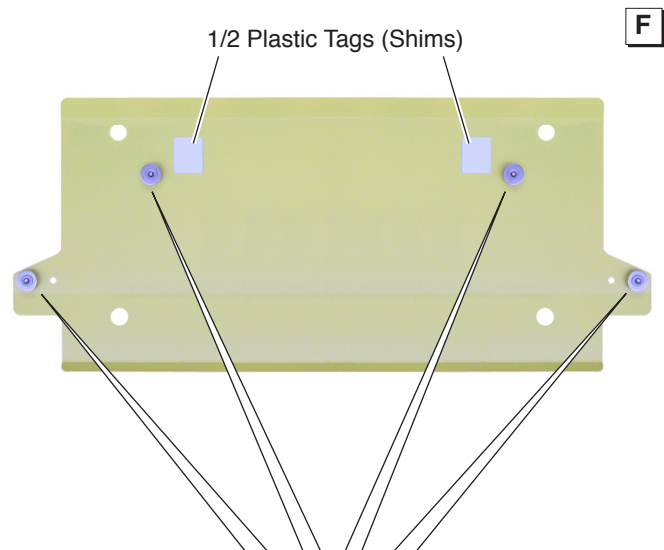
Ensure all hoses and wiring harnesses routed through the base plate gutter are positioned fully in the gutter and not located anywhere they could potentially interfere with activation of the tape switches. See Photo E.

4. Reposition the threshold plate (with shim). Align the keeper standoffs (studs) on the bottom of the threshold plate with the base plate keyhole slots. See Photos E, F and G. Insert studs and **carefully** slide the plate inward (engage slots fully).

Note: Spraying a light mist of glass cleaner (or other) to the strip switches will aid in the plate sliding easier into position. See Photos E, F and G.

Ensure all four keeper standoffs engage the base plate keyhole slots.
