Re: Defect Information Report FL-521, Air Disk Brake Bolts

Defect Information Report (Section 573.6)

Model(s) affected: Columbia, Cascadia, Century Class, and XCR Chassis

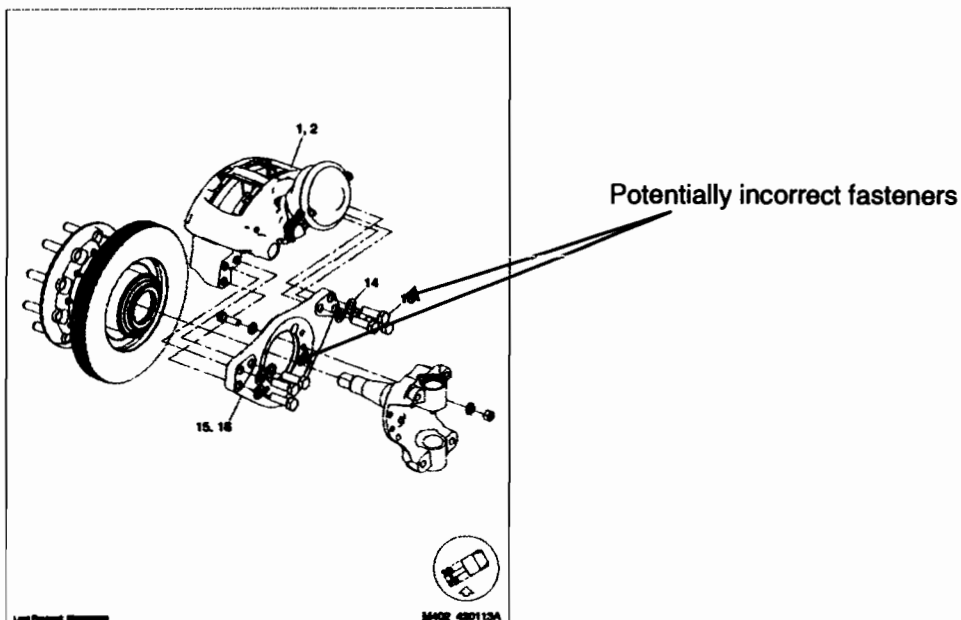
(c)(5) Description of the defect: $\frac{3}{4}$ x 10 standard fasteners may have been used in place of M20 x 2.5 metric fasteners to attach the brake caliper to the brake anchor plate.

49CFR Section 577.5(f) Evaluation of the risk to motor vehicle safety: Incorrect fasteners may not provide adequate clamping force between the brake caliper and brake anchor plate potentially resulting in reduce brake effectiveness. Reduced brake effectiveness could lead to a vehicle crash.

- (c)(6) **Chronology of principal events:** 11/11/07 Freightliner Custom Chassis received a report of a left front wheel locking up on an air disk break equipped vehicle. 11/19/2007 issue determined to be cause by incorrect fasteners installed at ArvinMeritor York facility. Containment action implemented.

- (c)(7) **Noncompliance-test or other data:** Not applicable
- (c)(8) **Remedial program:** Potentially affected vehicles will be inspected to determine if incorrect bolts were used. If incorrect bolts are found, vehicles will be inspected for possible additional damage and repaired as required. Repairs will be performed by Daimler Trucks North America dealerships and Direct Warranty customers, i.e., customers approved by Daimler Trucks North America to do their own warranty repairs.
Estimated dealer notification date – March 21, 2008
