08V-059  
(12 pages)

**DEFECT INFORMATION REPORT FOR CHRYSLER LLC RECALL H03**

## **Safety Recall #03 Front Control Module**

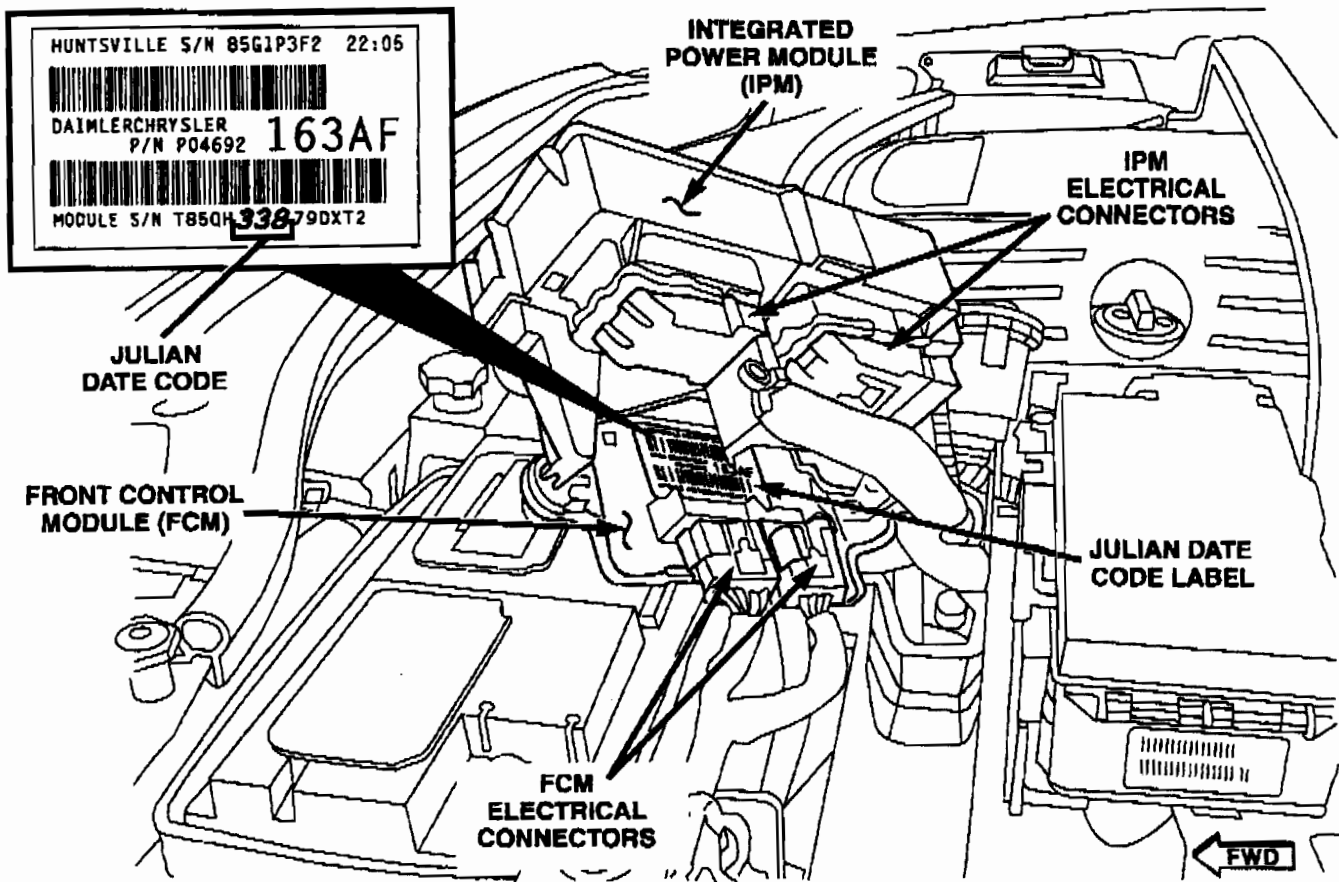
Figure 3

3. Inspect the Julian date code on the label located on the backside of the FCM (Figure 3).

**NOTE: The Julian date is the 6<sup>th</sup>, 7<sup>th</sup>, and 8<sup>th</sup> character in the bottom row of numbers (Figure 3).**

- If the Julian date code is lower than 337 or higher than 339 the FCM **does not** require replacement. Continue with Step 15 of this procedure.
- If the Julian date code is 337, 338, or 339 the FCM **must be replaced**. Continue with Step 3 of this procedure.
