Safety Defect and Noncompliance Report Guide for Vehicles  
**PART 573 Defect and Noncompliance Report**<sup>(1)</sup>

**08V-080**  
**(10 pages)**

**Make(s):** Toyota **Model Years Involved:** 2007 **Model(s):** Tundra

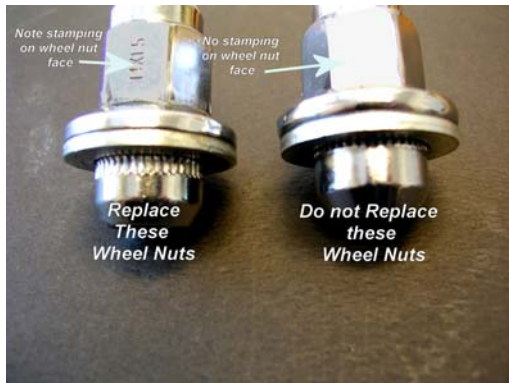
The wheel nuts can be overtorqued and break

The recalled component has a code stamped on the face of the wheel nut (see picture). The remedy component does not have this code.

A new wheel nut is the remedy. This wheel nut is more robust and has been tested under severe applications.
