Re: AMENDED PART 573 NOTICE - MCI G4500 TAG SWING AXLE ARM
NHTSA CAMPAIGN NO.: 06V458000

PART 573 Defect and Noncompliance Report

MODEL	TYPE	SECTION/GROUP	DATE
G Series Coaches	Field Change Program	2 - Tag Axle	
SUBJECT TAG AXLE RETROFIT			
CONDITIONS

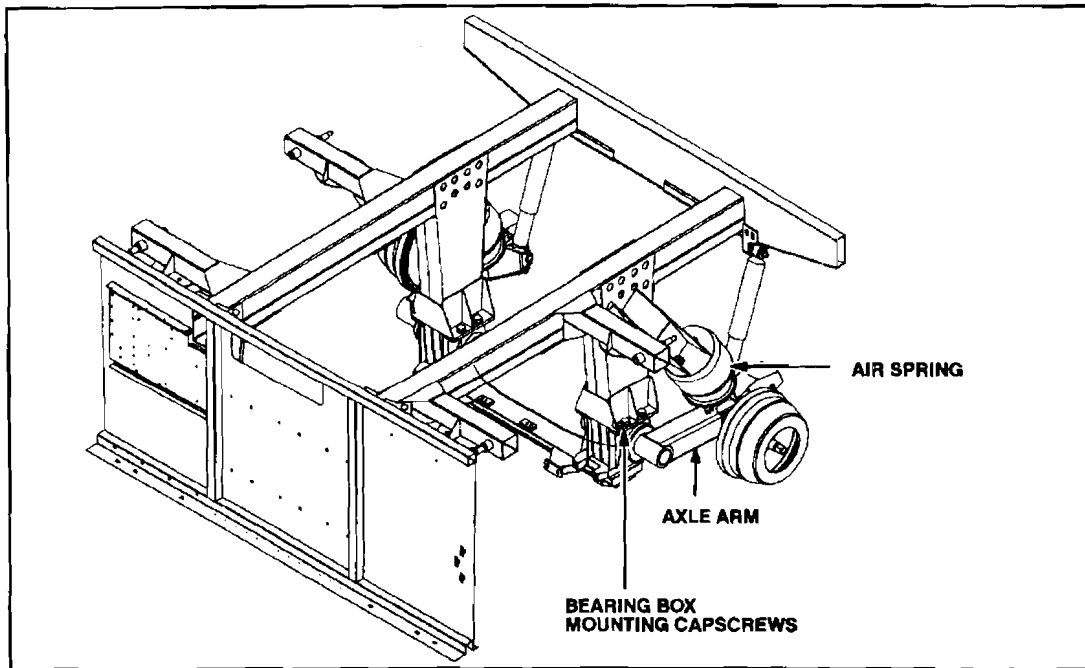
Figure 3.

7. Using solvent and a wire brush as necessary, carefully clean the welded joints on both tag axle assemblies. Visually inspect the LH and RH tag axle arm assemblies for cracks, paying particular attention to the welded areas.

IF NO CRACKS ARE PRESENT ON EITHER THE LH AND RH TAG AXLE ARM ASSEMBLIES INSTALL RETROFIT KIT P/N 26-02-0001, FOLLOWING THE OUTLINED STEPS 8. to 23.

IF CRACKS ARE PRESENT UPON TAG AXLE ARM INSPECTION ON EITHER OR BOTH THE LH AND RH TAG AXLE ARM ASSEMBLIES, NEW TAG AXLE ARMS WILL NEED TO BE INSTALLED ON BOTH SIDES OF THE THE COACH. PROCEED TO STEP 24.

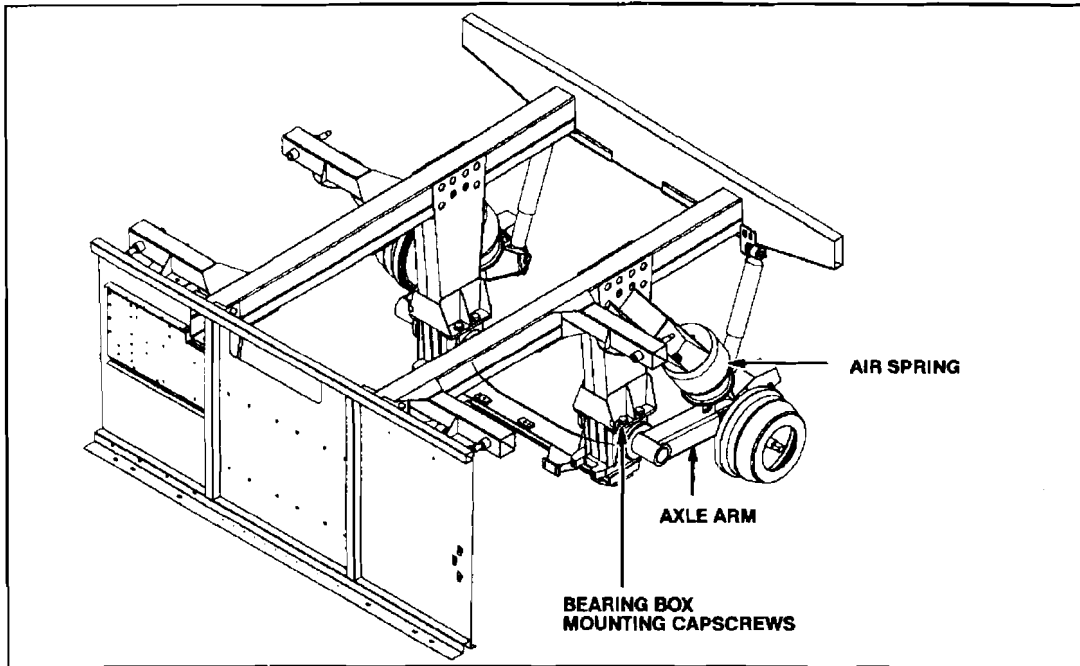
Figure 3.

7. Visually inspect the tag axle arm assembly for cracks.

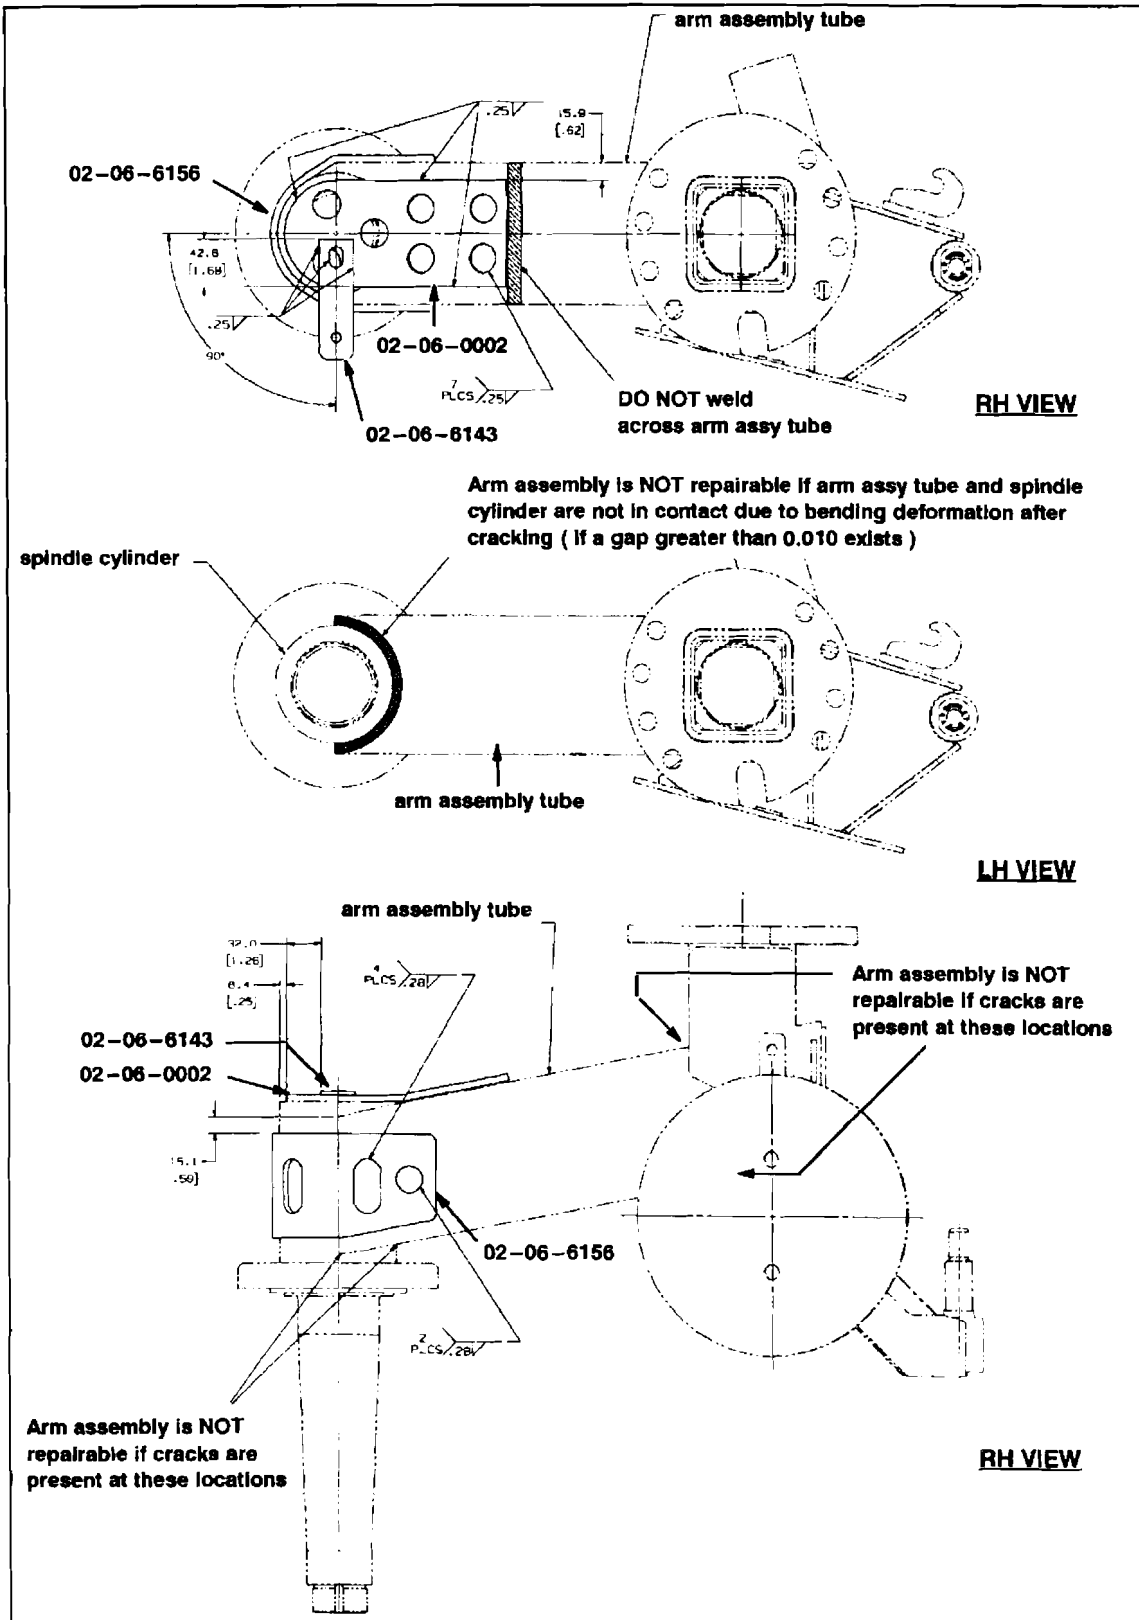
Figure 4.

4.8.1 Visual Inspection. For acceptable qualification, welds shall meet the following requirements;

- (1) The weld shall be free of cracks.*
- (2) All craters shall be filled to the full cross section of the weld.*
- (3) The face of the weld shall be flush with the face of the base metal, and the weld shall merge smoothly with the base metal. Undercut shall not exceed 1/32 in. (1 mm). Weld reinforcement shall not exceed 1/8 in. (3mm).*
- (4) The root of the weld shall be inspected, and there shall be no evidence of cracks, incomplete fusion, or inadequate joint penetration. A concave root surface is permitted within the limits shown below, provided the total weld thickness is equal to or greater than that of the base metal.*
- (5) The maximum root surface concavity shall be 1/16 in. (2 mm) and the maximum melt-through shall be 1/8 in. (3 mm). For tubular T-, Y-, and K. connections, melt-through at the root is considered desirable and shall not be cause for rejection.*
