08V-126  
AMENDED

**Re. : FMVSS Standard 573 - Defect and Noncompliance Responsibility and Reports**  
**Alternator B+ cable - Van Hool Model C2045**

**NHTSA ODI Resume - Investigation PE 08-003**

SB1210A

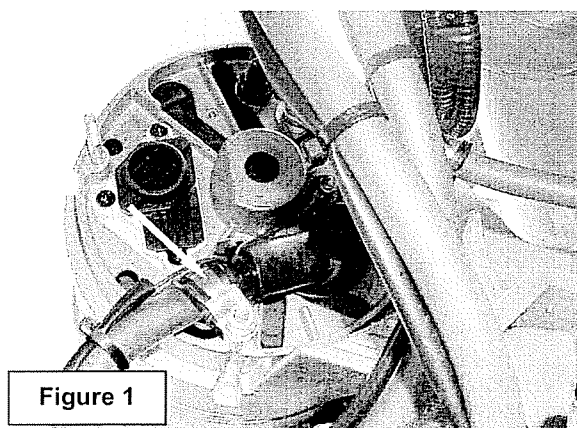
1. It has been determined that on the above-mentioned units a possible defect may exist which relates to motor vehicle safety.  
As a result of vibration the B+ alternator cable retention may fail through breakage of the B+ ring terminal. The positive battery cable detaching from the rear of the alternator could result in a loss of battery charging capability or cause a short-circuit and even start a fire.
2. To address these issues in production, a P-clamp is now fitted below the black PVC terminal cover in order to improve cable retention and ensure the service life of the terminal (Figure 1). This modification has been introduced on both the upper most and lower most mounted alternators as from Commuter Coach # 47448.

3. Owners and operators of affected field units should have the retention of the alternator B+ terminals checked without delay.

If the check reveals signs of ring terminals cracking then immediate remedial action should be taken and the terminals should be replaced by new ones.

**CAUTION:** In all cases it is necessary to improve the B+ cable retention and fit P-clamps as described in this Bulletin.

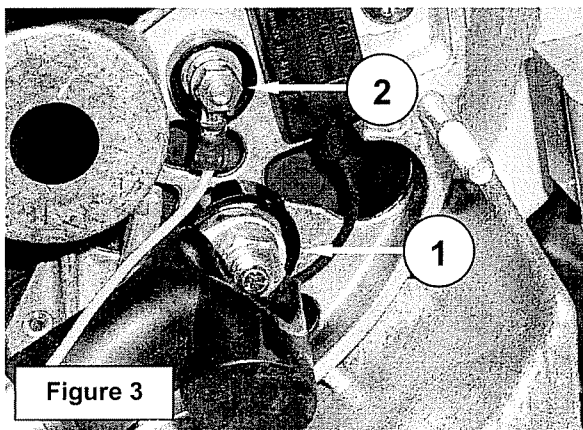
Check the terminal for possible damage.

If the terminal shows any signs of cracking, it should be replaced first.

Undo the nut securing the D+ terminal (2, Figure 3).

Cut cable ties as required to allow re-routing of the B+ and D+ cables.
