08V-129  
(37 Pages)

Re: Title 49 U.S.C. Chapter 301 Safety Recall; Big Bear American Made Choppers, Inc.

**PART 573 Defect and Noncompliance Report**

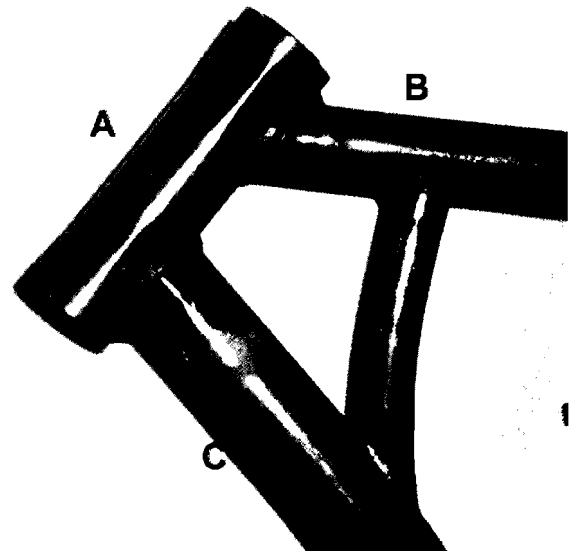
*The defect is a potential failure of a motorcycle frame at the point where frame tubes (B) and (C) connect to the Neck (A) as identified in illustration #1*

The primary cause is insufficient penetration of the weld joint where tubes (B and C connect to the Neck A) as identified in illustration #1

A secondary concern is, failure to maintain frame and engine bolts to the correct torque can cause excessive vibration in the frame which can contribute to advancement of the weld failure in the identified areas

- *If the weld joint cracks and this failure continues a separation of the neck from the backbone and down tubes can occur resulting in frame failure and a possible loss of control of the motorcycle if it is being driven.*

*The remedy frame differentiation from the recalled frame is clearly apparent. The obvious distinction is a 1/4" plate (gusset) that occupies what was previously an open space where the neck, backbone, down tube(s) and original tube gusset are joined. This repair is outlined in attachment D on page 6 "NECK GUSSET UPGRADE"*

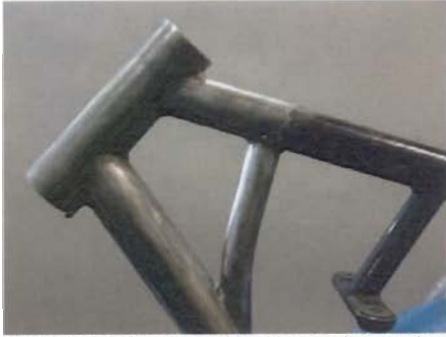
Example of a frame requiring the recall procedure

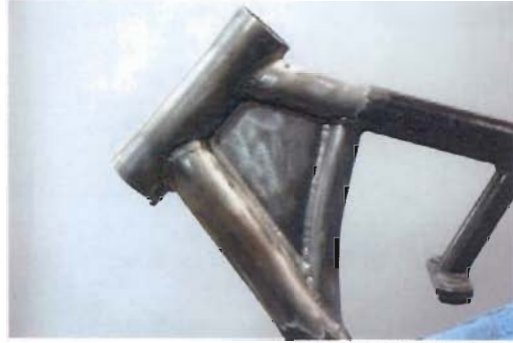
Example of a frame with recall procedure completed

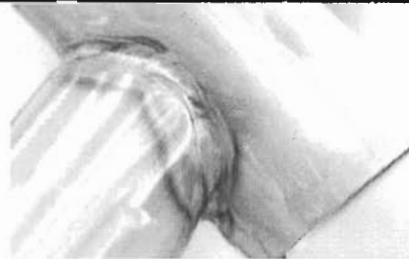
Completed root pass weld

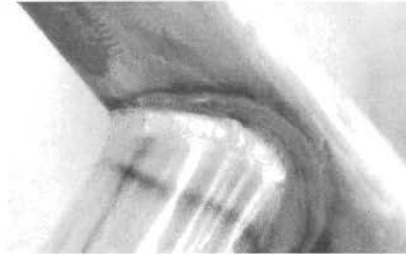
Photo of a concave/undercut 2<sup>nd</sup> pass, requiring third weld pass

The second cover pass is mandatory. Upon completion of the second pass inspect the profile of the weld. If the weld profile exhibits a concave form or is undercut, a third pass weld **MUST** be performed.

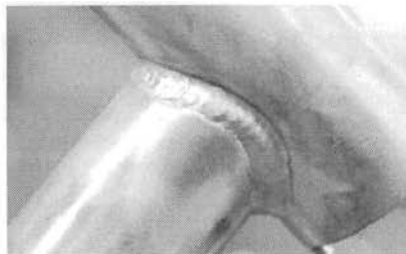
Finished lower weld with convex form

Upon completion of this weld, the joint must exhibit a convex profile as depicted in the photograph to the left.

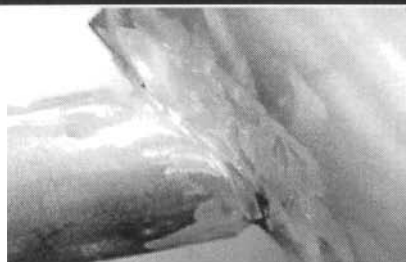
View showing upper joint ready for root weld pass

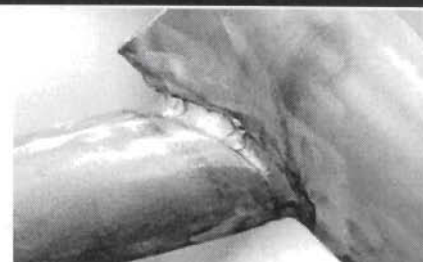
View of root pass completed

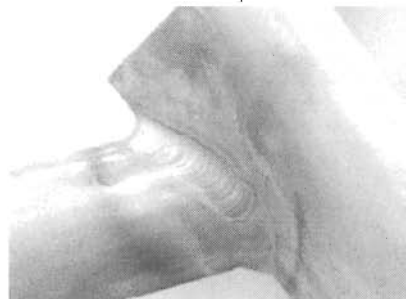
View showing the completion of the 3<sup>rd</sup> and final weld pass

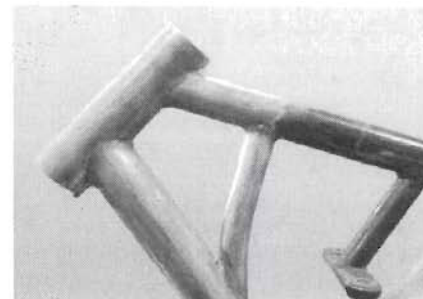
View showing the two new welds

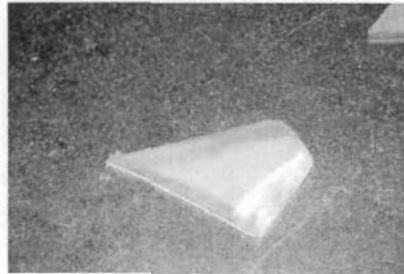
Example of a trimmed plate ready to be welded into frame opening.

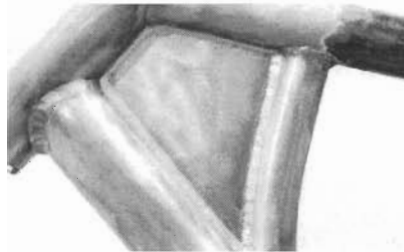
Completed weld
