08V-135
(5 pages)

RE: Part 573 Defect Information Report – 2002-2003 Subaru Impreza Rear Gate Stay Attachment Bolt Breakage

**Defect Information Report
49 CFR Part 573.6**

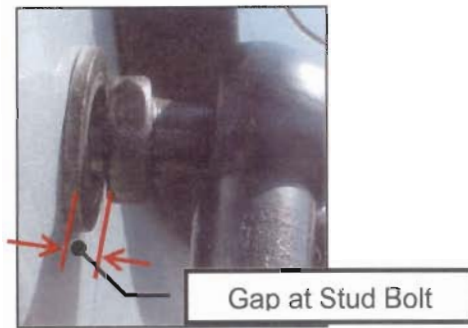
- (1) The stud bolt(s) of rear gate stay may have been tightened with insufficient tightening torque and a certain gap may have resulted between rear gate panel and stud bolt base.

The remedy plan calls for dealers to inspect each affected vehicle to see if there is any gap at the stud bolt of the rear gate stay installation. If there is any gap found, the stud bolt will be removed to check for damage to the welding nut. If cracks are found at the welding nut, the rear gate stay will need to be replaced.

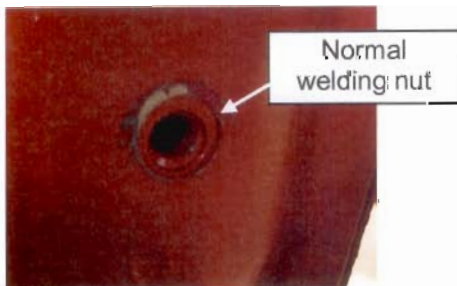
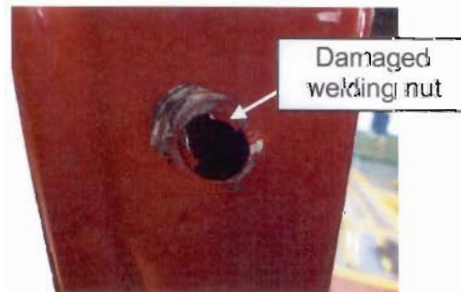
- (2) After repeated rear gate operations (opening and closing), the rear gate inner panel at the welding nut (rear gate stay fitting portion) may break, which will lead to detachment of the rear gate stay, and the rear gate dropping down.

The welding nut (W/N) to secure the rear gate stay was broken and dropped down at the rear gate reinforcement.

-The welded portion of the W/N breaks if the clearance between the stud bolt base and the rear gate inner panel is more than 1mm.
