08V-154  
(3 Pages)

## Re: Defect Information Report FL-529, M2 High Current Tail lamp PDM

## Defect Information Report (Section 573.6)

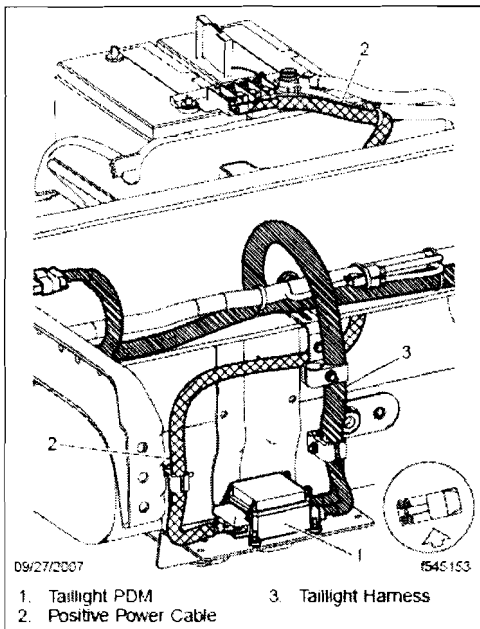
Fig. 1. High-Amp Taillight PDM Installation

**Basis for determining population:** Option Code 294-1AE – High Current Tail Lamps  
Chassis Mounted PDM (Power Distribution Module) mounted inboard and low on a bracket  
off the fuel tank.

(c)(5) **Description of the defect:** The optional High Current Tail lamp PDM (Power Distribution Module) was installed in a location highly susceptible to water intrusion. This may lead to a loss of rear lighting.

**49CFR Section 577.5(f) Evaluation of the risk to motor vehicle safety:** A loss of some or all rear lighting on the vehicle under certain conditions may be impair visibility of the truck and a crash may occur.

**(c)(8) (i) Remedial program:** The PDM will be relocated to inside the cab behind the driver's seat. Repairs will be performed by Daimler Trucks North America dealerships and Direct Warranty customers, i.e., customers approved by Daimler Trucks North America to do their own warranty repairs.
