Re: Gillig Safety Recall- SAF Holland ADL Suspension

Safety Defect and Noncompliance Report Guide for Vehicles
PART 573 Defect and Noncompliance Report¹

ADL T-BEAM WELD - PROFILE (ADL WELD RECALL)

Safety Defect and Noncompliance Report Guide for Equipment
PART 573 Defect and Noncompliance Report⁴

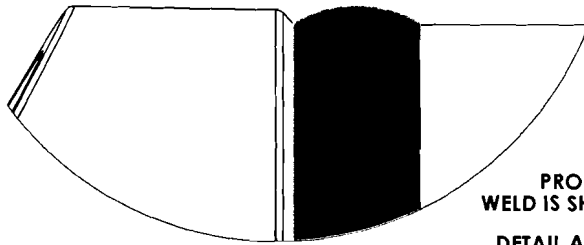
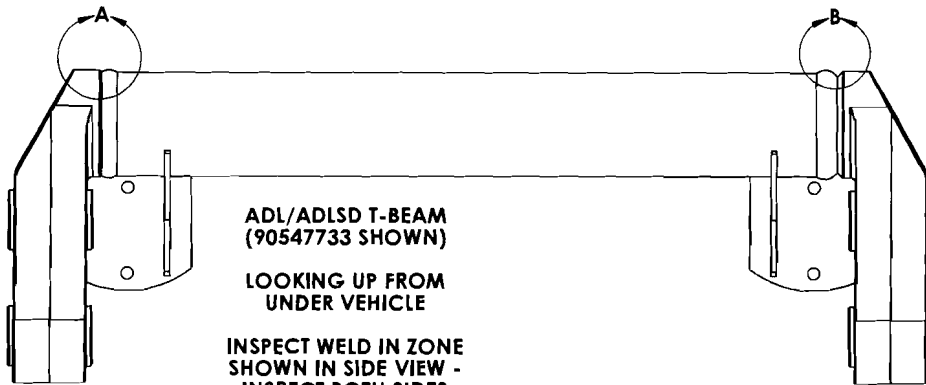
A=NO OFFSET TO 3/16" [5mm]
NORMAL

DEFECTIVE IF
A ≥ 2/16" [5mm] OR GREATER

INSPECT WELD IN ZONE
SHOWN IN SIDE VIEW -
INSPECT BOTH SIDES
(APPROX. 180° ARC TOP
TO BOTTOM)

MEASURE AGAINST
NORMAL STANDARD IN
DETAIL VIEW A

DEFECTIVE CONDITION
SHOWN IN DETAIL VIEW B

INSPECT REAR
SEGMENT OF
WELD

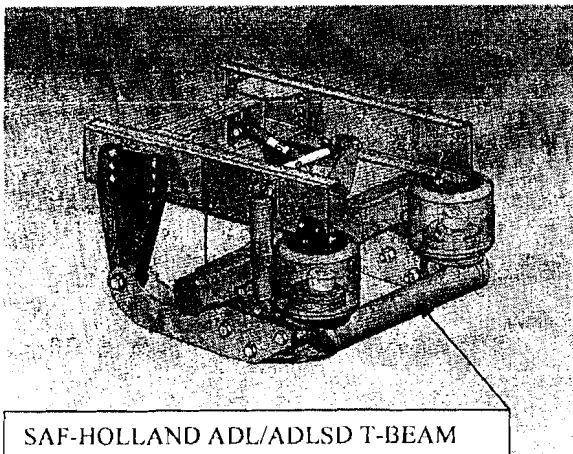
Figure 1 SAF-HOLLAND ADL SUSPENSION

The defect is related to the SAF-Holland ADL/ADLSD suspension products. An example of this product is shown in figure 1. The specific component of this system is the transverse beam. An example of this component is shown in figure 2. The appearance of a normal weld is shown in figure 3. If the defect is present it will have an appearance similar to that in figure 4. The defect may occur on either side of the assembly as shown by arrows in figure 2.

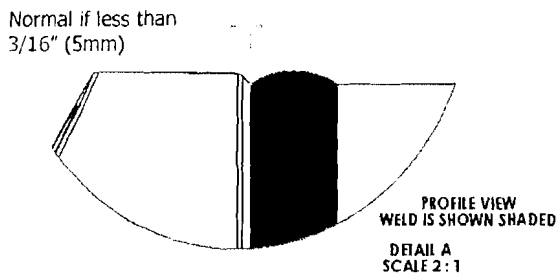
Figure 3 NORMAL WELD CONDITION

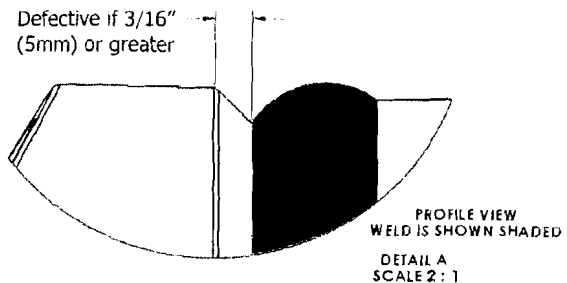
Figure 4 DEFECTIVE WELD CONDITION

An undetermined percentage of transverse beams we believe less than 6% have a weld that was not located correctly. Operator did not verify set-up when changing part numbers and/or operator did not re-verify torch after a loose clamp interfered with torch alignment on the fixed side of the fixture.

If the weld fails in the field, vehicle stability while cornering could be affected resulting in loss of vehicle control. In addition, the transverse beam could drop to the ground causing sparks that could cause a fire hazard.

The remedy is to visually inspect 100% of the units and replace any product containing the visual defect. The difference between the recall condition and the remedy is the recall condition is not welded per the engineering drawing.
