**Regarding: 2005– 2007 Model Year Yamaha YP400 and
2006 – 2007 CP250 Fuel Pump Coupler Factory Modification Campaign**

Technical BULLETIN

RECALL

2006~2007 CP250 (Morphous); 2005~2007 YP400 (Majesty) FACTORY MODIFICATION CAMPAIGN – Fuel Pump Harness

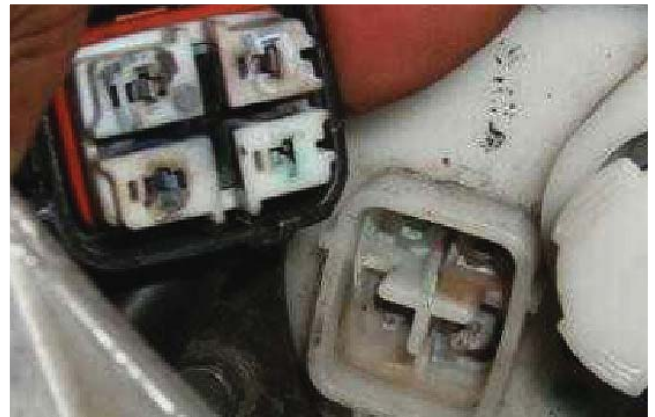
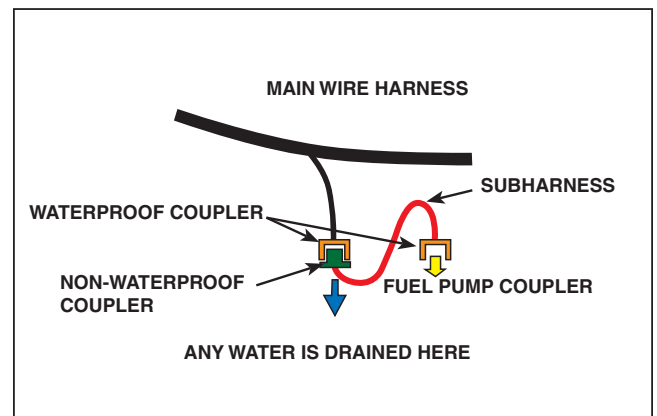
Yamaha Motor Corporation, U.S.A., has determined that a defect which relates to motor vehicle safety exists in all 2006 and certain 2007 CP250 (“Morphous”) and all 2005, 2006, and certain 2007 YP400 (“Majesty”) scooters. In affected scooters, the engine could stall and be difficult to restart because the wire terminals in the fuel pump wire coupler have corroded. This is because water can enter from the main wire harness end and run through the harness to the fuel pump coupler. If the water remains in the coupler for an extended period of time, the terminals can become corroded, which can prevent the fuel pump from operating properly. If this corrosion affects fuel pump operation while the scooter is being ridden, there could be an accident resulting in injury or death.

To correct this defect, Yamaha is initiating a Factory Modification Campaign. Affected scooters must have a sub-harness installed which is designed to allow any water between the wire harness and the fuel pump to drain out before it reaches the fuel pump. If either the main wire harness connector or the fuel pump connector is already corroded, the corresponding assembly(ies) must also be replaced.

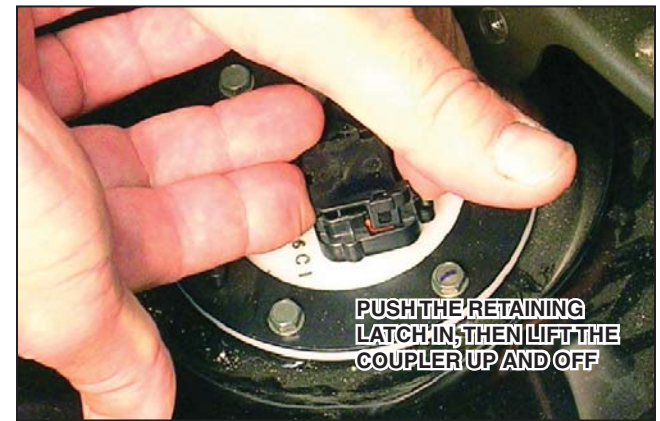
14. Remove the main wire harness coupler from the fuel pump.
15. Inspect the terminals on the harness connector and on the fuel pump. If there is corrosion, replace the main wire harness and/or fuel pump as necessary. Refer to the Service Manual (LIT-11616-18-38) for wire-harness replacement. For tips on replacing the fuel pump, see the procedures given in Technical Bulletin M2007-011R which covers fuel pump seal replacement. If the coupler is wet, but not corroded, dry it with compressed air.

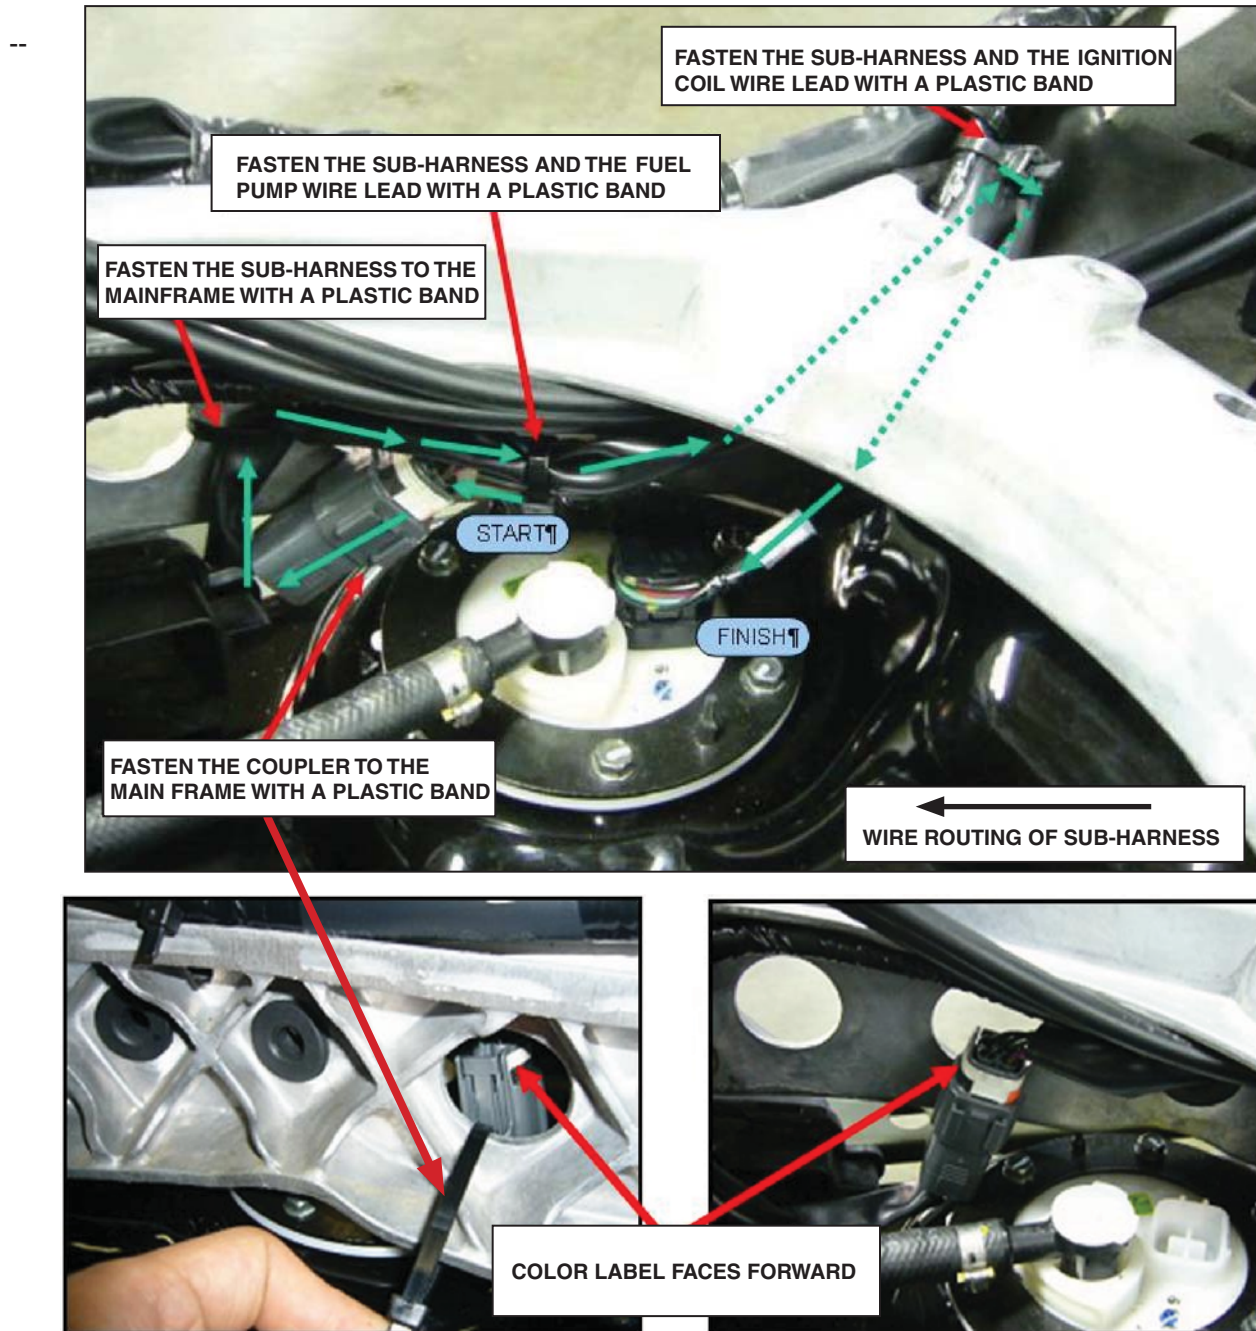
Be sure to secure the fuel pump sub-harness as shown. This positions the wire harness coupler of the main wire harness in a position that will allow any water that enters the wire harness to drain out.

6. Secure the fuel pump sub-harness with the supplied plastic bands (zip ties) as shown.

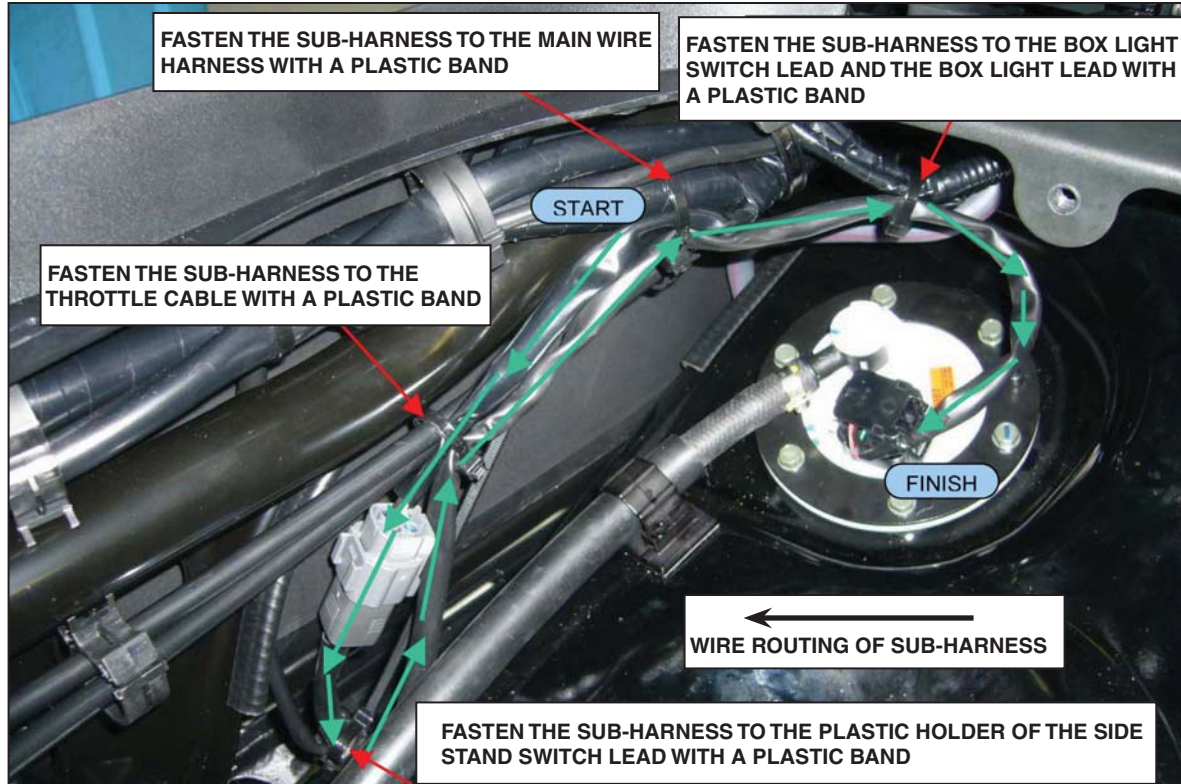
Be sure to secure the fuel pump sub-harness as shown below. This positions the wire harness coupler of the main wire harness in a position that will allow any water that enters the wire harness to drain.

10. Secure the fuel pump sub-harness with the supplied plastic bands (zip ties) as shown.
