## Safety Defect and Noncompliance Report Guide for Vehicles

**Re: Defect Information Report - Supplemental Report No. 3  
07V-306, FL-501, AAC Front Axle Steering Arm Bolts**

# Recall Campaign

## Subject: AAC Front Axle Tie Rod and Steering Arm Fasteners

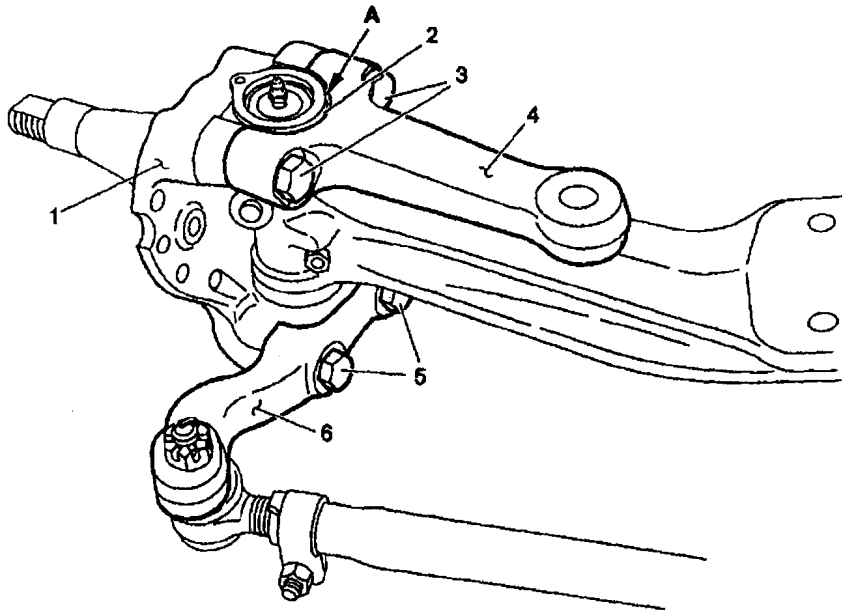
t330240

During front axle assembly, the fasteners that attach the steering arm or the tie rod arms to the spindle may have been over or under tightened. Incorrectly tightened fasteners may fatigue and fracture, resulting in a possible vehicle crash without prior warning.

If there is clearance, go to the "Steering Arm Capscrew Replacement" and "Tie Rod Arm Capscrew Replacement" procedures in these Work Instructions.

If there is **no clearance**, the steering arm must be replaced. Go to the "Steering Arm Replacement" procedure in these Work Instructions.

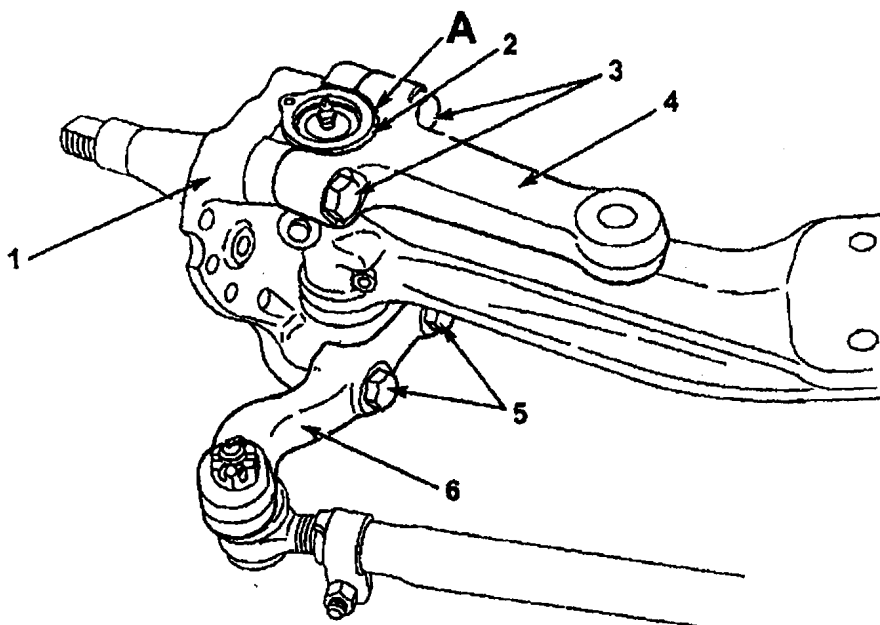
### A. Check for clearance between the steering arm and the king pin boss.

If there is clearance, go to the "Steering Arm Capscrew Replacement" and "Tie Rod Arm Capscrew Replacement" procedures found on page two of this document.

If there is no clearance, the steering arm must be replaced. Go to the "Steering Arm Replacement" procedure found on page two of this document.
