Re: Defect Information Notice FL-501, ACC axle Steering Arm Bolts

Defect Information Report
(Section 573.6)

Subject: AAC Front Axle Tie Rod and Steering Arm Fasteners

December 2007
FL501A
NHTSA #07V-306

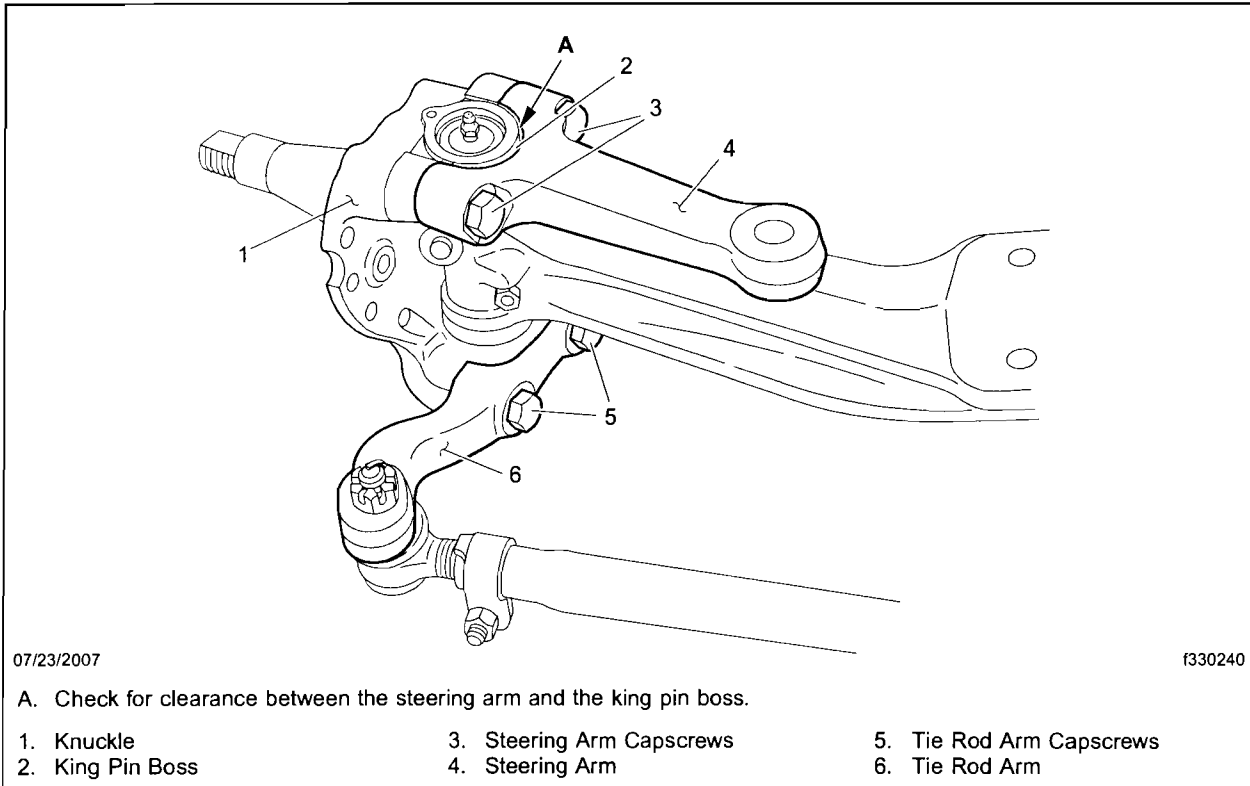
Fig. 1, Steering Arm and Tie Rod Arm

During front axle assembly, the fasteners that attach the steering arm or the tie rod arms to the spindle may have been over or under tightened. Incorrectly tightened fasteners may fatigue and fracture, resulting in a possible vehicle crash without prior warning.

1. Check the base label (Form WAR259) for a completion sticker for FL501 (WAR260) indicating this work has been done. The base label is usually located on the passenger-side door about 12 inches (30 cm) below the door latch on trucks, over the driver's window in school buses, on the front wall under the dash in motorhomes, or in the driver's area in step vans. If a completion sticker for FL501 is present, nothing more needs to be done. If no sticker is present, go to the next step.
2. Shut down the engine, and chock the front tires.
3. Using a 0.004 inch (0.1 mm) feeler gauge, check the clearance between the steering arm and the king pin boss. See **Fig. 1**.

1. Remove one of the capscrews that attaches the steering arm to the steering knuckle. See **Fig. 1**.
2. Check the capscrew threads to verify whether Loctite[®] or another thread locking compound was applied to them.

3. Apply Loctite 277 to the threads of a new M20 x 1.5 x 80 capscrew from the Recall kit.
4. Install the new steering arm capscrew and tighten it 425 lbf-ft (575 N-m).
5. Repeat steps 1 through 4 to replace the second capscrew.
6. Continue with the "Tie Rod Arm Capscrew Replacement" procedure in these Work Instructions.

1. Remove one of the capscrews that attaches the tie rod arm to the knuckle. See **Fig. 1**.
2. Check the capscrew threads to verify whether Loctite® or another thread locking compound was applied to them.
