Subject: 573 Submittal

Safety Defect Report Pursuant to 49 CFR part 573

RE: Notice of Safety Recall

Safety Defect and Noncompliance Report Guide for Equipment
PART 573 Defect and Noncompliance Report⁴

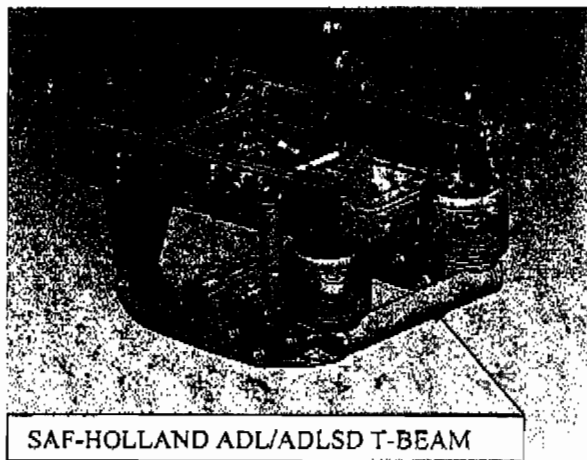
Figure 1 SAF-HOLLAND ADL SUSPENSION

The defect is related to the SAF-Holland ADL/ADLSD suspension products. An example of this product is shown in figure 1. The specific component of this system is the transverse beam. An example of this component is shown in figure 2. The appearance of a normal weld is shown in figure 3. If the defect is present it will have an appearance similar to that in figure 4. The defect may occur on either side of the assembly as shown by arrows in figure 2.

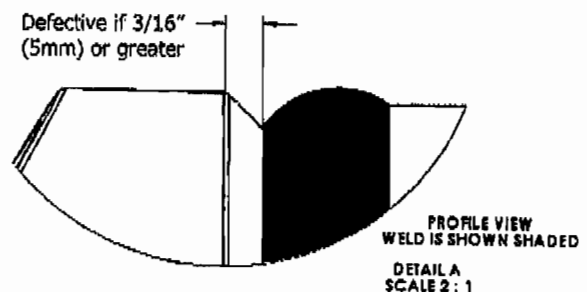
Figure 4 DEFECTIVE WELD CONDITION

An undetermined percentage of transverse beams we believe less than 6% have a weld that was not located correctly. Operator did not verify set-up when changing part numbers and/or operator did not re-verify torch after a loose clamp interfered with torch alignment on the fixed side of the fixture.

If the weld fails in the field, vehicle stability while cornering could be affected resulting in loss of vehicle control. In addition, the transverse beam could drop to the ground causing sparks that could cause a fire hazard.

A popping noise has been reported when the weld breaks.

The remedy is to visually inspect 100% of the units and replace any product containing the visual defect. The difference between the recall condition and the remedy is the recall condition is not welded per the engineering drawing.

The remedy component is welded per engineering drawing.
