08V-226
(14 Pages)

Re: Defect Information Report FL-501, AAC axle Steering Arm Bolts

**Recall Notification
Subject: AAC Front Axle Tie Rod and Steering Arm Fasteners**

December 2007
 FL501A
 NHTSA #07V-306

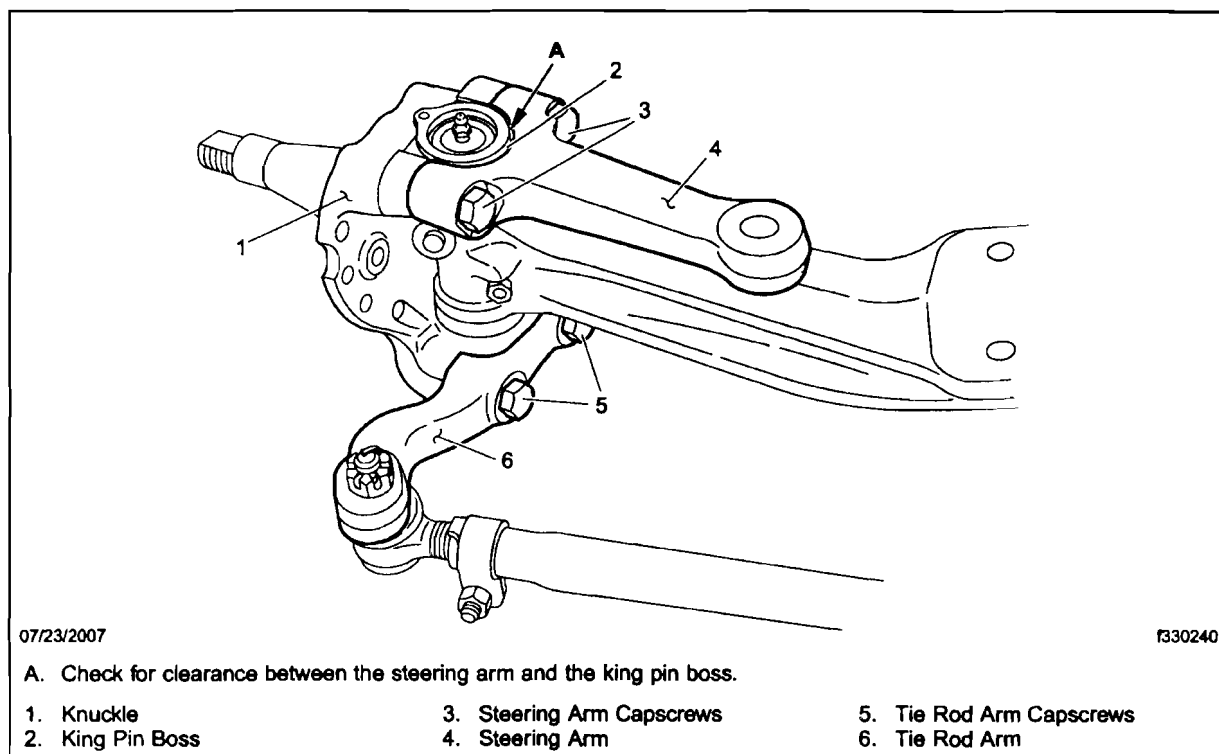
Fig. 1, Steering Arm and Tie Rod Arm

(c)(5) Description of the defect: During front axle assembly, the fasteners that attach the steering arm or tie rod arms to the spindle may be over or under tightened.

1. Check the base label (Form WAR259) for a completion sticker for FL501 (WAR260) indicating this work has been done. The base label is usually located on the passenger-side door about 12 inches (30 cm) below the door latch on trucks, over the driver's window in school buses, on the front wall under the dash in motorhomes, or in the driver's area in step vans. If a completion sticker for FL501 is present, nothing more needs to be done. If no sticker is present, go to the next step.
2. Shut down the engine, and chock the front tires.
3. Using a 0.004 inch (0.1 mm) feeler gauge, check the clearance between the steering arm and the king pin boss. See Fig. 1.

If there is **no clearance**, the steering arm must be replaced. Go to the "Steering Arm Replacement" procedure in these Work Instructions.

1. Remove one of the capscrews that attaches the steering arm to the steering knuckle. See Fig. 1.
2. Check the capscrew threads to verify whether Loctite® or another thread locking compound was applied to them.

3. Apply Loctite 277 to the threads of a new M20 x 1.5 x 80 capscrew from the Recall kit.
4. Install the new steering arm capscrew and tighten it 425 lbf-ft (575 N-m).
5. Repeat steps 1 through 4 to replace the second capscrew.
6. Continue with the "Tie Rod Arm Capscrew Replacement" procedure in these Work Instructions.

1. Remove one of the capscrews that attaches the tie rod arm to the knuckle. See Fig. 1.
2. Check the capscrew threads to verify whether Loctite® or another thread locking compound was applied to them.

3. Apply Loctite 277 to the threads of two new M20 x 1.5 x 80 capscrews.
4. Install a new steering arm with its engraved part number facing upward.
5. Install the new steering arm capscrews and tighten them 425 lbf-ft (575 N·m).
6. Go to the "Tie Rod Arm Capscrew Replacement" procedure in these Work Instructions.
