AMERICAN SUZUKI MOTOR CORPORATION

08V-249
(17 pages)

4 - STROKE
GS/GSX/GSX-R BULLETIN NO. 183
DATE: 6/6/2008

**SAFETY RECALL CAMPAIGN #2A05
CERTAIN 2008 GSX1300RK8 MOTORCYCLES
IGNITION SWITCH INSPECTION/REPLACEMENT**

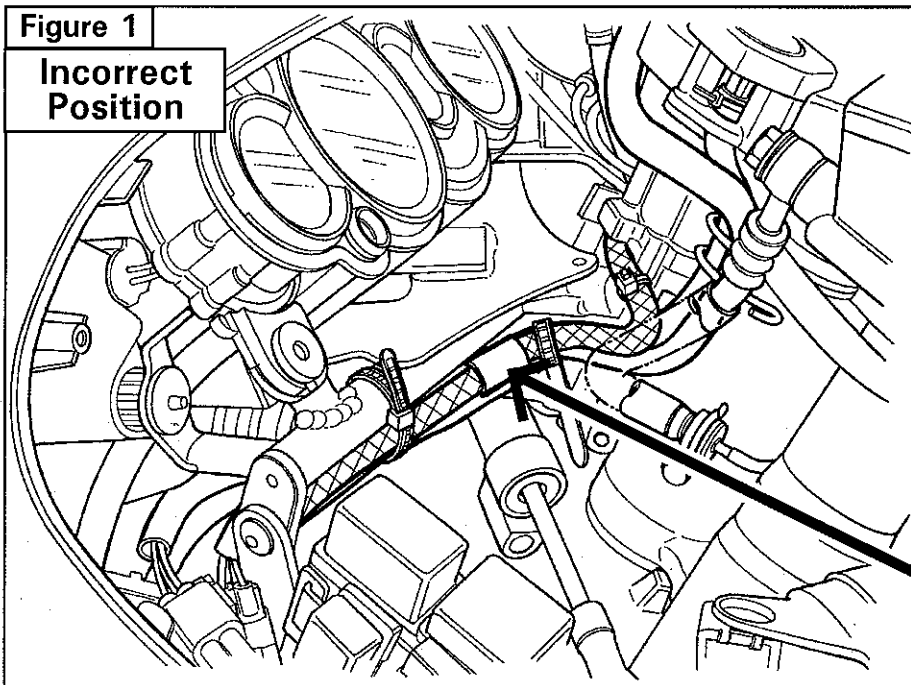
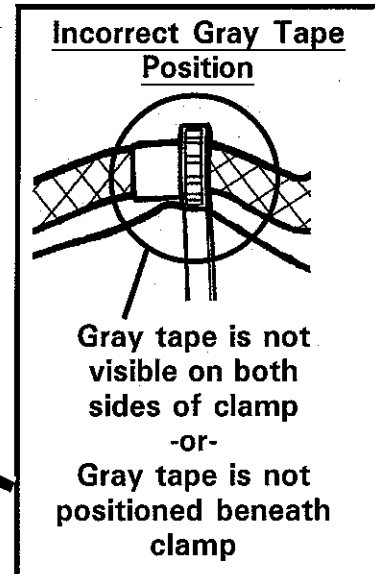
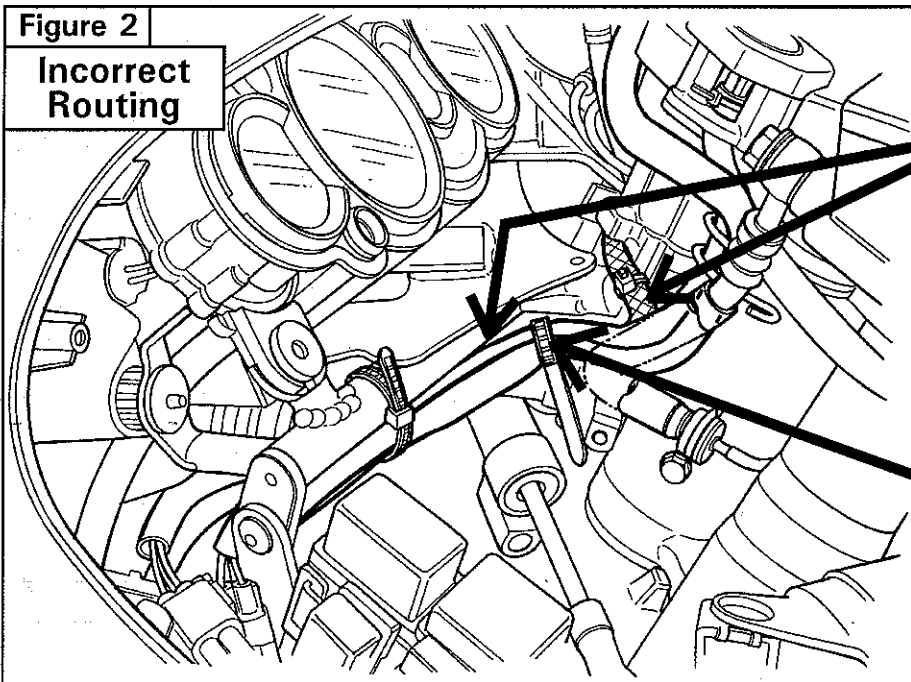
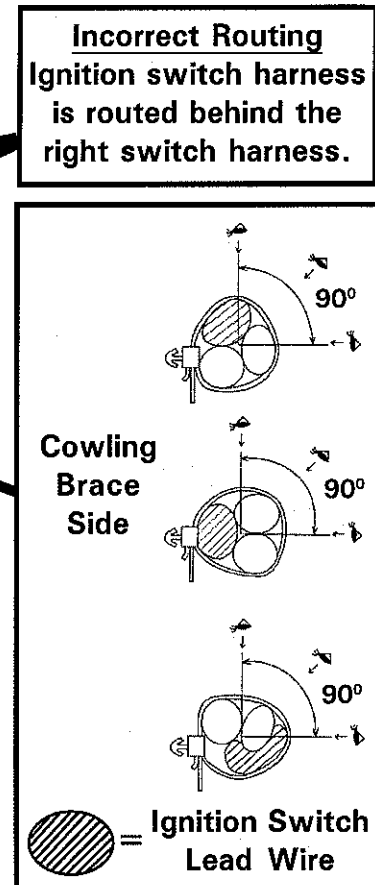
Figure 3

1. Remove the upper and lower meter panels (refer to Service Manual page 9D-15).
2. Check if the ignition switch lead wire is clamped and routed correctly. Incorrect positions are shown in Figures 1 and 2. Correct routing and clamping is shown in Figures 3 and 4 on page 5.

1. Reroute the ignition switch lead wire correctly (Figure 3 and Figure 4). The ignition switch lead wire should not be covered by the other wire harnesses.
2. Turn the handlebars back and forth to verify that the steering operates smoothly and the wiring harness does not become kinked or pinched.
3. Proceed to PUNCH MARK AT VIN on page 8.

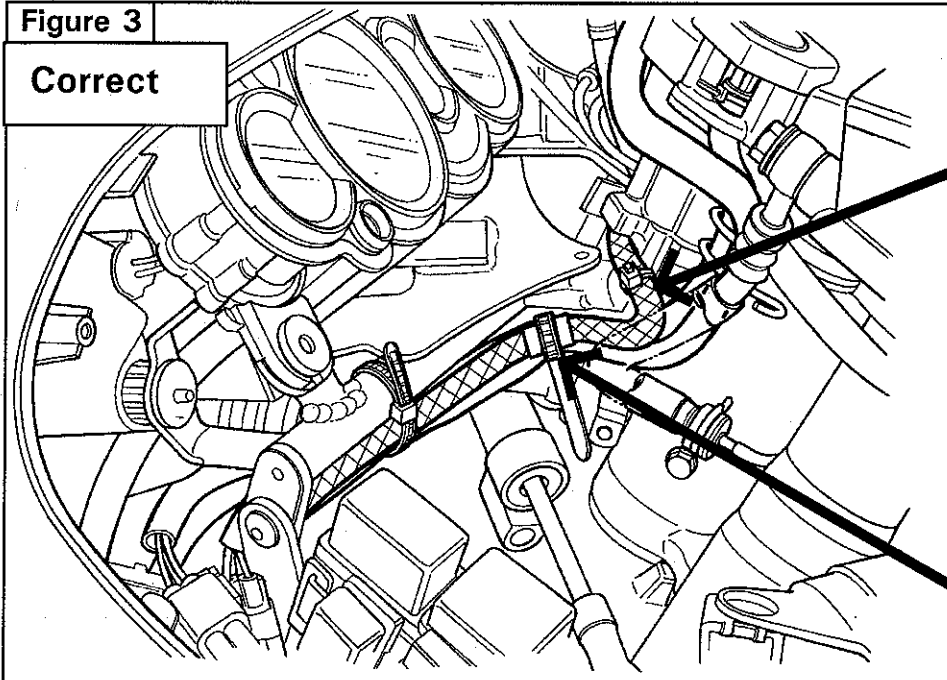
Correct Routing
The ignition switch lead wire is routed in front of the right switch lead wire.

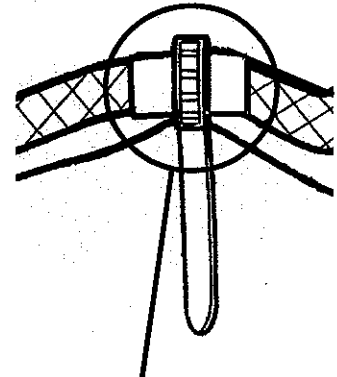
Correct Gray Tape Location

Gray tape is visible on both sides of clamp.
