Re: Defect Information Report FL-530, SAF Holland ADL Suspension Weld

Defect Information Report (Section 573.6)

(c)(11) Manufacturer's campaign number: FL-530

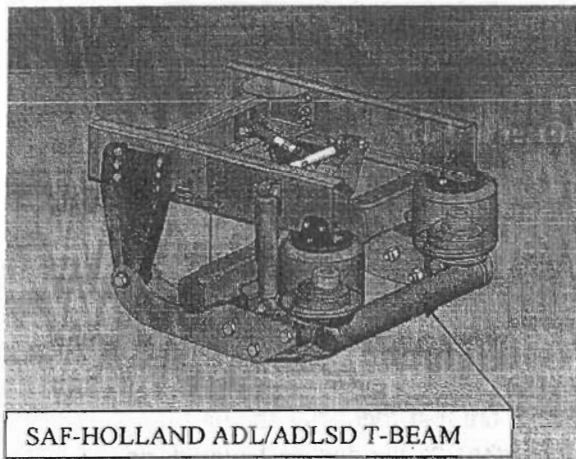
Figure 1 SAF-HOLLAND ADL SUSPENSION

The defect is related to the SAF-Holland ADL/ADLSD suspension products. An example of this product is shown in figure 1. The specific component of this system is the transverse beam. An example of this component is shown in figure 2. The appearance of a normal weld is shown in figure 3. If the defect is present it will have an appearance similar to that in figure 4. The defect may occur on either side of the assembly as shown by arrows in figure 2.

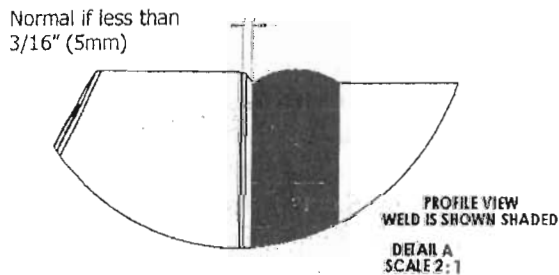
Figure 3 NORMAL WELD CONDITION

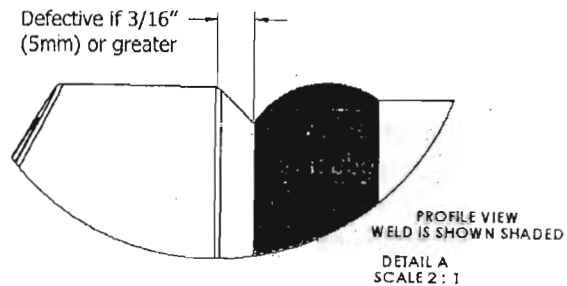
Figure 4 DEFECTIVE WELD CONDITION

An undetermined percentage of transverse beams we believe less than 6% have a weld that was not located correctly. Operator did not verify set-up when changing part numbers and/or operator did not re-verify torch after a loose clamp interfered with torch alignment on the fixed side of the fixture.

If the weld fails in the field, vehicle stability while cornering could be affected resulting in loss of vehicle control. In addition, the transverse beam could drop to the ground causing sparks that could cause a fire hazard.

The remedy is to visually inspect 100% of the units and replace any product containing the visual defect. The difference between the recall condition and the remedy is the recall condition is not welded per the engineering drawing.

The remedy component is welded per engineering drawing.
