Spartan Chassis, Inc.
1000 Reynolds Road - Charlotte, MI - 48813
573 DEFECT & NONCOMPLIANCE REPORT

Description:	Fractured Fasteners
---------------------	---------------------

08V-275
(15 pages)

RSB08-940-002

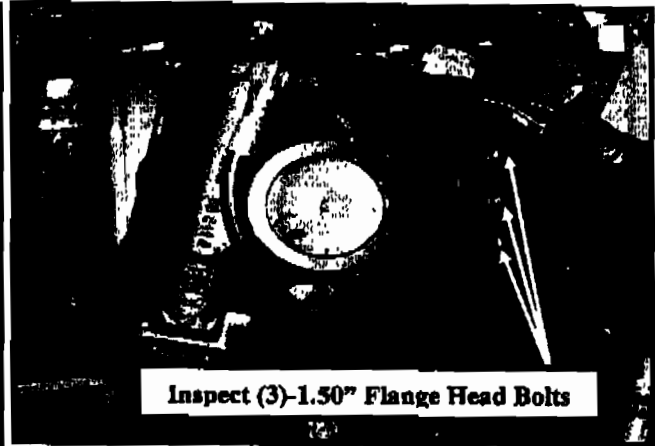
FIG. 2-1

Inspect (3)-1.50" Flange Head Bolts

STEERING GEAR SUPPORT MOUNTING LOCATION

2. Refer to FIG. 2-1. Visually inspect the six bolts attaching the steering gear support to the frame. If all of the bolts appear to be intact proceed to step 3. If any bolts are missing proceed to step 4.

3. Using a torque wrench set at 50 lbs. ft. attempt to rotate each bolt from which ever side is most accessible. If a bolt or nut rotates it must be replaced. If it does not rotate do not replace. Torque the new bolt and nut to 148 lbs. ft. from the nut, or 185 lbs. ft. from the bolt head.

4. Replace the missing bolts and nuts and torque them to 148 lbs. ft. from the nut or 185 lbs. ft. from the bolt head. Perform step 3 to the bolts that are not missing.

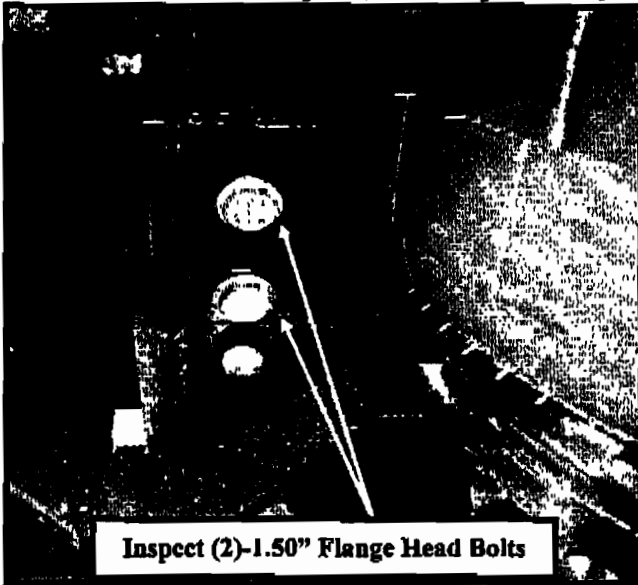
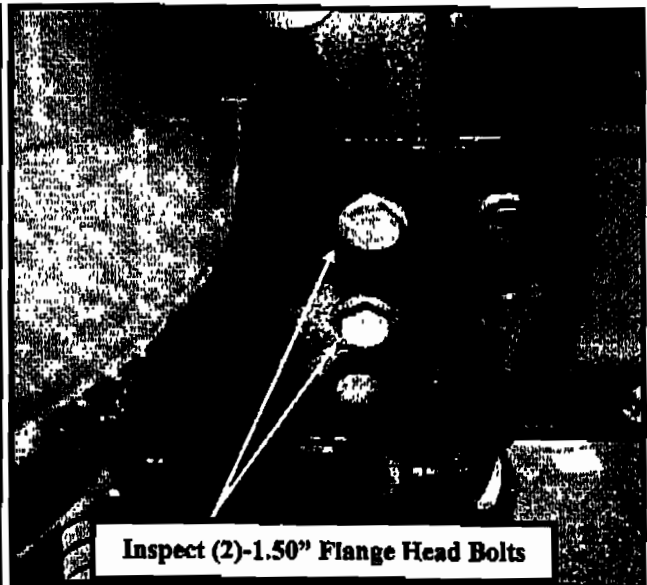
**TUTHIL/GRANNING IFS CRADLE MOUNTING LOCATION
(BEHIND AIRSPRING)**

5. Refer to FIG. 3-1 & FIG. 3-2. Visually inspect the bolts attaching the IFS cradle to each frame rail. If all of the bolts appear to be intact proceed to step 6. If any bolts are missing proceed to step 7.

6. Using a torque wrench set at 50 lbs. ft. attempt to rotate each bolt from which ever side is most accessible. If a bolt or nut rotates it must be replaced. If it does not rotate do not replace. Torque the new bolt and nut to 148 lbs. ft. from the nut, or 185 lbs. ft. from the bolt head.

7. Replace the missing bolts and nuts and torque them to 148 lbs. ft. from the nut or 185 lbs. ft. from the bolt head. Perform step 6 to the bolts that are not missing.

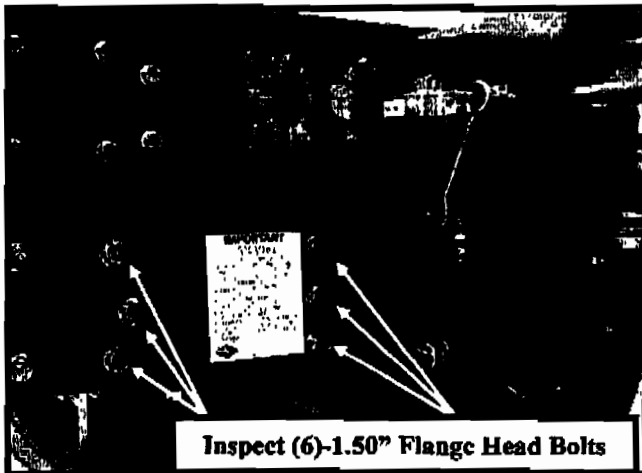
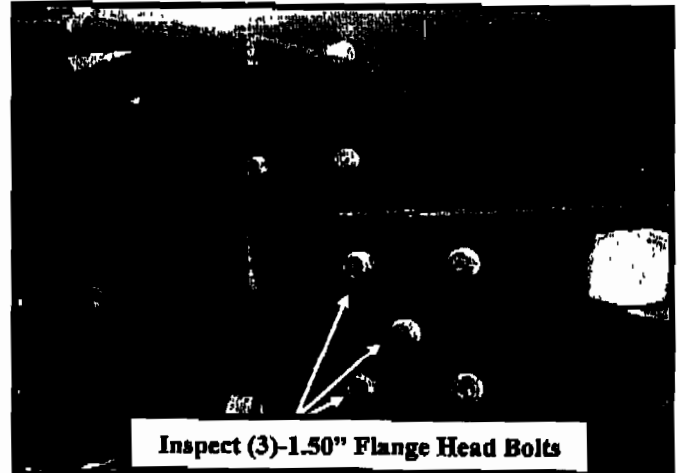
FIG. 3-2

TUTHIL/GRANNING IFS CRADLE MOUNTING LOCATION

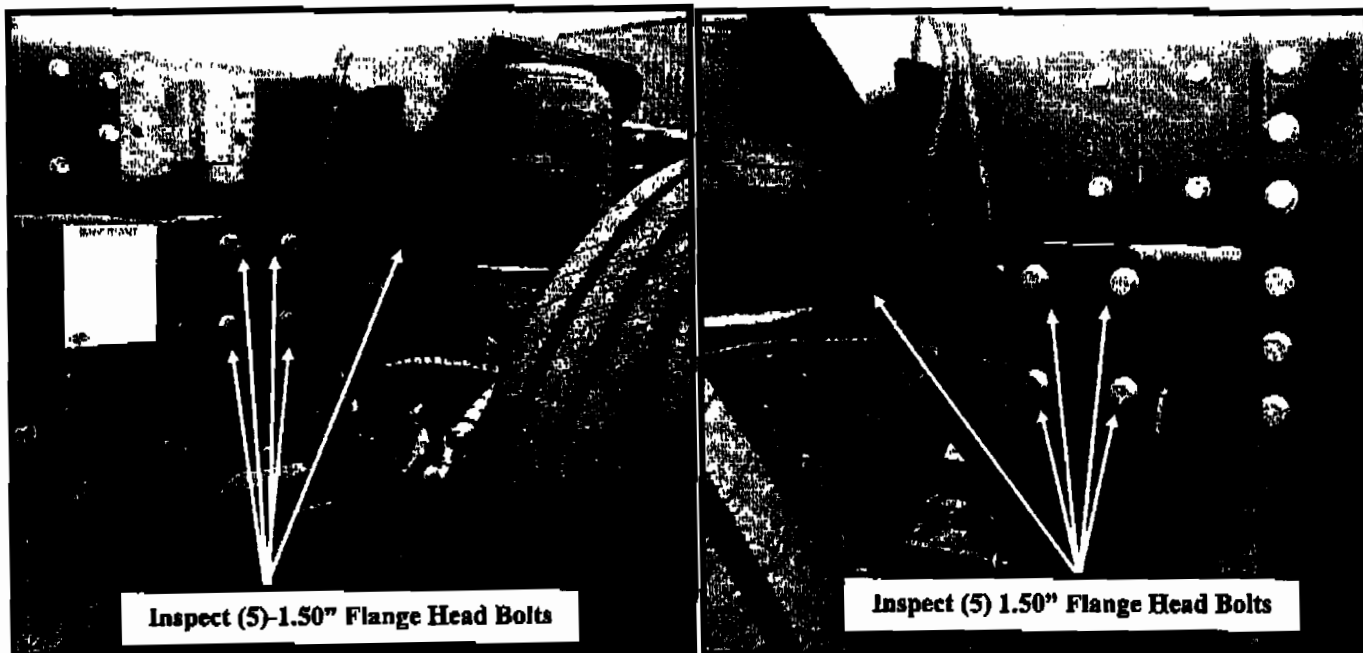
FIG. 4-1

HENDRICKSON IFS CRADLE MOUNTING LOCATION

1. Refer to FIG. 4-1. Visually inspect the bolts attaching the IFS cradle to each frame rail. If all of the bolts appear to be intact proceed to step 2. If any bolts are missing proceed to step 3.
2. Using a torque wrench set at 50 lbs. ft. attempt to rotate each bolt from which ever side is most accessible. If a bolt or nut rotates it must be replaced. If it does not rotate do not replace. Torque the new bolt and nut to 148 lbs. ft. from the nut, or 185 lbs. ft. from the bolt head.
3. Replace the missing bolts and nuts and torque them to 148 lbs. ft. from the nut or 185 lbs. ft. from the bolt head. Perform step 2 to the bolts that are not missing.
4. Reconnect any power source previously disconnected.

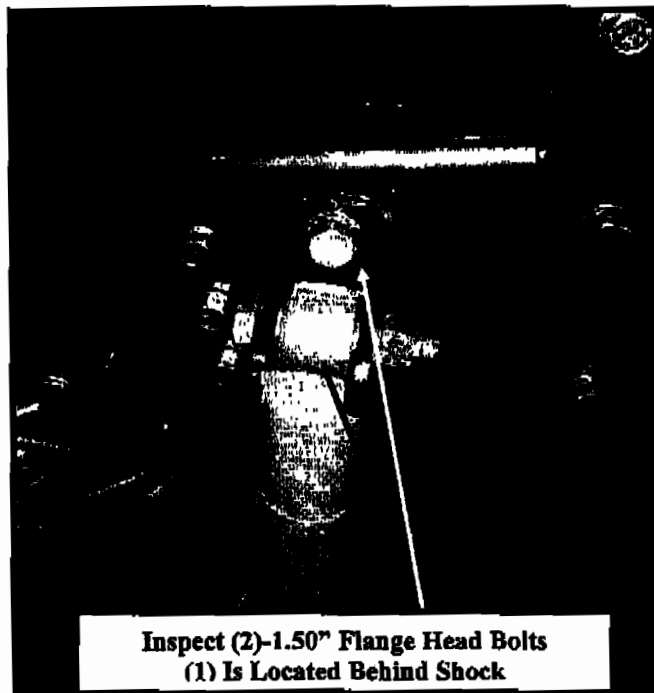
FIG. 5-1

**Inspect (2)-1.50" Flange Head Bolts
(1) Is Located Behind Shock**

HENDRICKSON AIRTEK SHOCK MOUNTING LOCATION

1. Refer to FIG. 5-1. Visually inspect the bolts attaching the front suspension shock absorber upper mounting brackets to each frame rail. If the bolts appear to be intact proceed to step 2. If any bolts are missing proceed to step 3.
2. Using a torque wrench set at 50 lbs. ft. attempt to rotate each bolt from which ever side is most accessible. If a bolt or nut rotates it must be replaced. If it does not rotate do not replace. Torque the new bolt and nut to 148 lbs. ft. from the nut, or 185 lbs. ft. from the bolt head.
3. Replace the missing bolts and nuts and torque them to 148 lbs. ft. from the nut or 185 lbs. ft. from the bolt head. Perform step 2 to the bolts that are not missing.
4. Reconnect any power source previously disconnected.
