Re: Defect Information Notice FL-530, SAF Holland ADL Suspension Weld

Defect Information Report (Section 573.6)

(c)(5) Description of the Defect: Transverse beam weld may be improperly located on SAF Holland ADL and ADLSD Suspensions allowing the transverse beam to separate from the suspension casting. Reference the attached SAF Holland Defect Information Report 08E-031.

Safety Defect and Noncompliance Report Guide for Equipment
PART 573 Defect and Noncompliance Report⁴

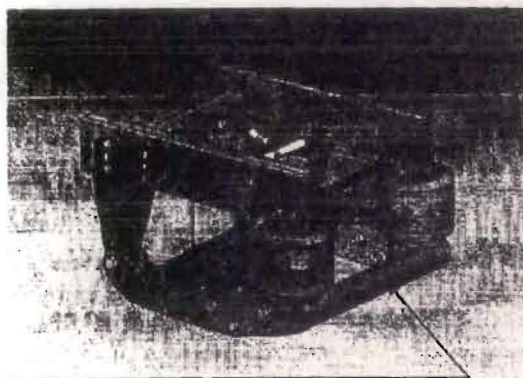
Figure 1 SAF-HOLLAND ADL SUSPENSION

The defect is related to the SAF-Holland ADL/ADLSD suspension products. An example of this product is shown in figure 1. The specific component of this system is the transverse beam. An example of this component is shown in figure 2. The appearance of a normal weld is shown in figure 3. If the defect is present it will have an appearance similar to that in figure 4. The defect may occur on either side of the assembly as shown by arrows in figure 2.

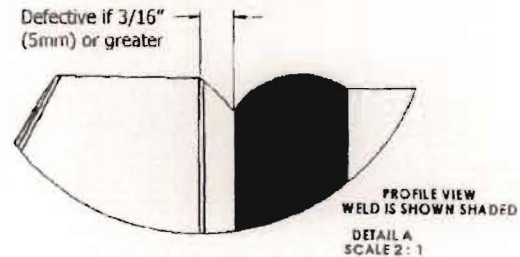
Figure 4 DEFECTIVE WELD CONDITION

An undetermined percentage of transverse beams we believe less than 6% have a weld that was not located correctly. Operator did not verify set-up when changing part numbers and/or operator did not re-verify torch after a loose clamp interfered with torch alignment on the fixed side of the fixture.

If the weld fails in the field, vehicle stability while cornering could be affected resulting in loss of vehicle control. In addition, the transverse beam could drop to the ground causing sparks that could cause a fire hazard.

The remedy is to visually inspect 100% of the units and replace any product containing the visual defect. The difference between the recall condition and the remedy is the recall condition is not welded per the engineering drawing.
