MOTOR COACH  
INDUSTRIES

**RE: DURA AUTOMOTIVE SYSTEMS, INC. WINDOW DE-BONDING RECALL**  
**NHTSA #: 07E042000**

Safety Defect and Noncompliance Report Guide for Vehicles  
**PART 573 Defect and Noncompliance Report**

<b>MODEL</b> D4005 / D4505 Series Coaches	<b>TYPE</b> Field Change Program	<b>SECTION/GROUP</b> 3-Body	<b>DATE</b> June 10, 2008
<b>SUBJECT</b> DURA AUTOMOTIVE SYSTEMS WINDOW DE-BONDING			
<b>CONDITIONS</b>

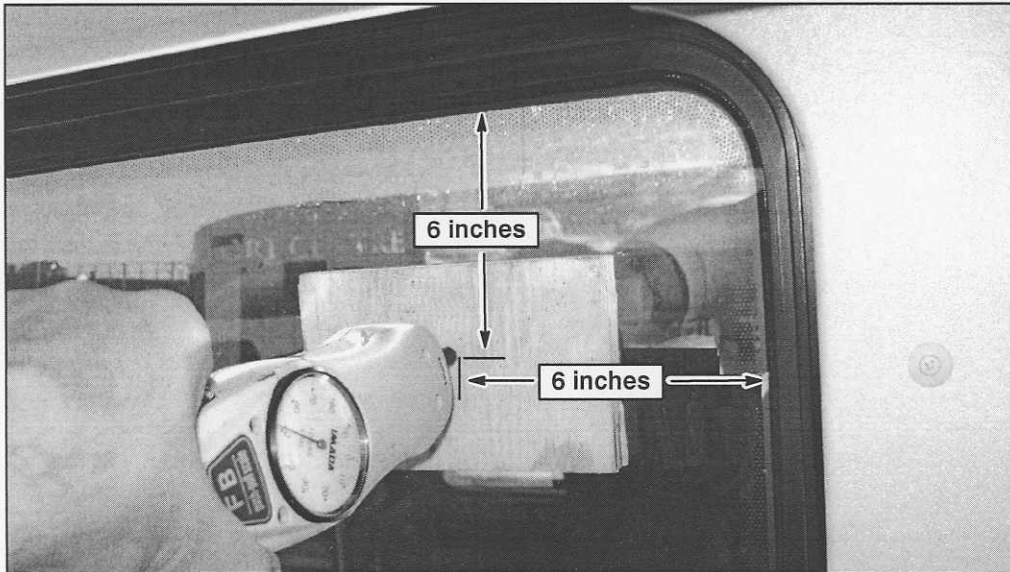
Figure 1.

2. Ensure window is in locked position.
3. From inside the coach, carefully position a 4.0 x 4.0 x 0.5 inch flat wood block flat against glass surface six inches from both edges (Figure 1). Position a push / pull gauge at center of wood block and apply 50 lbs. push force against glass perpendicular to the glass surface, to accentuate any partial de-bonding.
4. Observe any evidence of glass separation / de-bonding against the frame, as force is applied.

*Any window having more that seventy ( 70 ) inches of de-bonding along it's perimeter should be taken out of service until replacement window(s) are installed.*

*If window displays evidence of glass separation / de-bonding against the frame as force is applied, contact the MCI Fleet Support Technical Center at 1-800-241-2947. Upon receipt of replacement window from MCI, proceed to Step 1 of the applicable attached MCI D4005 / D4505 Coach De-bonding Egress Window Service Replacement Work Instruction or, MCI D4005 / D4505 Coach De-bonding NON-Egress Window Service Replacement Work Instruction.*

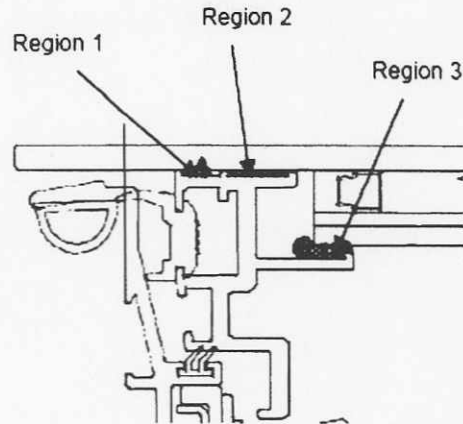
indicate either missing or incorrect placement of primer in Regions 1 & 2. All windows (including service replacement) are identified via applied sticker with the window manufacturing date.

The primed regions identified above are not visible in a complete window assembly. The blackout surface on the glass prevents visual identification of the primed and bonding surface in a completed assembly. As such, it is not possible to identify inconsistent primer application until partial de-bonding is initiated. As the de-bonding is a gradual process there are ample warning indicators such as wind noise and water leak to prompt the owner/operator to seek remedy.

Post 7/19/06, Region 1, 2 & 3 all use the same primer and this uniformity remedies any process inconsistencies. All windows (including service replacement) are identified via applied sticker with the window manufacturing date.
