RE: NHTSA Recall 08V-429, Hyundai Recall 086

HYUNDAI Technical Service Bulletin

Group	CAMPAIGN
Number	08-01-011-1
Date	SEPTEMBER, 2008
Model	2008 ELANTRA

Subject
**FUEL PUMP SUBASSEMBLY REPLACEMENT
 (CAMPAIGN 086)**

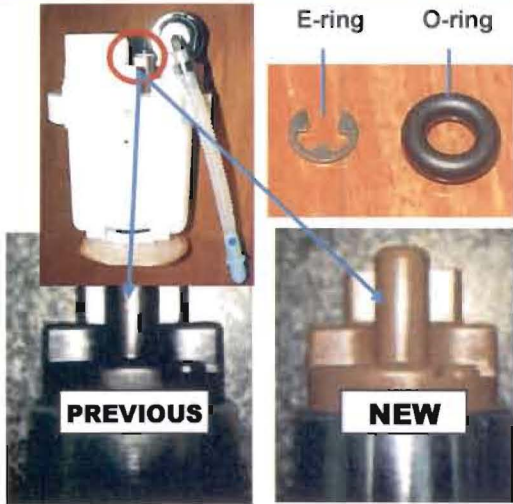
<p>The diagram illustrates the fuel pump subassembly. A top view shows the white plastic upper body with a red circle around the connector area. Below it, two images compare the 'PREVIOUS' black connector and the 'NEW' brown connector. To the right, two separate images show the 'E-ring' and 'O-ring' components with blue arrows pointing to their respective locations on the pump assembly.</p>
<p>NOTE</p>	<p>The color of the new fuel pump upper body connector change: BLACK → BROWN</p>

To correct this condition, follow the repair procedure outlined in this bulletin to replace the fuel pump subassembly with a new service part.
