08V-461
(6 Pages)

**Regarding: 2007 Model Year XF50 and XC50 Connecting Rod
Factory Modification Campaign**

2007 XC50W (“Vino Classic”) and XF50W (“C³”) Scooters FACTORY MODIFICATION CAMPAIGN – Connecting Rod

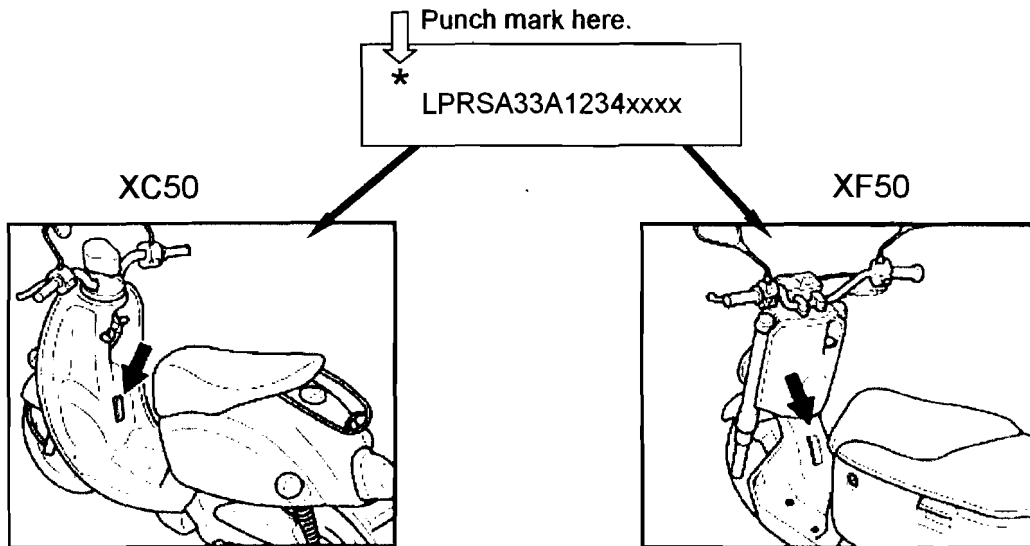
When the modification is complete, put a punch mark next to the Primary ID as shown. Check for this punch mark if you encounter an unfamiliar unit. You can also check unit status on YDS or by contacting your Regional Technical Advisor.
