08V-571
(5 Pages)

WORKHORSE CUSTOM CHASSIS SERVICE BULLETIN

BULLETIN NO: 20801-C

SUBJECT: Steering arm castle nut

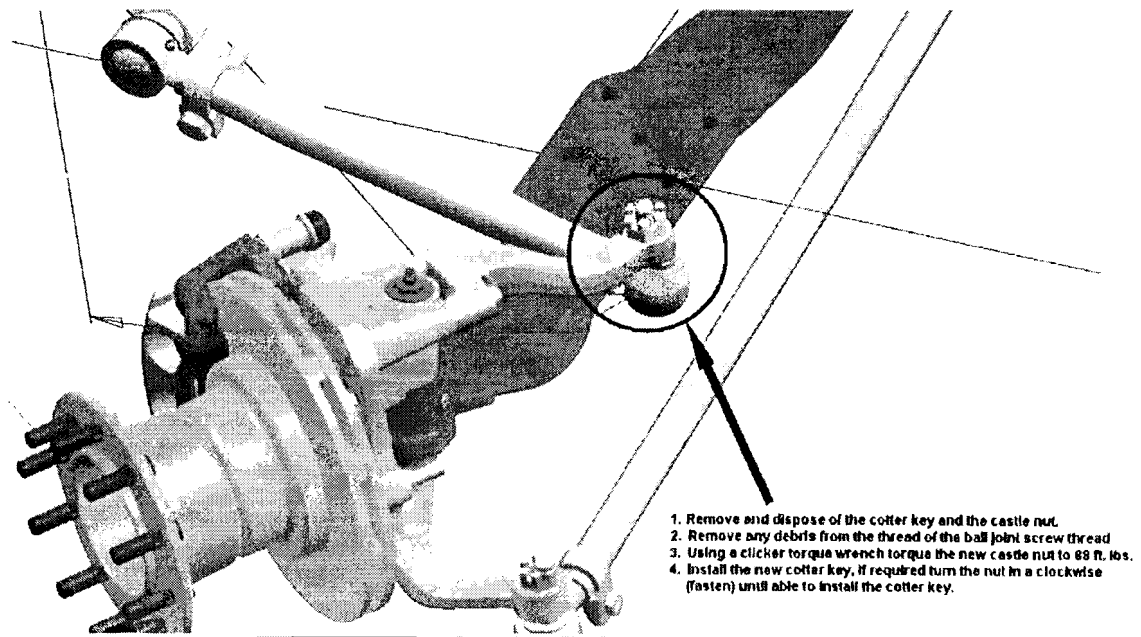
It is possible that the above models may have had a drag link to steering arm castle nut stripped from an over-torque condition. If the castle nut is stripped, it can become loose from the drag link stud allowing the drag link to separate from the steering arm. This will result in a loss of steering control and a possible vehicle crash.

1. Refer to the appropriate Service Repair Manual for general information involving steering system repairs.
2. Remove existing castle nut and cotter pin as shown in graphic below.
3. Check ball joint threads for any metal contamination from the nut and clean as necessary. (The ball threads are very hard material and the castle nut is soft material. A stripped nut will not damage the ball joint threads, but may contaminate the threads.)
4. Install new castle nut and torque to 88 ft-lbs. (120 nM).
5. **USE CLICKER WRENCH TO TIGHTEN**
6. Install cotter key. If necessary, turn nut clockwise (tighten) until nut slots align with cotter pin hole.
