08V-573  
(15 Pages)

## Subject: SAF Holland ADL Suspension Transverse Beam Welds

**Models Affected: Specific Freightliner Custom Chassis XC motor home chassis manufactured between July 2, 2007, and October 30, 2007 with SAF Holland ADL suspensions.**

September 2008  
FL530AB  
NHTSA #08V-269

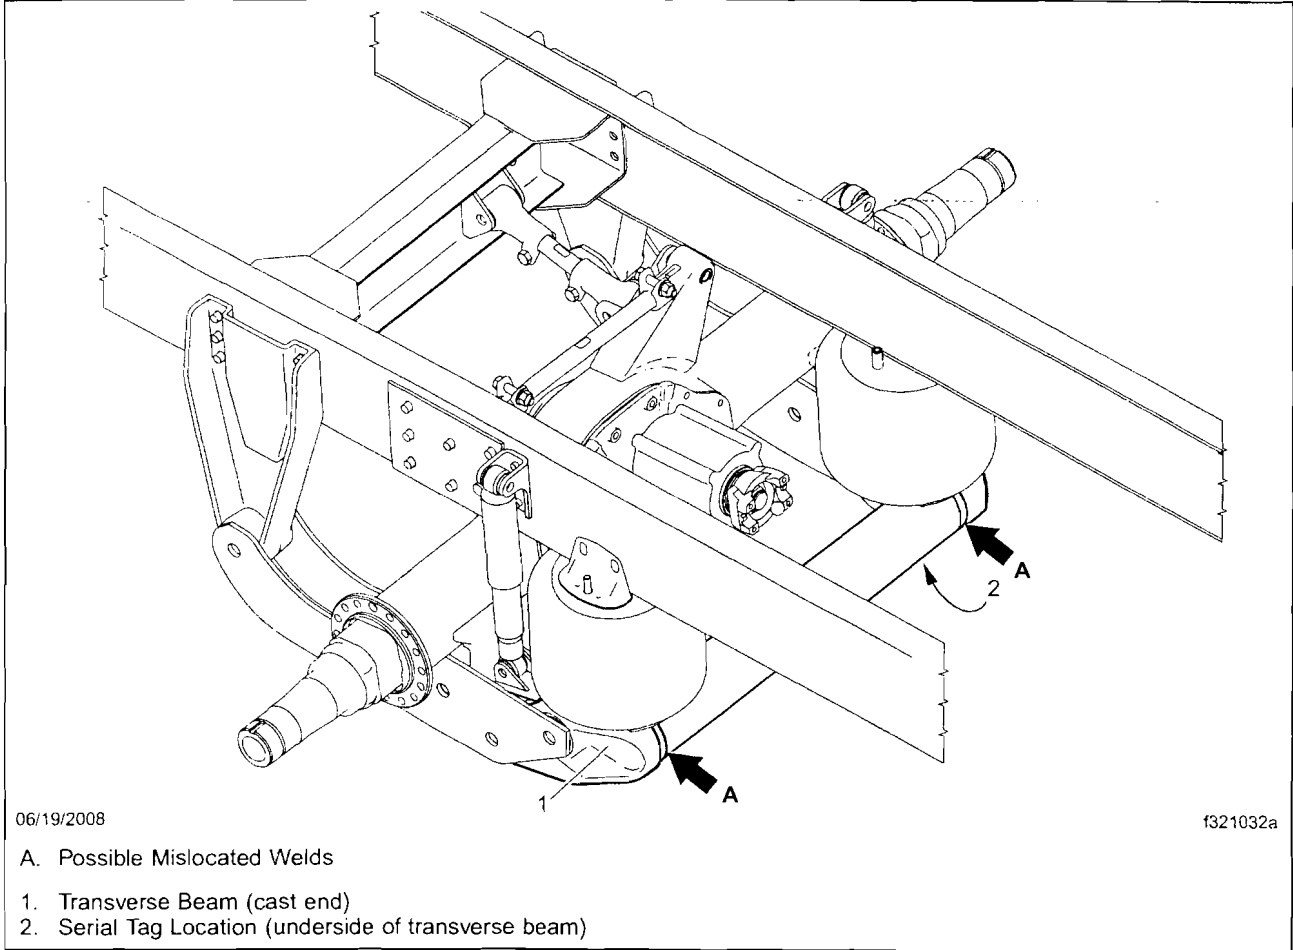
Fig. 1, Transverse Beam Area

4. At the rear of the drive suspension, look for the serial tag located under the transverse beam to identify the part number and 2-letter date code that describes the manufactured month as follows.
  - July 2007 - suspension date code GM
  - August 2007 - suspension date code HM
  - September 2007 - suspension date code JM
  - October 2007 - suspension date code KM

See **Fig. 1**, Item 2, and **Fig. 2**.

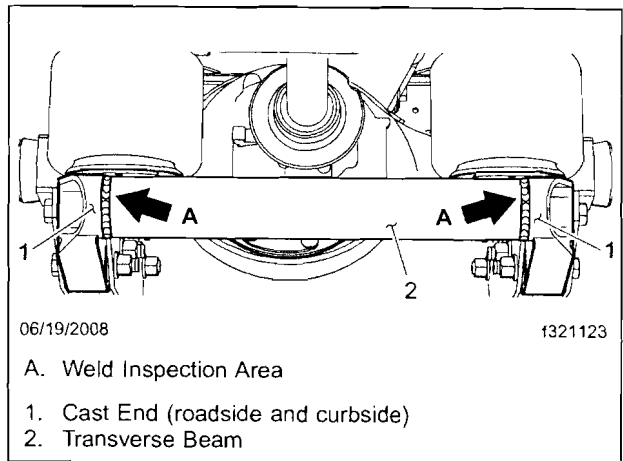
Fig. 3, Rear View of Transverse Beam

**NOTE:** There are two weld joints where defects may have occurred on the transverse beam. A joint at each end of the beam connects a cast end to the beam's tube structure. See **Fig. 3**. Welds at these joints are a circular band that wrap completely around the tube.

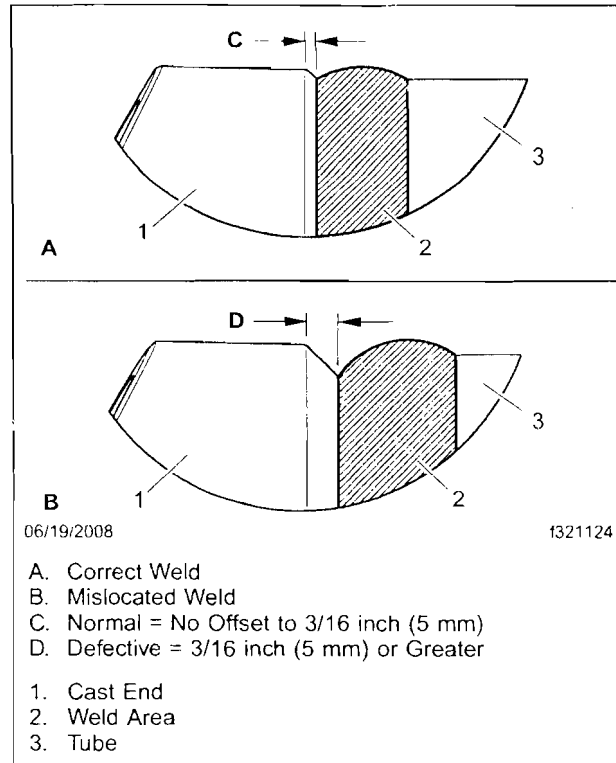
Fig. 4, Mislocated Weld Inspecting

5. Visually inspect each weld joint at each end of the transverse beam. If damaged, the transverse beam must be replaced.

**IMPORTANT:** Do not attempt to repair mislocated welds. See **Fig. 4**, for an example of correctly located and mislocated welds.
