MOTOR COACH
INDUSTRIES

RE: ZF FRIEDRICHSHAFEN AG, (“ZF”) SOFTWARE UPDATE CAMPAIGN
DUE TO CELL PHONE AND RADIO INTERFERENCE - ZF NHTSA 06E100

Service Bulletin No. 308

MODEL D / E / J Series Coaches	TYPE Field Change Program	SECTION/GROUP 13 – Transmission	DATE
SUBJECT ZF SOFTWARE UPDATE CAMPAIGN FOR CELL PHONE & RADIO INTERFERENCE			
CONDITIONS

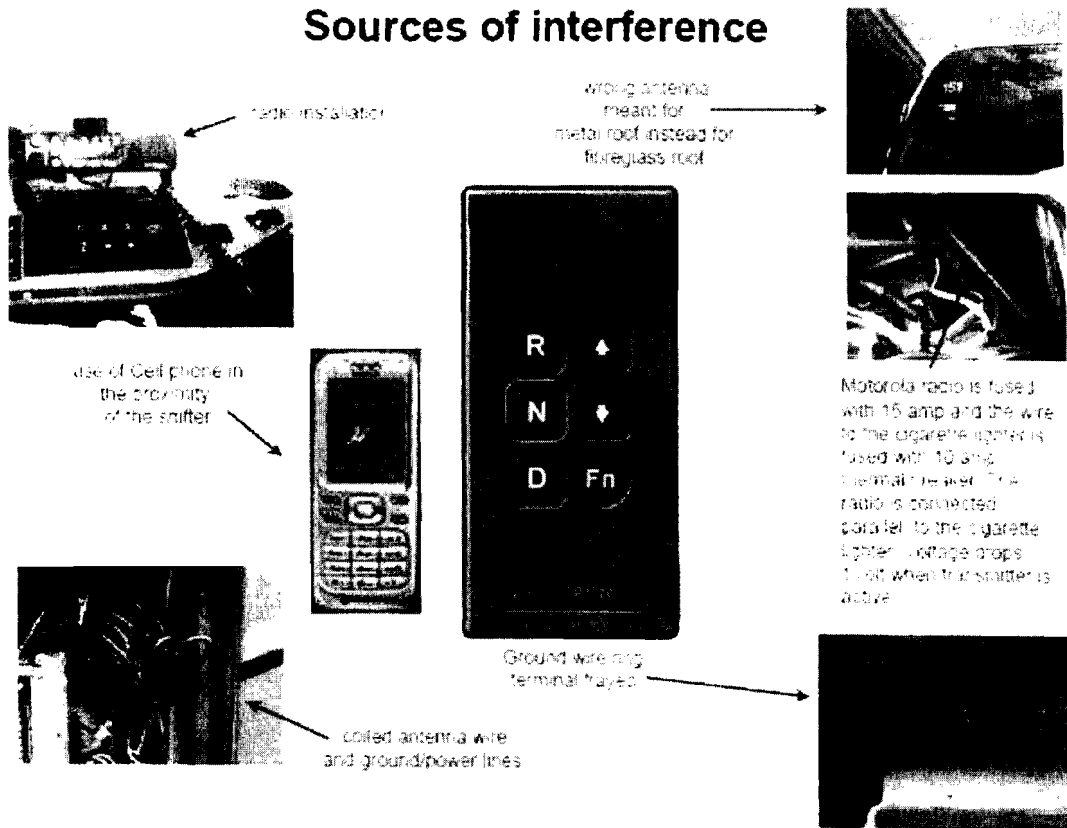
Sources of interference

It has been identified that there is a potential for the ASTRONIC shift selector to malfunction as a result of cell phone or radio interference, improper radio, antenna and power supply installation beyond the automotive requirements. For this malfunction to occur, a GSM network cell phone or a Blackberry (PDA) must be placed on or in the proximity of the touch pad of the Arens shifter.

Necessary action: Reprogramming of the ASTRONIC Software, update on all MCI coaches in the field prior to ZF transmission serial no.: **515993**

- Software modification:**
- a) Default to N for false D or R request - to avoid the potential for unintentional change in vehicle direction
 - b) 10 speed to 12 speed (for pre 2007 emission engines) - to improve vehicle start availability
 - c) Upgrade existing 12 speed (for 2007 emission engines)
 - d) Engine over-speed protection in manual mode - to prevent engine damage
 - e) Avoid possibility to be stuck in 7th gear due to "gear butting"
