Re: Reinke Manufacturing Company, Inc. Part 573 Report Submission

## **PART 573 Defect and Noncompliance Report**

**Generic Name:** Intermodal Tank Chassis frame

**Part Number:** 241032 (10 sold to Agmark Foods)

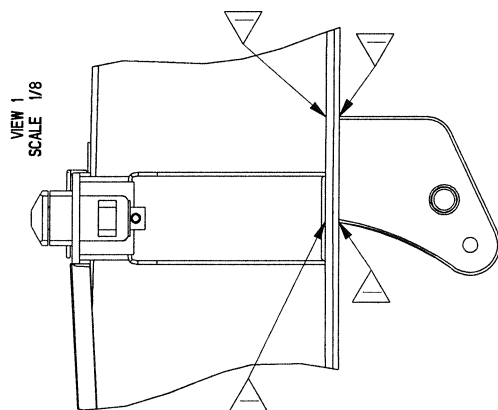
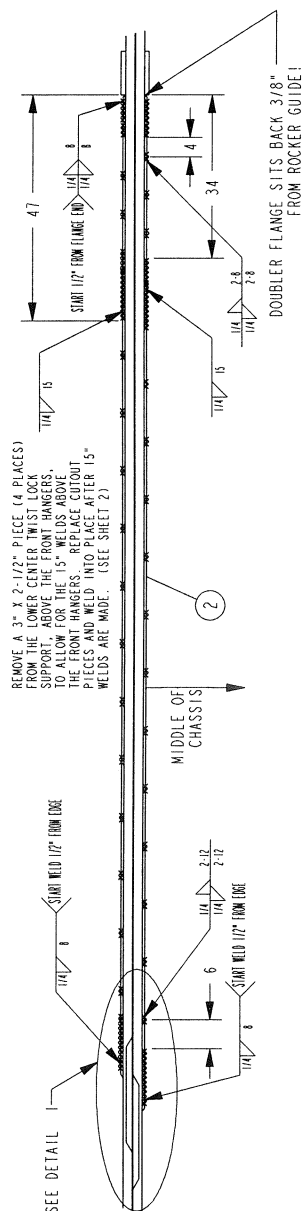
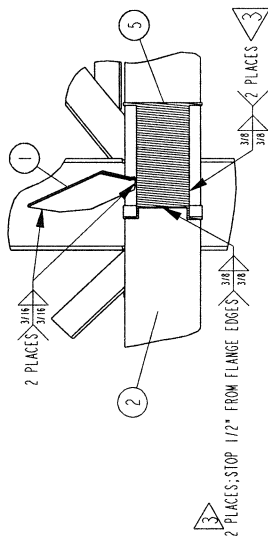
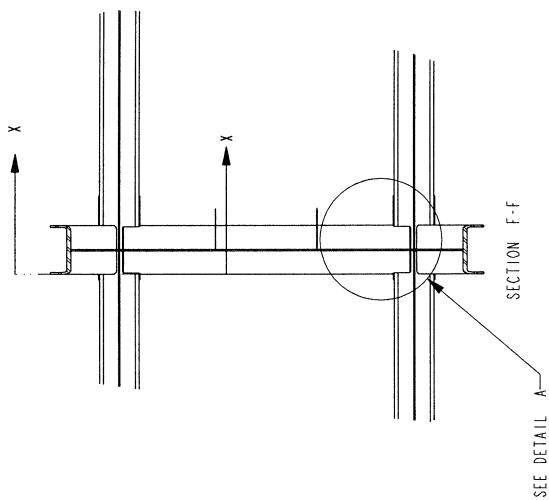
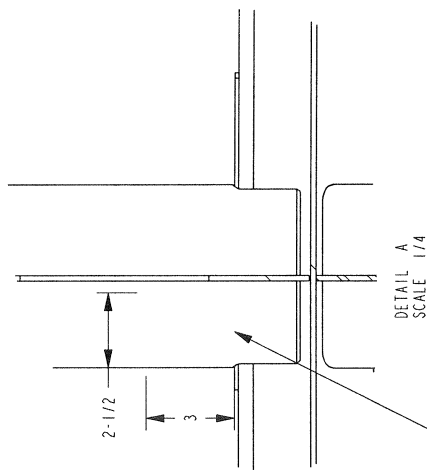
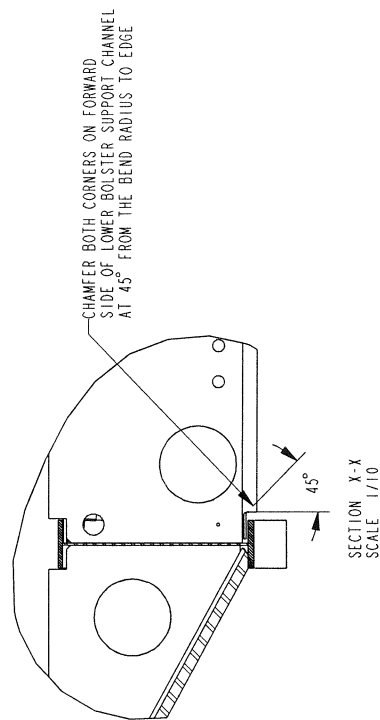
In some instances the lower flange(s) of the frame will develop a crack either in front of or behind the front suspension hanger.

**Detailed description of defect addressing nature and physical location, cause, consequence and any preceding warning (including graphic aids as necessary):** The failure mode is the progression of a fatigue crack within one or both of the lower flanges in front of or behind the front suspension hanger which is attached to the tank chassis frame. These small cracks can in some cases further develop based on trailer usage whereby in certain applications the lower flange(s) may fail. As stated above, due to the delamination in the one flange we have had a failure on one chassis operated by VPL.

STEP 1: VISUALLY INSPECT THE BOTTOM FLANGE IN FRONT AND BEHIND THE FRONT HANGER ON BOTH TOP AND BOTTOM AS INDICATED BY NOTE 1 ON VIEW 1.

STEP 2: IF NO CRACKS ARE FOUND, NO MODIFICATION IS REQUIRED. HOWEVER THE AREA DESCRIBED IN STEP 1 SHOULD BE REINSPECTED ON A REGULAR BASIS. MAXIMUM NUMBER OF MILES BETWEEN INSPECTIONS IS 5,000 MILES, UNDER NORMAL LOAD AND ROAD CONDITIONS. MORE FREQUENT INSPECTIONS ARE RECOMMENDED IF CONDITIONS ARE SEVERE.

**STEP 3: IF CRACKS ARE FOUND, INSTALL UPDATE PER DRAWING.**

1. STOP ALL WELDS 1/4" FROM EDGE UDS.
2. DUE TO HIGH STRENGTH STEEL, BOTTOM FLANGE MUST BE BETWEEN 210° AND 400°, BEFORE WELDING ANY COMPONENTS TO THE FLANGES OR CUTTING AGAINST THE FLANGES.
3. WELD FROM EDGE TO CENTER AND EDGE TO CENTER
