**08V-609**  
**(7 pages)**

This notice covers certain American LaFrance Condor chassis-cabs that have been fitted with a certain hydraulic system to raise and lower the vehicle cab for maintenance activities. The issues described in this notice also are relevant to certain vehicles manufactured and badged as Freightliner and/or Sterling by certain direct or indirect affiliates of Daimler Trucks North America, LLC, formally Freightliner, LLC (collectively, "Sellers") from whom American LaFrance purchased certain assets under an Asset Purchase Agreement dated as of December 14, 2005 (the "Agreement").

### **Description of Potential Defect:**

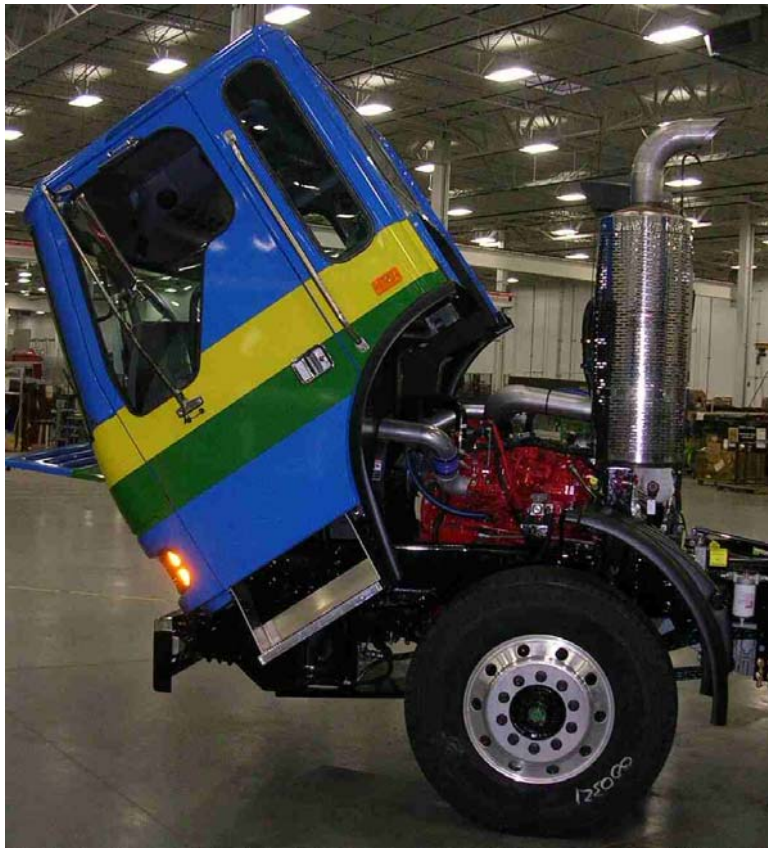
PHOTO # 1

The cab can be tilted open 42 degrees to access the engine and other components (See Photo # 1 on Page 4). A hydraulic pump located behind the right side of the cab is used to operate the hydraulic cab tilt mechanism. The hydraulic cylinder is attached to the cab through a clevis and pin assembly that attaches to a cast aluminum bracket (see Photos 2 & 3). It is believed that the cast aluminum bracket is at risk of failing.

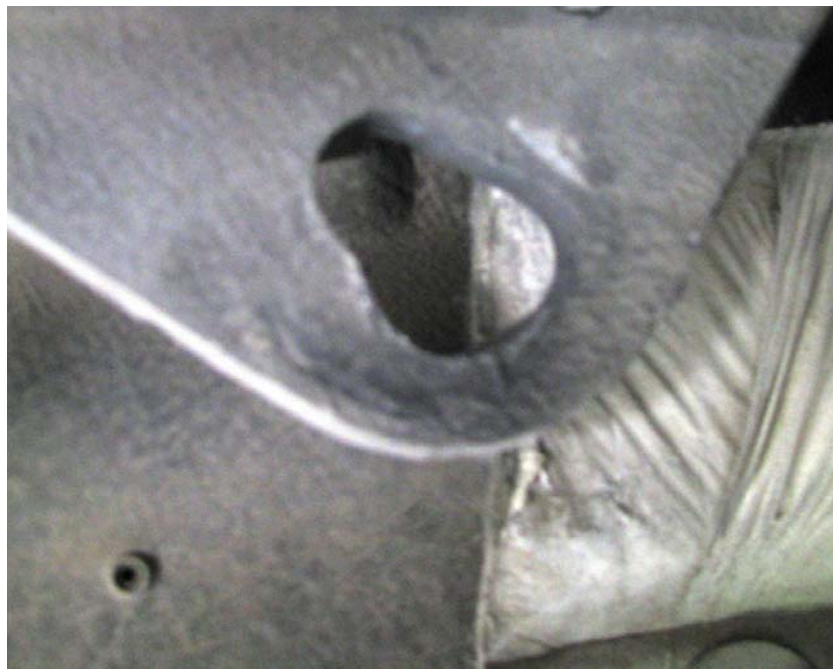
PHOTO # 4

Based on our investigation to date, which is continuing, there appears to be two modes of bracket failure. The first mode is that the clevis pin elongates the slot in the cab bracket to a point that the bracket will fail due to lack of bracket material (see Photo # 4). The second mode is due to wear between the clevis on the end of the hydraulic cylinder and the cab bracket. The material around the hole where the clevis pin attaches the two together wears thin and eventually the bracket material will fail (see Photo 5). Photo # 6 shows a combination of the two failure modes. If the bracket fails during the lifting segment of raising the cab, the cab will fall unrestrained back down onto the chassis. If the bracket fails due to the forces encountered when the cab passes the break over point and reaches the end of the cylinder travel, the cab will continue its forward movement until it reaches the ground (see Photo # 7). To date, no injuries have occurred to our knowledge related to the above.
