08V-645
(4 Pages)

RE: Part 573 Defect Information Report – 2008-2009 Subaru Tribeca VDC G-Sensor

Defect Information Report (49 CFR Part 573.6)

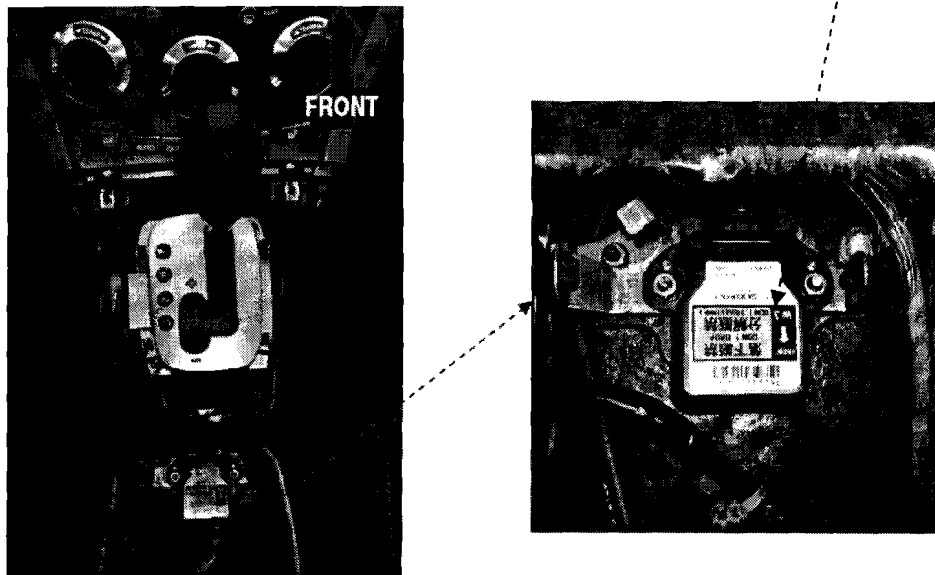
While a customer was driving along a highway at approximately 100-120km/h and cornered to the left, one of the front wheels locked up and forced the vehicle to go to the right. As a result of an investigation at a dealer, it was found that the VDC G-Sensor had been installed backwards in the fore-aft direction.

Note : Directional arrow on top of sensor

The VDC system was changed in SIA production of '08MY Tribeca vehicles beginning February 18, 2008. Before this change, the VDC sensor was restricted structurally so that it could only be installed in the proper direction. However, afterwards the VDC sensor could be installed backwards.

- a) The standard installation procedure was not consistently observed, and
- b) The assembly line procedure to prevent the sensor from being installed in the opposite direction was discontinued when the system was changed.

The remedy plan calls for dealers to inspect each affected vehicle to see if there is improper installation of the VDC G-Sensor. If no abnormality is found, no additional work will be necessary. If the sensor was improperly installed, the original sensor will be reinstalled in the correct position.
