Safety Defect and Noncompliance Report Guide for Vehicles  
**PART 573 Defect and Noncompliance Report**<sup>1</sup>

**Subject:** Incorrect Installation of Air Suspension Rear Axle U-Bolts

**Bulletin:** R0027

**Affected Models:** Certain 2008 and 2009 ND8J (238), NE8J (268), NJ8J (268A), NV8J (338)

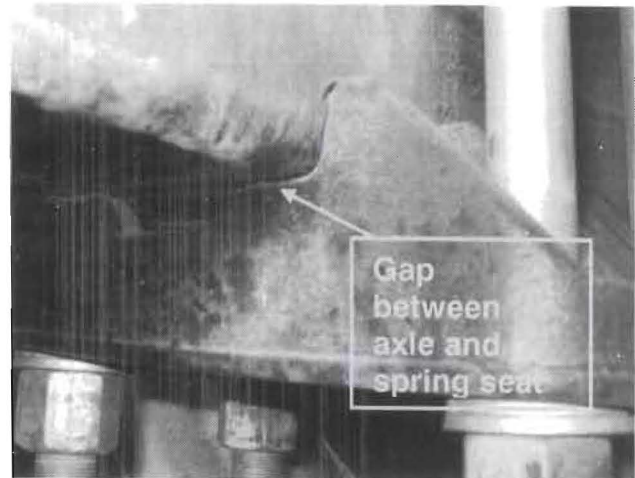
1. Inspect the rear air suspension lower spring seat for a gap between rear axle and lower spring seat. Axle should sit flat on the lower spring seat with no gaps on the front or rear of the lower spring seat.

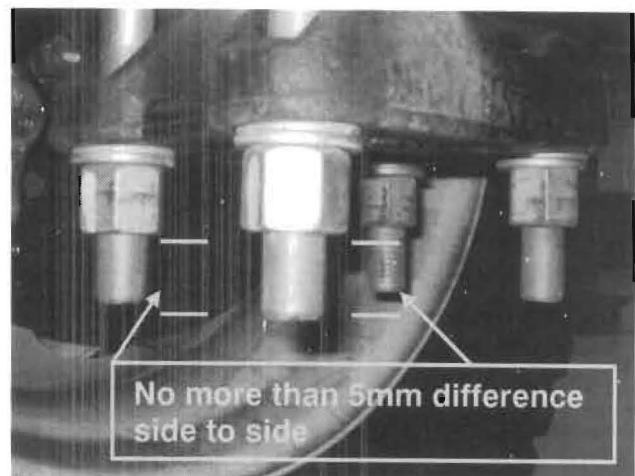
2. In comparing the height of the thread protruding through each U-bolt nut, there should not be more than a 5mm difference between the thread height from one side to the other side. If a difference of more than 5mm is not present, no further action is required. If a difference of more than 5mm exists, proceed to step 3.
