Michael A. Berardi
Director
Service Engineering Operations
Ford Customer Service Division

February 6, 2008

SUBJECT: DEMONSTRATION / DELIVERY HOLD Safety Recall 08S03:
Certain 2007 - 2008 Model Year Expedition and Navigator Vehicles
Interior Side Door Handle Spring Replacement

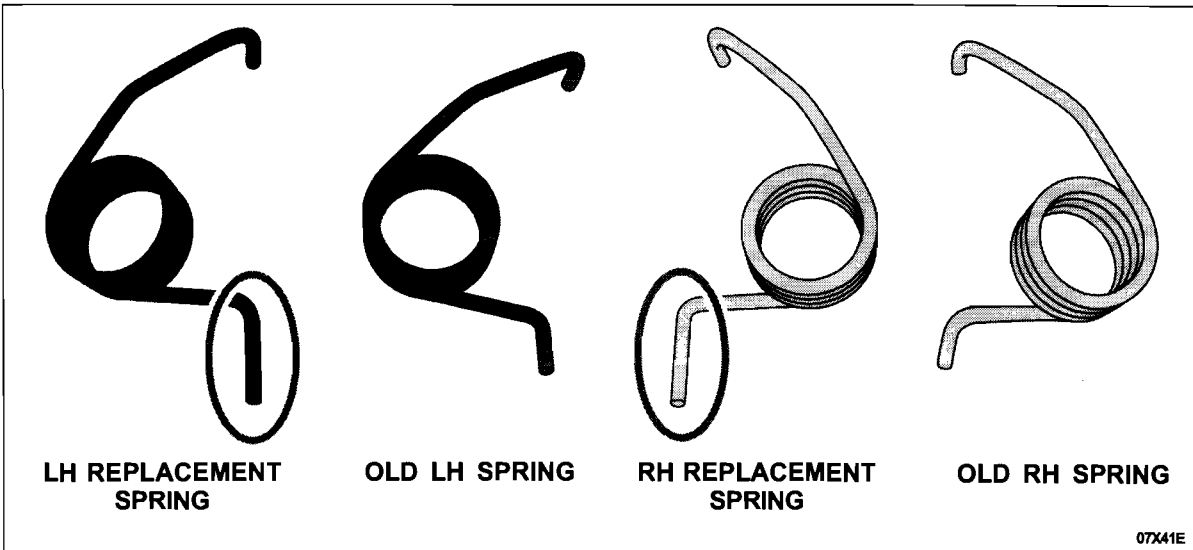
FIGURE 5

5. NOTE: The interior side door handle spring retainer may be cracked or missing. See Figure 6 for the location of the spring retainer. The **new** re-designed spring has a longer leg and does not need the retainer to function. The door handle does not need to be replaced, even if the spring retainer is damaged. See Figure 5 for example of re-designed spring.

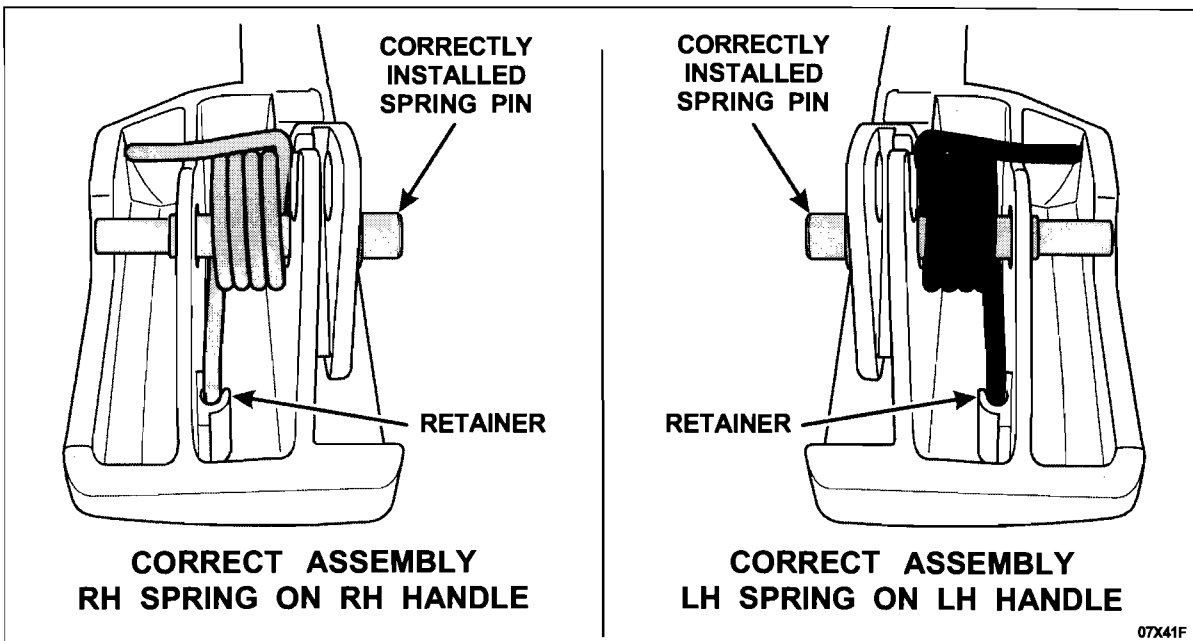
FIGURE 6

In some of the affected vehicles, the spring retainer located in the interior side door handles may fracture. If the retainer fractures, the spring could rotate, and may cause loss of tension on the door handle. If the spring loses tension, the side door handle could open in the event of a side impact collision. The rear liftgate handle is not affected by this recall.

Position the **new** interior side door handle spring (LH is green, RH is gray) into the interior side door handle and install the interior side door handle spring pin. The **new** spring can be installed into the retainer even if the retainer is damaged or broken. See Figure 6 for example of correct assembly.
