## Subject: Business Class M2 Headlight Height

Models Affected: Specific Freightliner All-Wheel Drive Business Class M2 vehicles and All-Wheel Drive Business Class M2 Sportchassis vehicles built with Cummins ISC engines manufactured August 15, 2007, through March 25, 2009.

March 2010  
FL531A  
NHTSA #08V-270  
SECOND REVISED NOTICE

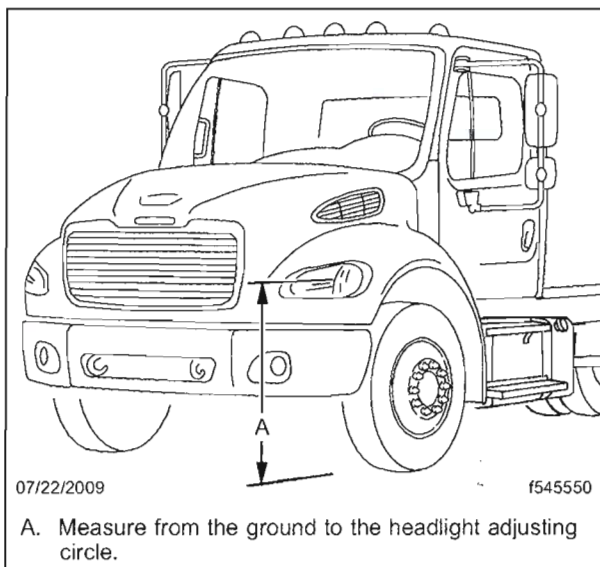
Fig. 1, Headlight Measurement

If the distance is more than 54 inches (137 cm), go to the next step.
