**Re: Defect Information Report – Supplemental Report No. 04  
08V-398, 08C-4, FL-535, Sterling 360 Turbocharger Bracket**

To: FLLC Sterling Dealers  
Attn.: General Service Manager  
Subject: **Safety Recall 08C4**  
Sterling 360 Turbocharger Bracket

Subject: **Safety Recall 08C4**  
**Sterling 360 Turbocharger Bracket**

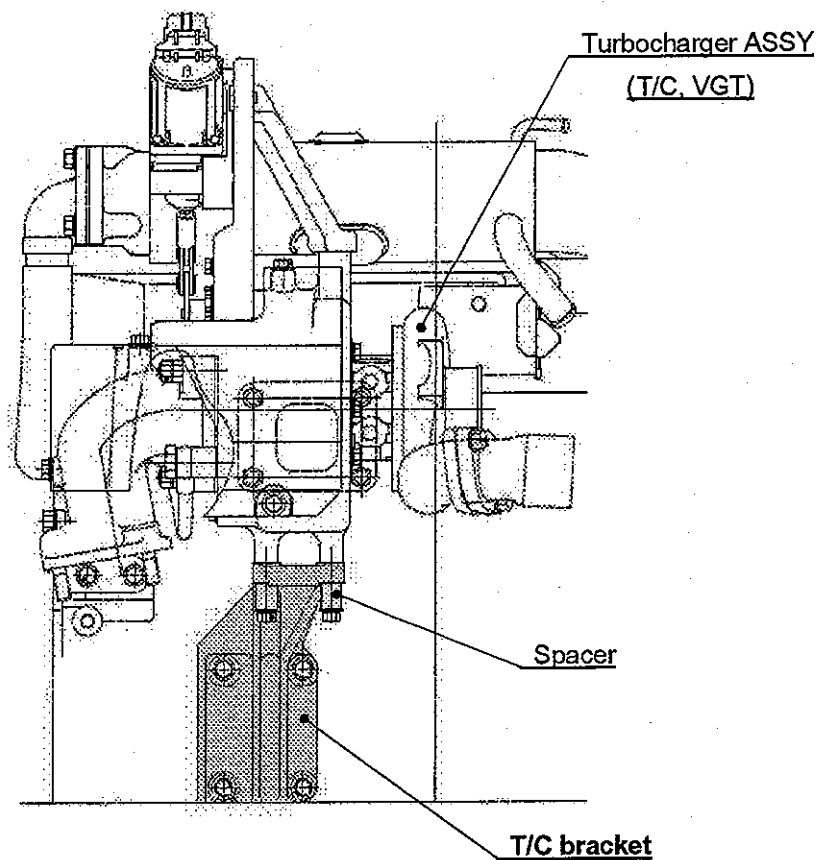
Replace VGT Bracket to countermeasure one in order to prevent the crack of turbine housing.

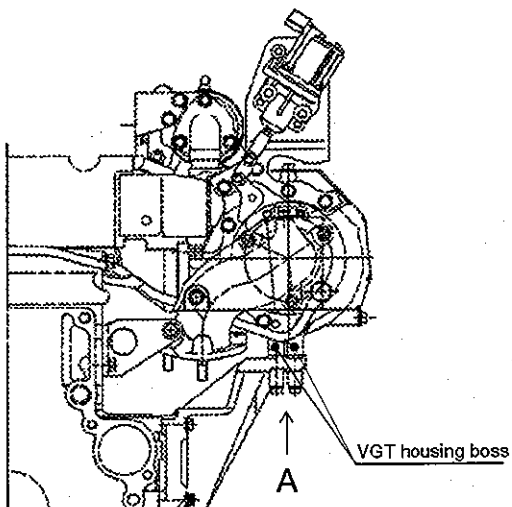
ENG Rear Side View

Conduct a penetrant inspection to confirm existence of crack occurrence around VGT housing boss. If a crack is found, replace VGT with a new one. → Jump to chapter "4".

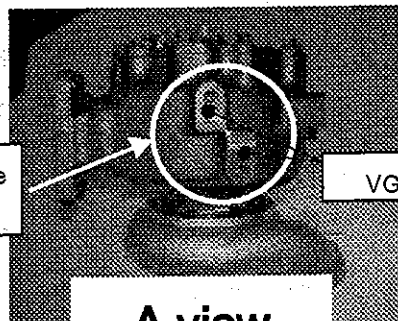
**A view**

Confirm existence of crack occurrence  
around VGT housing (See white

VGT Housing
