# Recall Bulletin

## F/CMVSS NONCOMPLIANCE RECALL

**SUBJECT:** Instrument Panel Storage Bin Door Compliance – Add Reinforcement Bracket

**MODELS:** 2006-2008 Chevrolet HHR

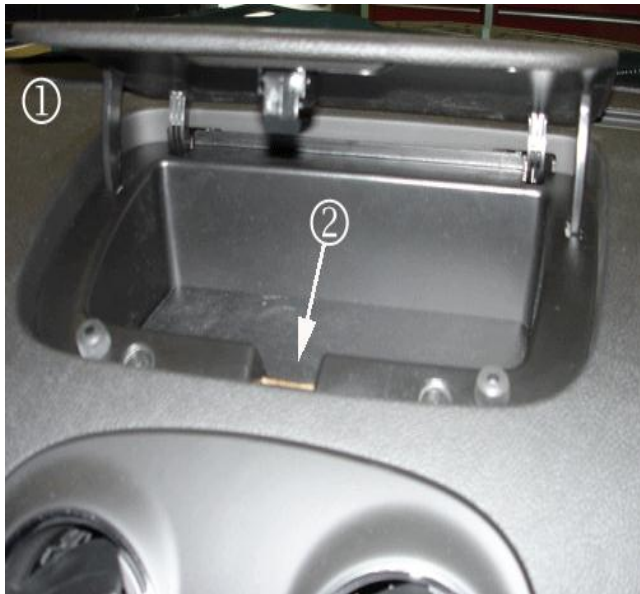
2200528

1. Locate and open the instrument panel storage bin (1).
2. Locate the instrument panel storage bin latch (2).

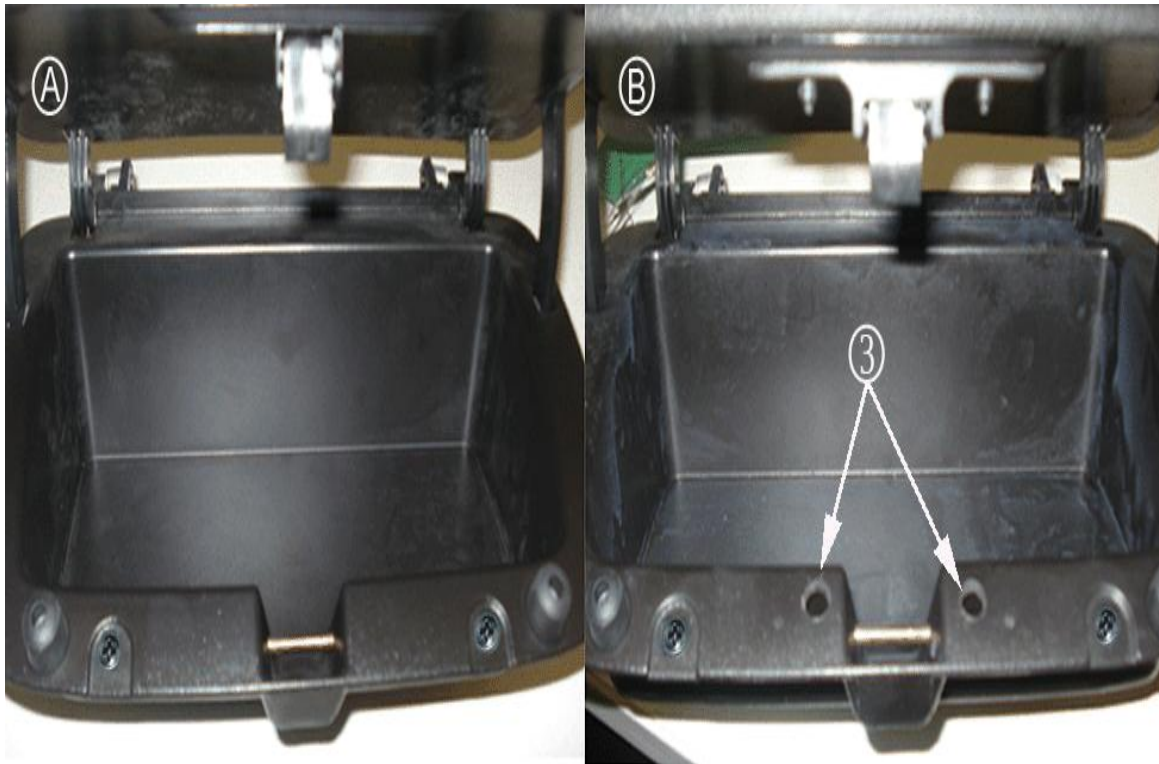
2219118

3. Determine if the storage bin is a first (A) or second (B) design storage bin. The second design storage bin (B) includes latch pin holes (3) on the left and right side of the latch.
  - If the vehicle is equipped with a first design storage bin (A), installing a reinforcement latch plate bracket IS required. Proceed to Step 4.
  - If the vehicle is equipped with a second design storage bin (B), installing a reinforcement latch plate bracket is NOT required. No further action is required.
