**** ADVANCE TECHNICAL INFORMATION NOTICE ****

DATE: October 28, 2008
TO: Mitsubishi Motors Service Managers
RE: SR-08-005 – Fuel Tank Bracket Safety Recall
ATIN NO. ATIN-08-SR-007

AFFECTED VEHICLES: 2005-07 Endeavor
2006-07 Eclipse
2005-07 Galant
2007 Eclipse Spyder

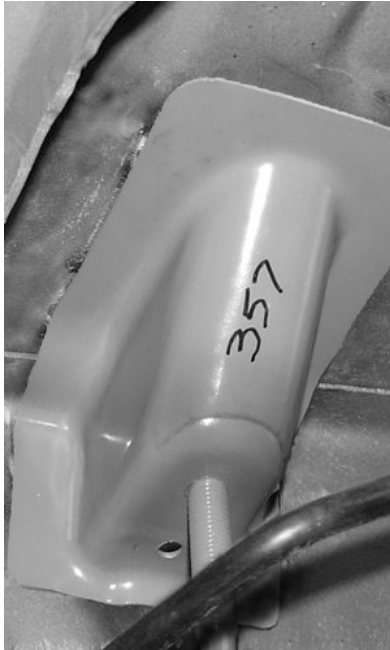
The photo must clearly show the last three positions of the VIN. This may be done by writing on the bracket with a marker (see below) or by holding a piece of paper or an index card in the photo with the last 3 positions of the VIN written on it.

Shown with fuel tank removed.
