SKF NOTICE TO END USERS

SAFETY RECALL NOTICE TO END USERS

NHTSA Recall #08E-064 of SKF BR930361 hub bearing assembly; SKF Recall # PRO 08-029US/CA

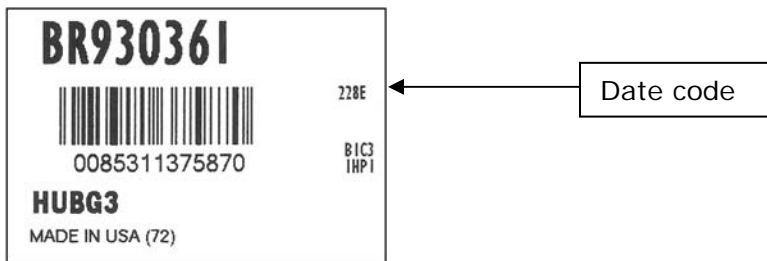
This recall involves SKF part number BR930361 that is identified by the following packaging date codes: 155E, 161E, 170E, 171E, 185E, 213E and 228E. This part was sold exclusively in the aftermarket for use on the vehicle identified. **Important note: Only parts with one of these date codes are covered by this campaign.** The box part number label is shown below.

The date code appears on the upper right hand side of the part number label.

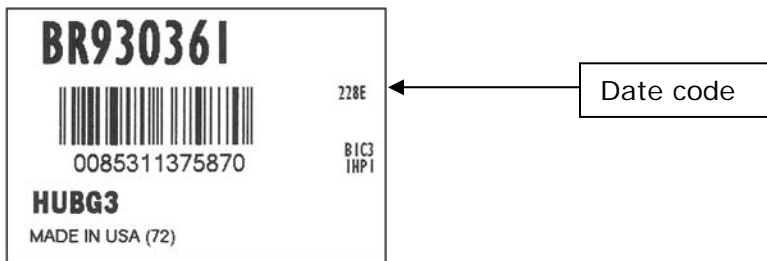
This recall involves SKF part number BR930361 that is identified by the following packaging date codes: 155E, 161E, 170E, 171E, 185E, 213E and 228E. **Only parts with one of these date codes are covered by this campaign.** The box part number label is shown below.

The date code appears on the upper right hand side of the part number label.

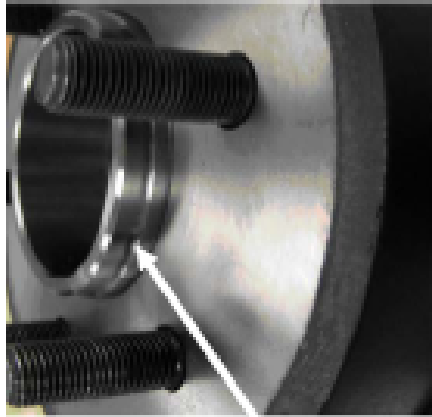
Figure 1 Defective

1. Raise and support the vehicle following the manufacturer's guidelines and remove the front wheel.
2. Carefully examine the center brake rotor pilot depth. *The affected hub bearing assembly will have a noticeable visible step just above where the brake rotor is seated. Refer to Figures 1 & 2. Figure 1 illustrates the incorrectly machined hub and brake rotor mounting set up. Figure 2 illustrates the correctly machined hub and brake rotor mounting set up.*

3. If you have identified a hub bearing assembly that is defective, remove the defective hub assembly and replace it with a non-defective replacement hub assembly using the manufacturers recommended repair procedures. Caution: Verify that the replacement SKF BR930361 is not a defective part by repeating step 2 listed above.
4. Complete the information on the front side of this form; contact your SKF parts distributor for assistance in completing the WD/DC and Jobber Information sections. When completed, send the form and the defective hub assembly if applicable to SKF at the address indicated on the form.
