Recall 08V-087

Instruction Sheet #TBB 85490092

RECALL #08V-087

**SUBJECT:** EMERGENCY / SIDE DOOR HANDLE RETROFIT

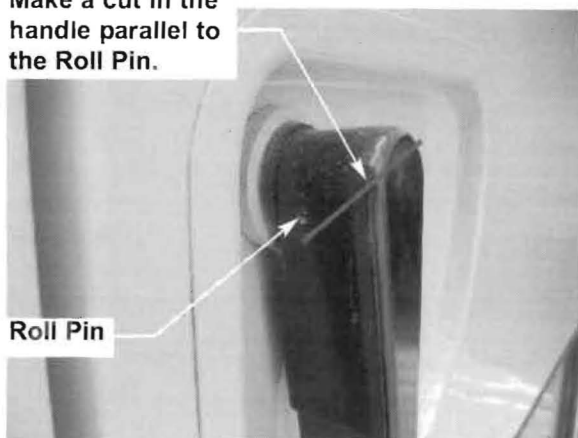
**Figure 1**

Make a cut in the handle parallel to the Roll Pin.

1. Cut off the existing door handle to break it loose from the square shaft it is attached to. **(Figure 1)** Retain nylon washer and rubber washer to be reinstalled.
  - 1.1 Make cut in the direction pictured approximately 1/2" deep and then use a mallet / pry bar to remove handle.
  - 1.2 Be careful not to damage the square shaft. **Figure 2**
  - 1.3 Discard the existing pin and handle.
