SUBJECT: G4500 TAG AXLE ARM ASSEMBLY ASSEMBLIES

Ref.: **NHTSA # 08V-121**
TRANSPORT CANADA # 08-093
MCI Service Bulletin 289

Service Bulletin No. 289

MODEL G Series Coaches	TYPE Field Change Program	SECTION/GROUP 2--Tag Axle	DATE Mar. 18, 2008
SUBJECT TAG AXLE RETROFIT			
CONDITIONS

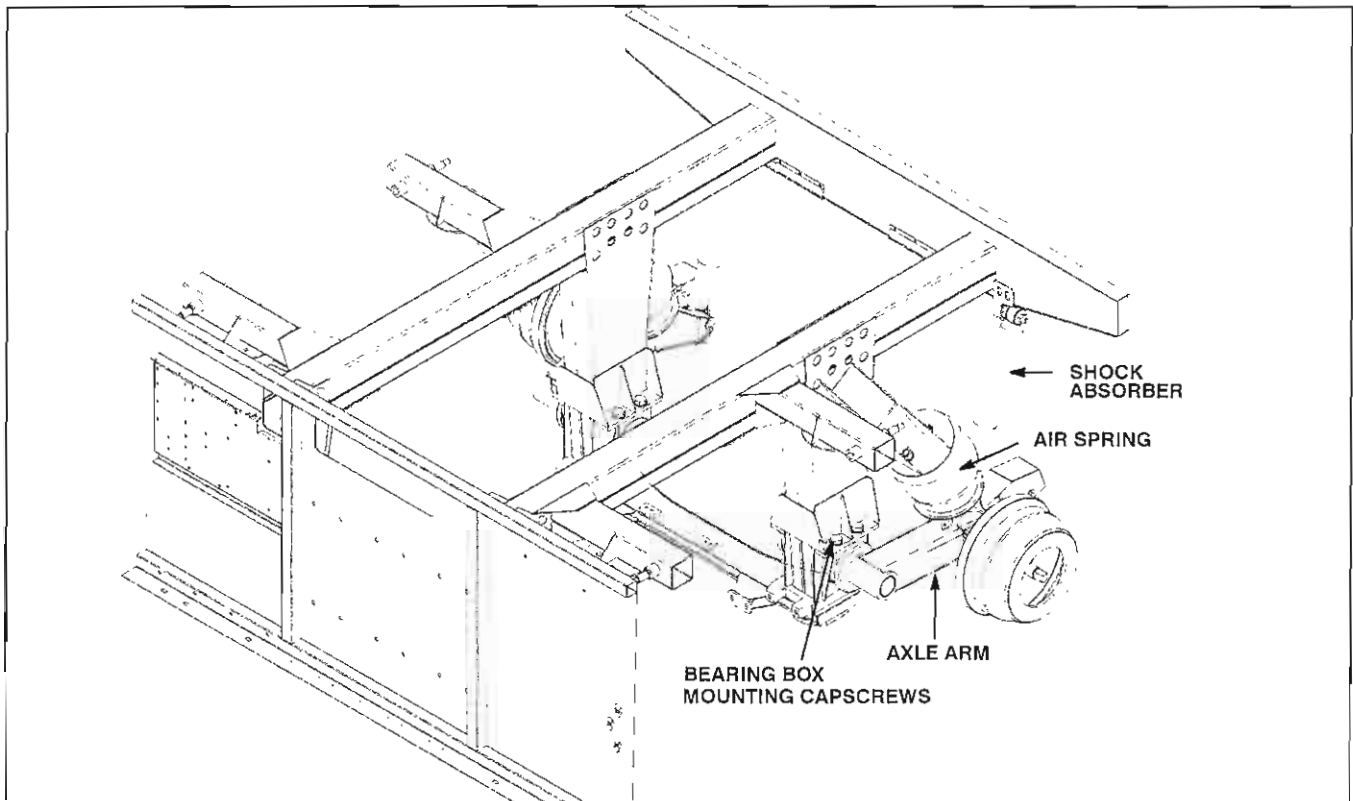
Figure 6. Tag axle arm.

Some customers have reported cracking originating at the heat-affected zone of the weld on tag axle arm assemblies reworked during MCI Campaign 212, released in December 2003 (Ref. NHTSA Recall No.: 03V-411, Ref. TC Recall No.: 03-251).

Incorrect identification / inspection of the tag axle arm assemblies for identifiable cracks or incorrect welds in the previously repaired areas.

MCI will make arrangements for a re-inspection of all G model tag axle arms for identifiable cracks or incorrect welds in the previously repaired areas. If any related issue is identified, both right and left tag axle arm assemblies will be replaced with newly designed assemblies.

31. Remove the tag axle arm assembly from the coach.
