CUSTOMER LETTER

RE: IMPORTANT SAFETY RECALL INFORMATION REGARDING YOUR MOTO GUZZI NORGE 1200 MOTORCYCLE

Repair Instructions:

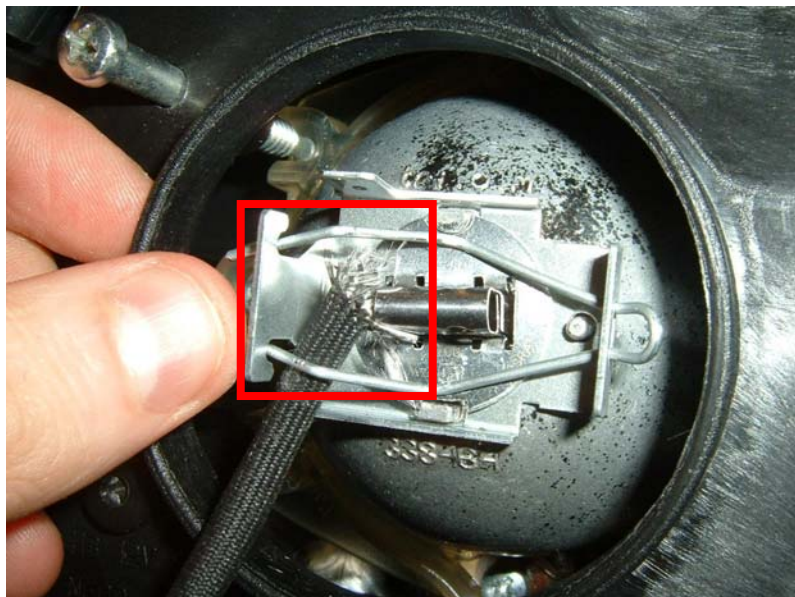
The power wires to the bulbs for the low beam lights on the above model, within the noted model years, may contact and wear against the bracket that holds the low beam bulbs in place in the low beam reflector. When worn through to a bare wire, there exists the possibility of an electrical short to ground. This electrical short would “blow” the main fuse in the motorcycle’s electrical system causing a loss of all electrical power to the motorcycle’s engine. If running at the time, the engine would stall which under certain circumstances could result in a crash, personal injury or death.

When remounting, make sure the cable harness goes under the lock fork as illustrated in the following picture.
