Daimler Buses Recall Bulletin

Orion V/VII Models

NHTSA 08V-480/TC 08-354

1.0 CABLE ROUTING RECALL NOTICE

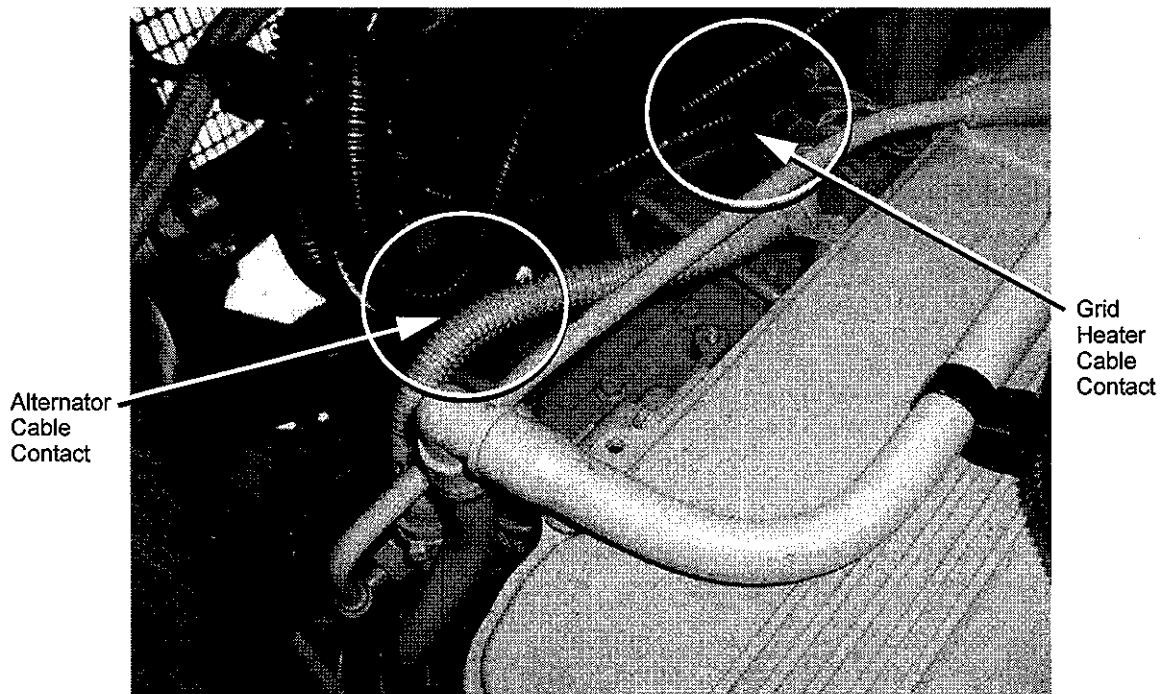
FIGURE 1-1 IMPROPERLY ROUTED CABLES IN CONTACT WITH FUEL LINES

3. Inspect the alternator cable and grid heater cable for proper routing in the rear engine compartment to avoid the possibility of rubbing/chaffing against the #3 and #4 fuel injector lines. (See Figure 1-1.)
 - a. If the cables come in contact with the fuel injector lines as indicated in Figure 1-1 but no damage is found, reroute the cables following the procedure outlined in "Rerouting Improperly Routed Cables" on page 5.
 - b. If the cable loom or insulation is damaged on either cable, replace the cable(s) as indicated in "Alternator Cable Replacement" on page 6 or "Grid Heater Cable Replacement" on page 6.

If the alternator cable and grid heater cable are making contact with the #3 and #4 fuel injector lines as indicated in **Figure 1-1** but no damage is found:

1. Loosen the p-clamp or clamps securing the alternator and grid heater cables in the rear engine compartment.
2. Lift the cables clear of the injector line(s) and secure with a Dual Clamp Tie (**ORION P/N 051048002**) as indicated in **Figure 1-3**.
3. Re-tighten any p-clamps loosened in **step 1**.
4. Close the interior access panel located under the rear center seat section inside the bus.
5. Return the battery isolator switch to the ON position.

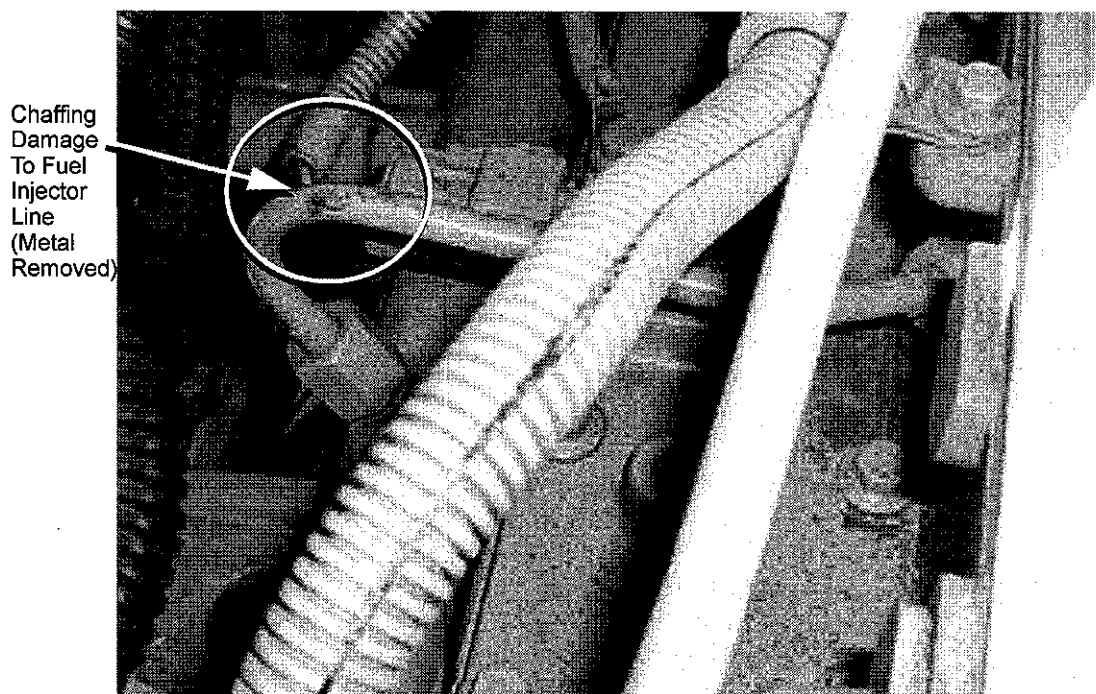
FIGURE 1-2 CHAFFING DAMAGE TO FUEL INJECTOR LINE

4. Inspect the #3 and #4 fuel injector lines for chaffing damage as shown in Figure 1-2. If any metal has been removed, replace the fuel injector line as indicated in "Fuel Injector Line Replacement" on page 6.

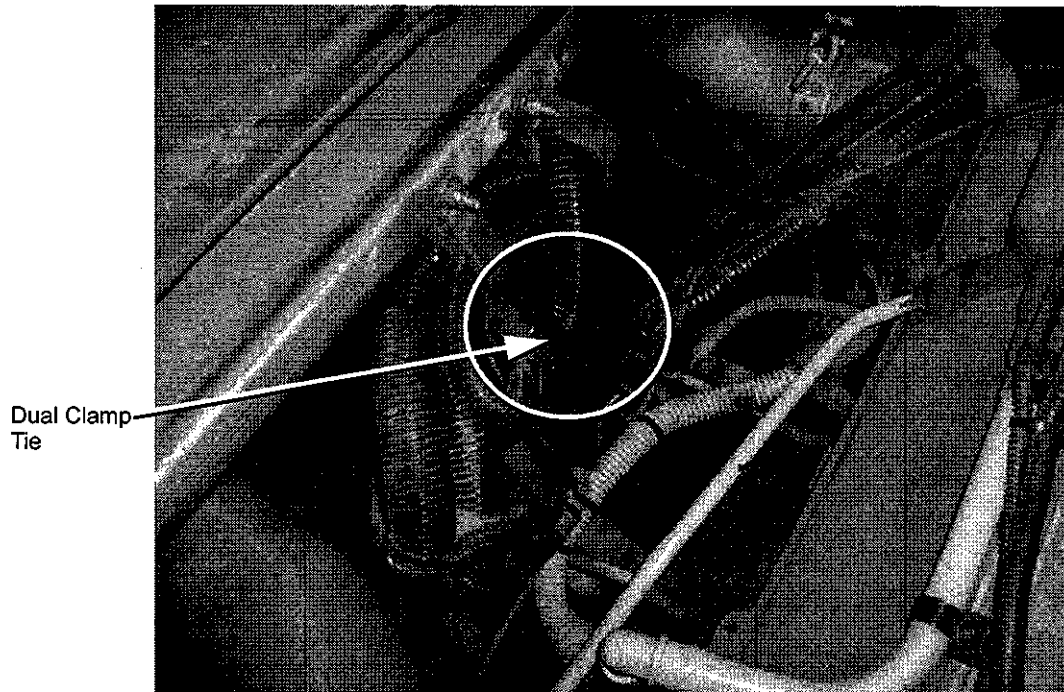
FIGURE 1-3 ALTERNATOR AND GRID HEATER CABLES WITH DUAL CLAMP TIE INSTALLED
