**SUBJECT: ZF FRIEDRICHSHAFEN AG, ("ZF") SOFTWARE UPDATE
CAMPAIGN DUE TO CELL PHONE AND RADIO INTERFERENCE**

Ref.: ZF NHTSA #06E100
MCI NHTSA #08V-603
TRANSPORT CANADA # 08-404
MCI Service Bulletin 308

Service Bulletin No. 308

Software Update campaign because of cell phone and radio interference (NHTSA no.06E100)

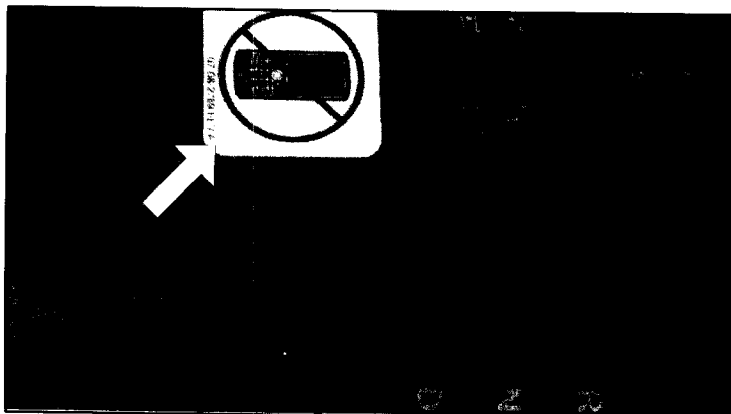
Figure 1. NO cellular phone decal.

The only part required for this change is the 07-08-2789 Decal.

Installation of a warning sticker onto the dashboard area

- to avoid any malfunction due to the use of electronic
equipment (ZF part no.: 1348 753 101)

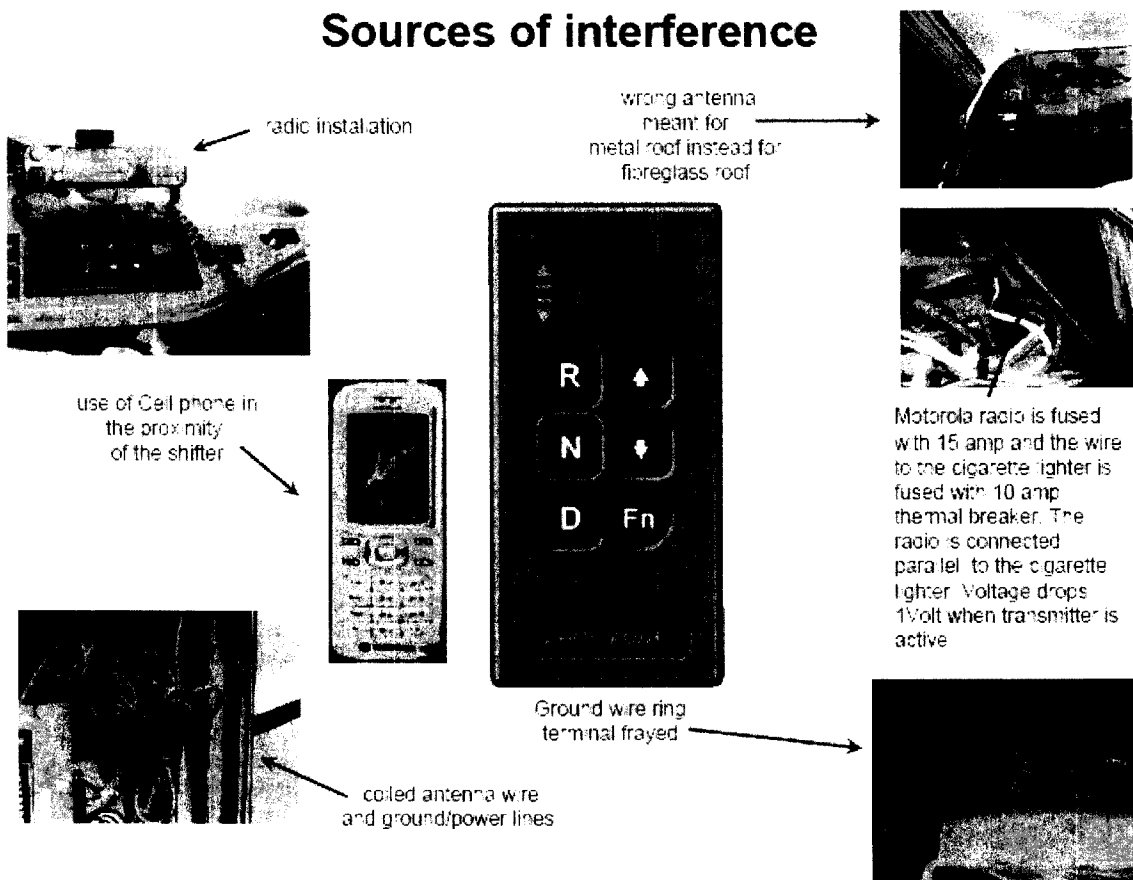
Sources of interference

It has been identified, that there is a potential for the ASTRONIC shift selector to malfunction as a result of cell phone or radio interference, improper radio, antenna and power supply installation beyond the automotive requirements. For this malfunction to occur, a GSM network cell phone or a Blackberry (PDA) must be placed on or in the proximity of the touch pad of the Arens shifter.
