**Re: Defect Information Report - Supplemental Report No. 3
08V-356, FL-534, TBB MVP-ER Alternator Cable Routing**

Subject: RECALL 08V-356 – Power Cable Routing

RECALL #08V-356
INSTRUCTION SHEET #TBB 85490100

SUBJECT: POWER CABLE ROUTING

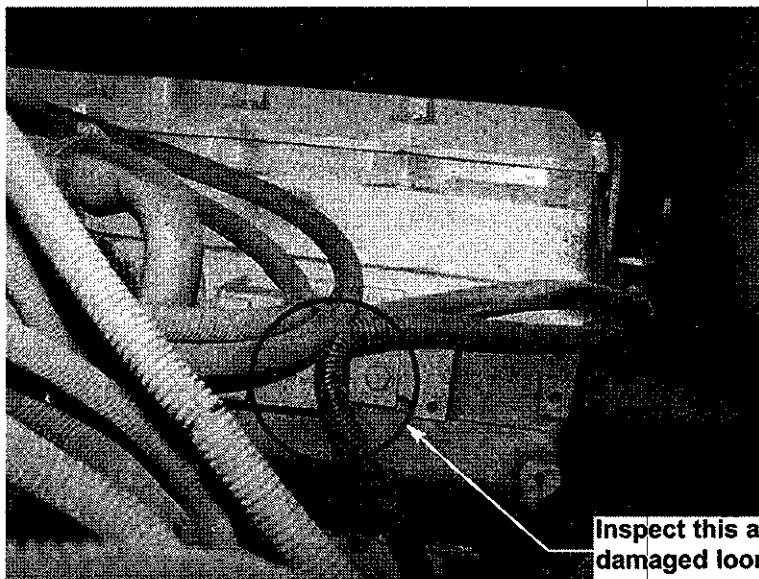
Figure 1

1. Disconnect battery cables from batteries.
2. To inspect wiring, cut any existing zip ties from electrical box on right side of engine compartment to the alternator, and the relay for intake heater. These are two red 2ga. wires.
3. Inspect wire loom for damage in these areas. **Figure 1**

Inspect this area for damaged loom.

- 3.1 If damage to the wire loom exists, continue to step 4.
- 3.2 If no damage to wire loom exists, skip to step 8.
4. Partially remove existing wire loom at area of contact with fuel line.
