**Southeast Toyota Distributors, LLC**  
100 N.W. 12th Avenue  
Deerfield Beach, Florida 33442  
(954) 429-2000

Subject: Safety Recall- 08E-029  
Wheel nuts

## Campaign number 08E-029

### 2007 Tundra Wheel Nut Replacement Procedure

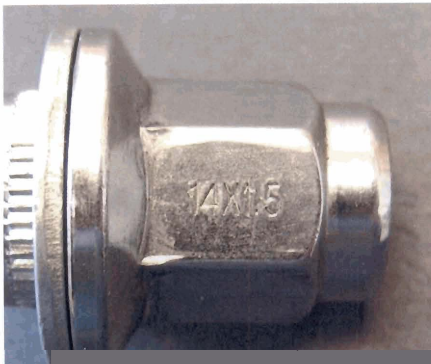
An alloy wheel was sold and/or installed by Toyota Dealers in Southeast Toyota region (Alabama, Florida, Georgia, North Carolina, South Carolina). The alloy wheels are packaged with attaching wheel nuts. It has been determined that the wheel nuts may crack and break if the wheels are not installed carefully or if the wheel nuts are not carefully torqued. This condition may occur at time of wheel installation, tire rotation or service.

Figure 1 Identifying wheel nuts requiring replacement

You are requested to replace all of the non locking wheel nuts on the vehicle (4 per wheel, total 16 wheel nuts per vehicle).

1. Raise the wheels off the ground.
2. Remove the 4 non-locking wheel nuts from wheels.

**NOTE:** Locking wheel nuts are not to be replaced.

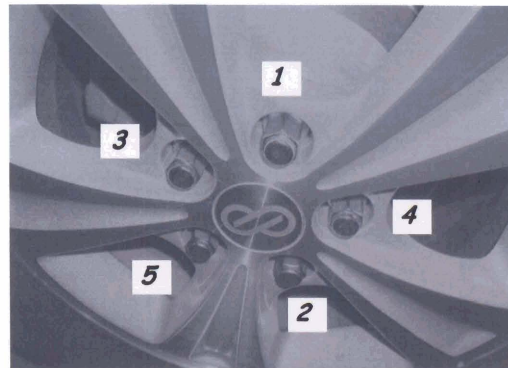
Figure 2. Torque wheel nuts in the order shown.

3. Save removed wheel nuts for parts return.
4. With wheel firmly positioned against hub, install new wheel nuts finger tight on the wheel studs.
5. Torque each wheel nut a little at a time until a torque of 97 ft. lb is reached. Use the tightening sequence shown in Figure 2.
