# Recall Bulletin 71221

Bounder  
Diesel,  
Discovery,  
Excursion,  
Expedition,  
Providence,  
Revolution LE,  
with serial  
numbers  
listed in this  
Bulletin

**SUBJECT:**  
Replacing  
the Magnum  
Inverter

**ISSUE DATE:**  
January 2008

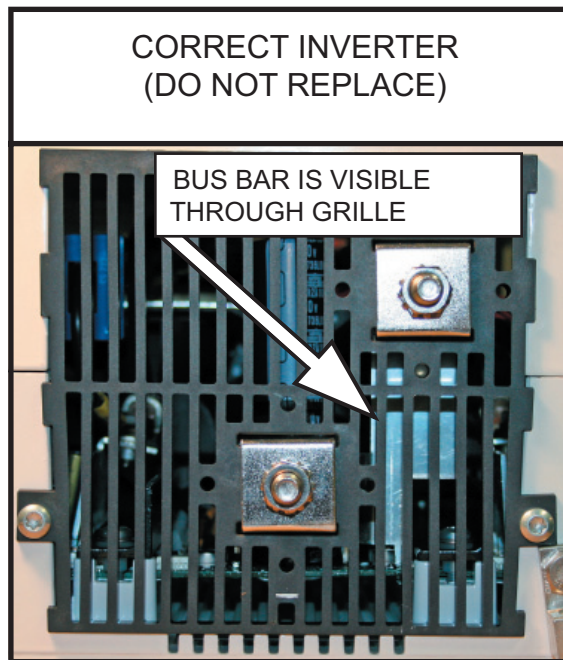
**Figure 1**

3. Open the motor home's electrical compartment containing the Magnum inverter and look through the grille covering the inverter's circuitry:
  - A. If a bus bar can be seen through the grille, as shown in Figure 1, the inverter is correct and no further action is necessary.
  - B. If red, yellow, and blue wires are visible, AND a bus bar is NOT visible, as shown in Figure 2, the inverter must be replaced. Contact Fleetwood Dealer Technical Support for a Prior Authorization Request (P.A.R.), then proceed with the Correction, "Replacing the Magnum Inverter", on Page 3.

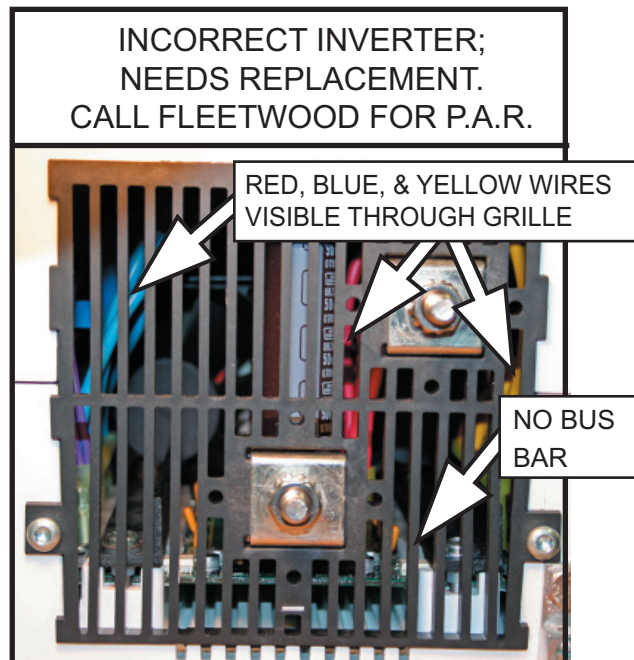
**Figure 2**

Circuitry inside certain Magnum Inverters can cause an inoperative condition, overload, and risk of fire.

**For this recall only, if the inspection procedures determine defective components, the entire inverter must be replaced.**
