NEWMAR CORPORATION WARRANTY DEPARTMENT

TECHNICAL SERVICE BULLETIN							
DATE ISSUED	MODEL YEAR(S) AFFECTED		MODEL(S) AFFECTED			TSB #	
3/31/08	2007-2008		All DP on Freightliner Chassis			329	
BRAND						TYPE	
All	<input type="checkbox"/>	American Star	<input type="checkbox"/>	Mountain Aire	<input type="checkbox"/>	All	<input type="checkbox"/> TT <input type="checkbox"/>
Cypress	<input type="checkbox"/>	Dutch Star	<input checked="" type="checkbox"/>	Kountry Aire	<input type="checkbox"/>	FW	<input type="checkbox"/> CA <input type="checkbox"/>
Northern Star	<input type="checkbox"/>	Kountry Star	<input checked="" type="checkbox"/>	Essex	<input type="checkbox"/>	DP	<input type="checkbox"/> DB <input type="checkbox"/>
Scottsdale	<input type="checkbox"/>	King Aire	<input type="checkbox"/>	London Aire	<input type="checkbox"/>		
All Star ME	<input type="checkbox"/>	Ventana	<input checked="" type="checkbox"/>				
<input type="checkbox"/> Air Conditioning & Heating <input type="checkbox"/> Appliances & Accessories <input type="checkbox"/> Cabinets & Furniture <input checked="" type="checkbox"/> Chassis Components <input type="checkbox"/> Construction Components				<input type="checkbox"/> E

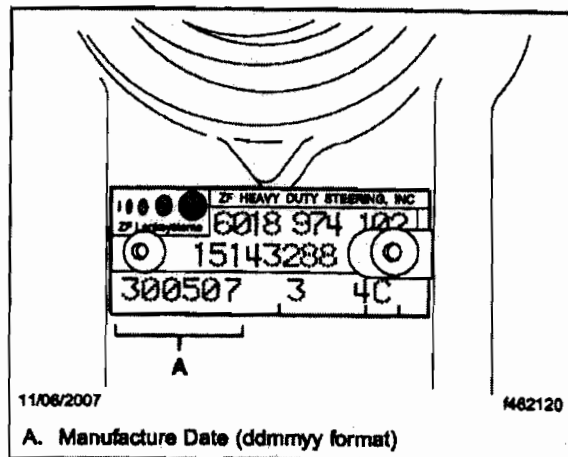
Fig. 1, Data Plate Identification

1. Check the base label (Form WAR259) for a completion sticker for FL509 (Form WAR280) indicating this work has been done. The base label is usually located on the front wall under the dash in motorhomes. If a sticker for FL509 is present, nothing further needs to be done. If a sticker is not present, go to the next step.
2. Shut down the engine, set the parking brake, and chock the tires.
3. Check the date code on the data plate of the steering gear. See Fig. 1.
 - 3.1 If the date code is 250407 or more, nothing further needs to be done. Go to step 4.
 - 3.2 If the date code is less than 250407 go to "Steering Gear Replacement."
4. Clean a spot on the base label, write the Recall number, FL509, on a blank completion sticker, and attach it to the base label.
5. Remove the chocks from tires.
