SAFETY RECALL BULLETIN

AUTOCAR SAFETY RECALL A-0801 NHTSA RECALL 08V-024

FEBRUARY 2008

SUBJECT: INTERMEDIATE STEERING SHAFT LENGTH

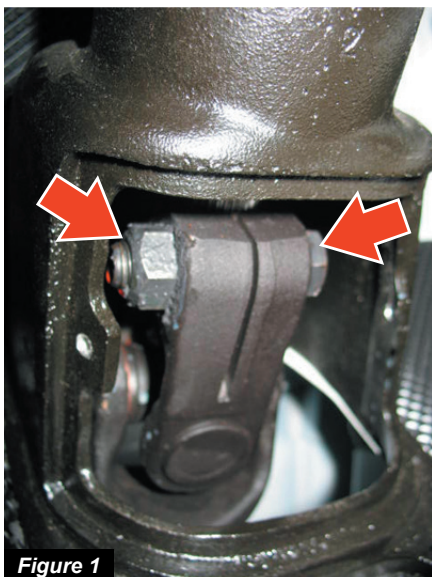
Figure 1

Autocar has determined that the intermediate steering shaft between the in-cab steering components and the power steering gear box, located on the vehicle's frame, is too long. The additional length in the steering shaft results in the need for increased steering effort on the part of the vehicle's driver. The driver may not be prepared for such need, which could result in an unpredictable reaction by the driver.

- Using a #2 Phillips screw driver, remove the cover over the lower steering column universal joint. This will expose the steering column to intermediate shaft pinch bolt (*Figure 1*).

- Note the orientation of the yoke on the splined steering column. The replacement steering shaft must be oriented the same as the previous intermediate shaft.
- Using a 11/16" socket and 5/8" box wrench, remove the pinch bolt and backing nut (*Figure 1*).
