**Re: Defect Information Report – Supplemental Report No. 1  
08V-031, FL-522, Brake Pedal Pushrod Assembly**

## Subject: Brake Pedal Push Rods

**Models Affected: Specific Freightliner FLD, Classic, and Classic XL models manufactured between July 23, 2007, and October 12, 2007.**

February 2008  
FL522A  
NHTSA # 08V-031

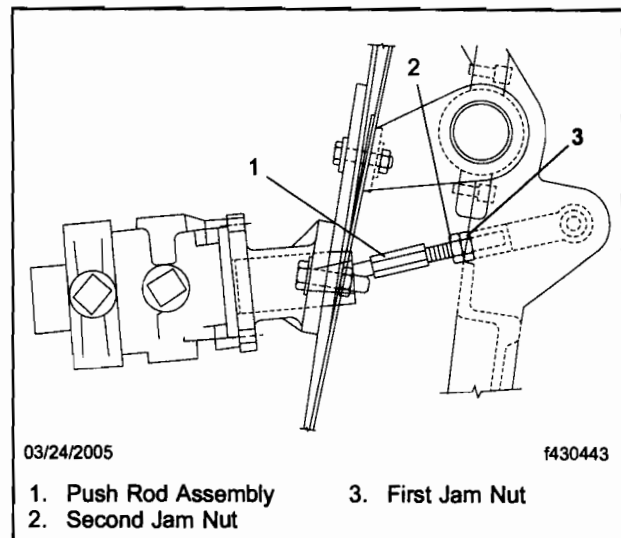
**Fig. 2, Push Rod Adjustment**

The jam nuts that secure the adjustment of the brake pedal pushrod may not be tightened properly. This could result in a gradual loss of braking performance or a complete loss of brakes, leading to a possible vehicle crash without prior warning.

7. After the stop bracket has been positioned and locked, adjust the length of the push rod assembly. Hand-tighten the push rod until there is no free-play and it is no longer free to rattle. See **Fig. 2**.

8. Holding the push rod in position with a wrench, tighten the first jam nut to the clevis. Torque the jam nut 12 to 18 lbf-ft (16 to 24 N-m).

9. Holding the push rod in position, tighten the second jam nut to the first, then torque it to 12 to 18 lbf·ft (16 to 24 N·m).
10. Check for free-play. If the push-rod assembly can rattle after depressing the brake pedal no more than 1/4 inch (5 mm), there is too much free-play. If necessary, repeat the adjustment of the push rod assembly. Air should actuate within 1/4 inch (5 mm) of pedal travel.
11. Install the carpet and backing.
12. Install the driver-side lower electrical panel cover.
13. Install the driver-side lower dash covers.
14. Remove the chocks from the tires.
15. Clean a spot on the base label (Form WAR259). The base label is usually located on the passenger-side door about 12 inches (30 cm) below the door latch. Write the recall number on a blank, red completion sticker and attach it to the base completion label.
16. Remove the chocks from the tires.
