Safety Recall #03 Front Control Module

Models

2008 (WK) Jeep® Grand Cherokee

2008 (XK) Jeep® Commander

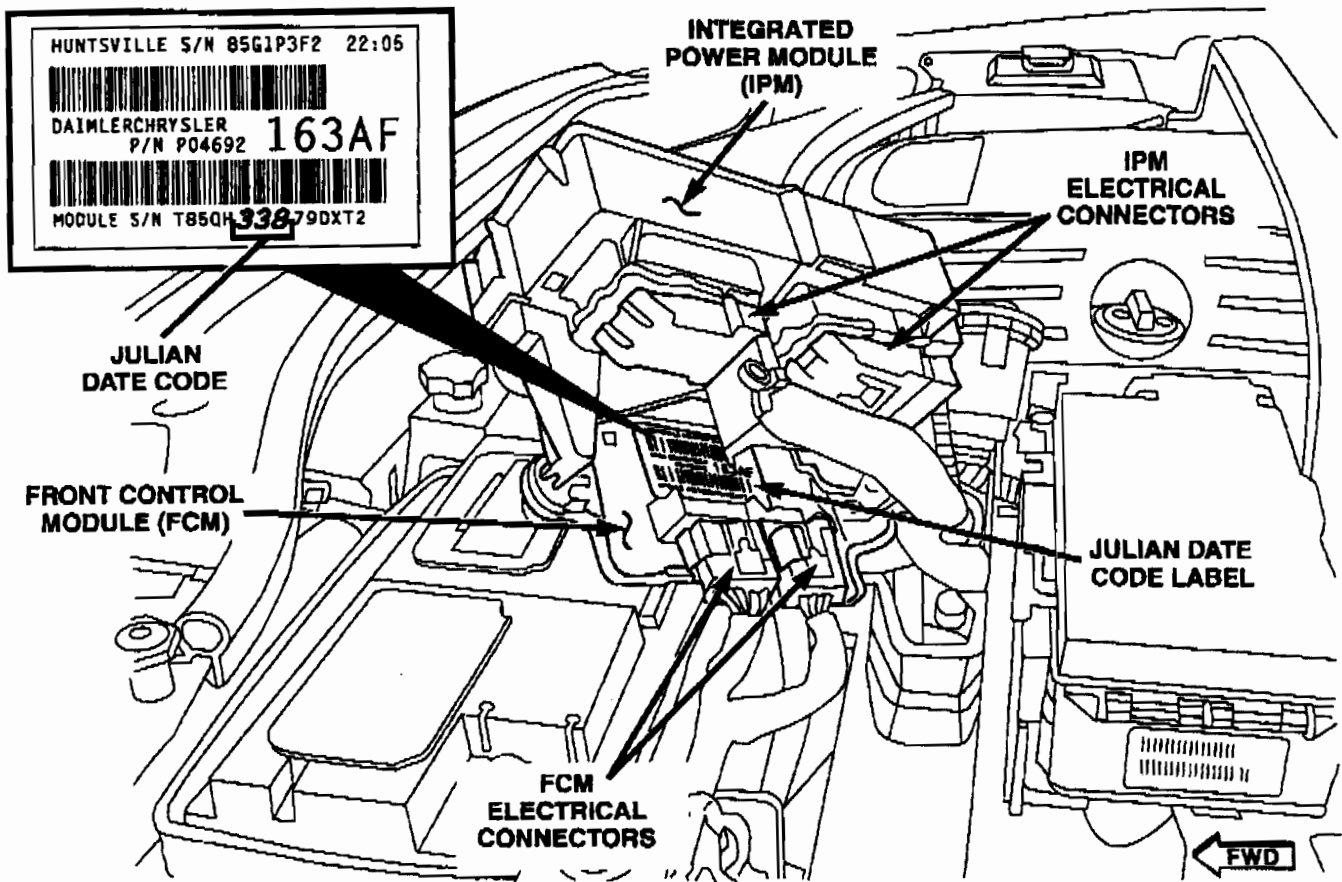
Figure 3

3. Inspect the Julian date code on the label located on the backside of the FCM (Figure 3).

CAUTION: The FCM has two labels. One label is located on the front side of the FCM. The second label is located on the back side of the FCM between the module electrical connectors. The Julian date code label to be inspected is located on the back (electrical connector) side of the FCM.

NOTE: The Julian date is the 6th, 7th, and 8th character in the bottom row of numbers (Figure 3).

- If the Julian date code is lower than 337 or higher than 339 the FCM **does not** require replacement. Continue with Step 15 of this procedure.
- If the Julian date code is 337, 338, or 339 the FCM **must be replaced**. Continue with Step 3 of this procedure.

4. Disconnect the two IPM electrical connectors (Figure 3).
5. Disconnect the two FCM electrical connectors (Figure 3).
6. Remove the IPM assembly from the vehicle.
7. Remove the four fasteners securing the FCM to the IPM (Figure 4).
8. Separate the original FCM from the IPM by pulling the two straight away from each other to disengage the electrical connector (Figure 5).
9. Transfer the plastic cover from the original FCM module to the new FCM module (Figure 4).
10. Connect the new FCM to the IPM by lining up the electrical connector and pushing the two modules together (Figure 5).
11. Install the four fasteners securing the FCM to the IPM (Figure 4).
12. Position the IPM into the vehicle.
13. Connect the two FCM electrical connectors (Figure 3).
14. Connect the two IPM electrical connectors (Figure 3).
