**Subject: Revised Documents for Recall Campaigns 08V-157 (20L8/JY),
08V-064 (70D1/JX) and 07V-375 (JL00/JL)**

Safety Recall Circular

Code: **JX/70D1**

**Subject: 2008 MY Audi TT Coupe
Replace C-Pillar Trim Cover Clip**

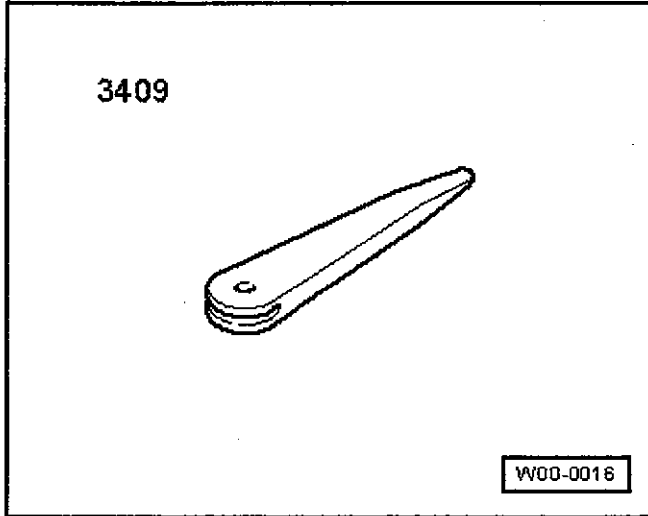
← Trim Removal Wedge -3409-

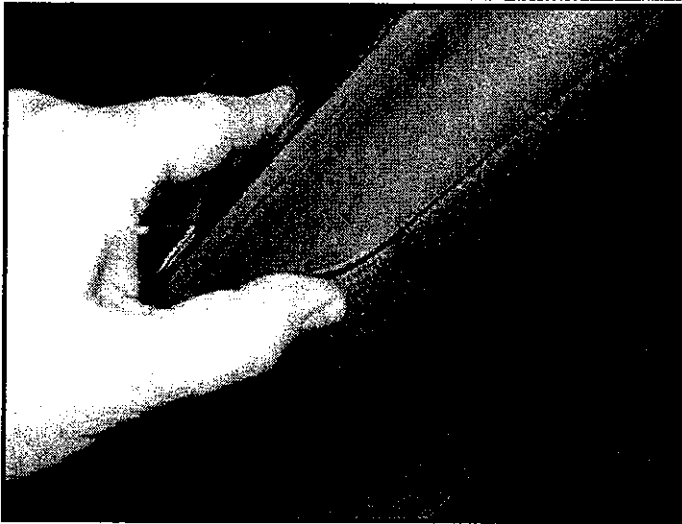
If door seals are not installed properly water leaks may occur

- ← Reinstall right side C-pillar trim. Restore door seal position after trim is reinstalled
- Repeat installation of left side C-pillar trim and ensure door seal position after trim is installed
